# Twelve-Fatality Hotel Arson

Reno, Nevada

USFA-TR-164/May 2008

# **TWELVE-FATALITY HOTEL ARSON RENO, NEVADA**

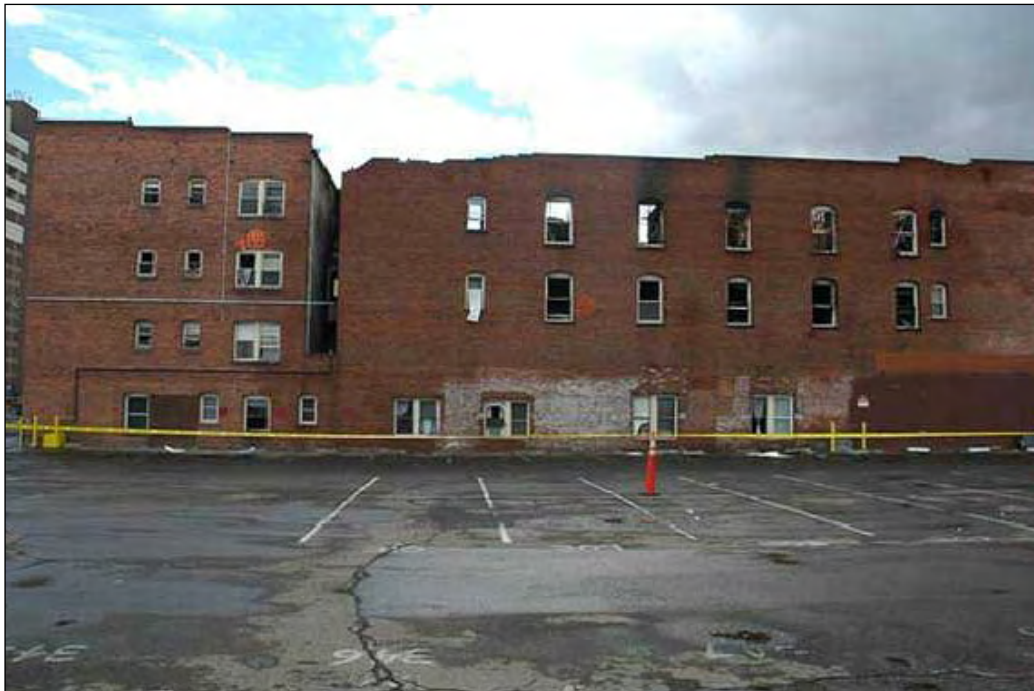
**Figure 2. Offset Between the Annex and North Wing.**

The north and south wings of the hotel were three stories in height, and the Annex was four stories. The Annex was attached to the east end of the north wing at ground level, and above the first floor only by narrow enclosed staircases, which can be seen in the following photo between the Annex and north wing. The height difference between the north wing and Annex created a slight offset of approximately 3 to 4 feet between floors of the Annex and north wing. Figure 2 shows the offset in height between the Annex and north wing.

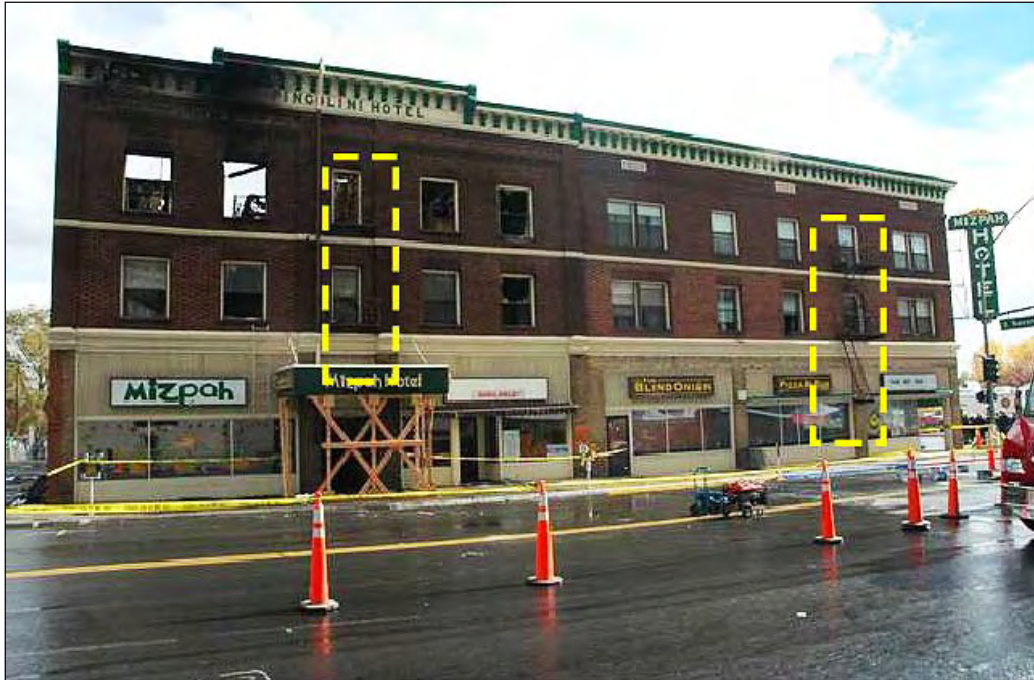
**Figure 5. Front Fire Escapes.**

The hotel had four exterior fire escapes. Two were located on the front (Side A) of the hotel at the west end of the north and south wings, and two at the rear of the building that serviced the south wing and Annex. The north and south wing fire escapes serviced the second and third floors of the hotel. The fire escape at the rear of the Annex serviced the second through the fourth floors of the Annex. **The only access to the fire escapes was through the interior hallways.** During the fire, the interior conditions deteriorated so rapidly that the interior hallways and stairwells quickly became untenable and residents who failed to exit the building immediately could not get to the fire escapes

and to safety. Figure 5 and Figure 6 show the location of the exterior fire escape on the front and rear of the hotel.

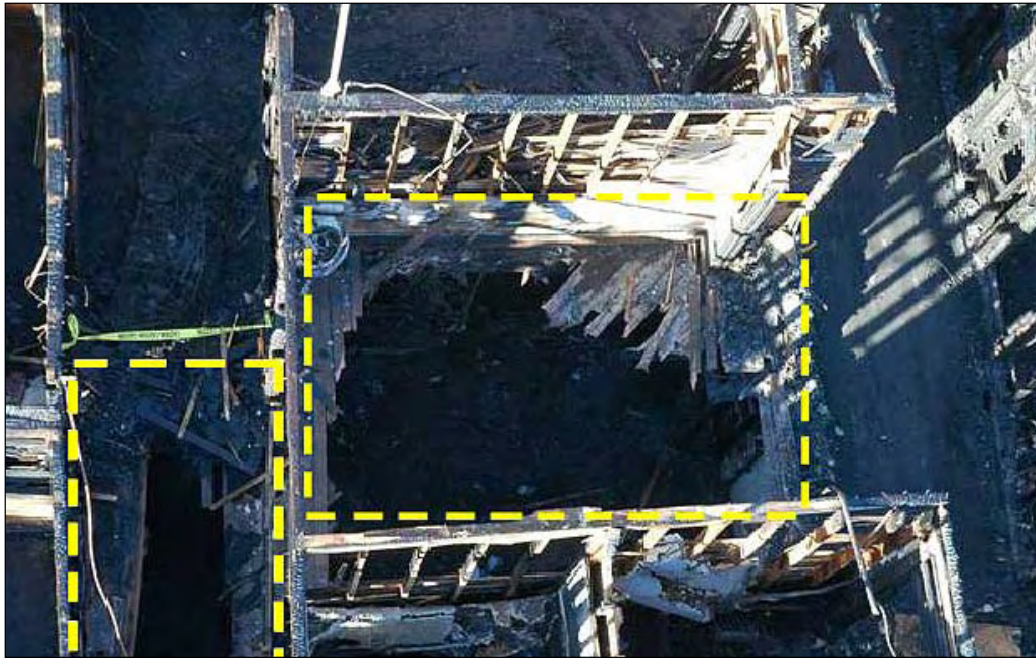
**Figure 9. Overhead Photo of Collapsed Areas of Third Floor.**

The fire spread rapidly throughout the second and third floors, fed primarily by the polyurethane mattresses stacked along the hallways. The fire extended to the third floor via the stairwells at the west and east ends of the north wing. Virtually all of the rooms on the second and third floors of the north wing were either destroyed or heavily damaged by fire and smoke. Although the annex and south wing suffered little direct fire damage, these areas sustained moderate to heavy smoke damage. The majority of the roof over the north wing was consumed by the fire and eventually collapsed, and a segment of the third floor partially collapsed as well.

ordered, and all personnel were present. Figure 9 shows the partial collapse of the north wing's third floor south hallway.

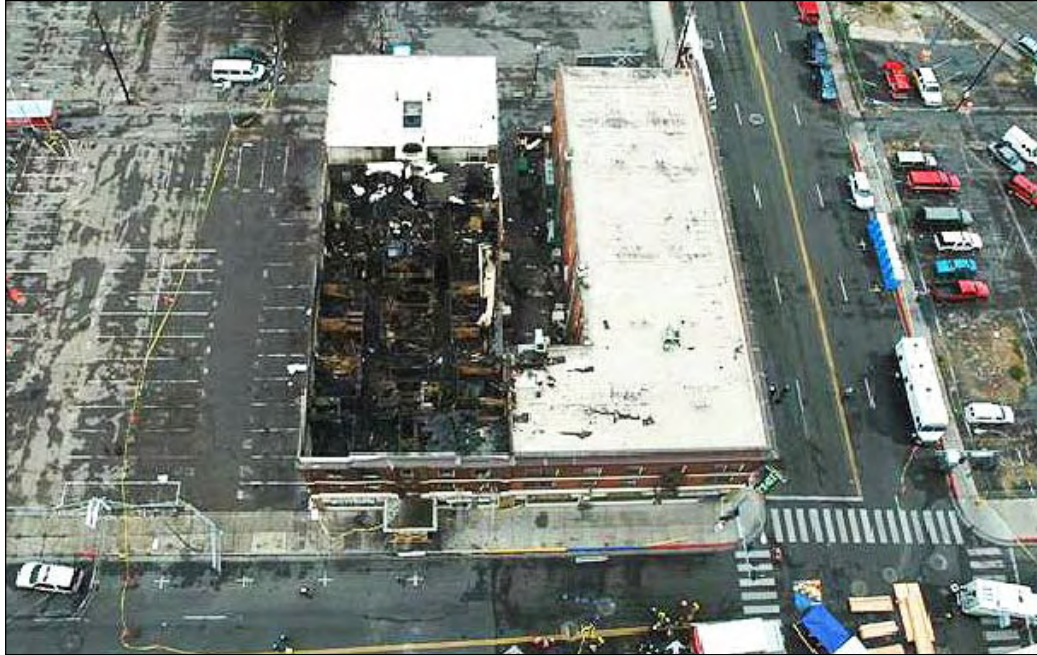
**Figure 14. Extent of Fire Damage—North Wing.**

**Fire Investigation Process**—A systematic postfire investigation was conducted of the building, moving from areas of least fire damage to areas most heavily damaged. Scene processing began with an inspection of the exterior of the building. The entire exterior of the building was photographed from the ground, from overhead using aerial apparatus, and from the roof of Harrah's Hotel and Casino across the street from the Mizpah Hotel. It was determined that the fire had been contained to the north wing, and did not extend into the south wing, which was the goal of the

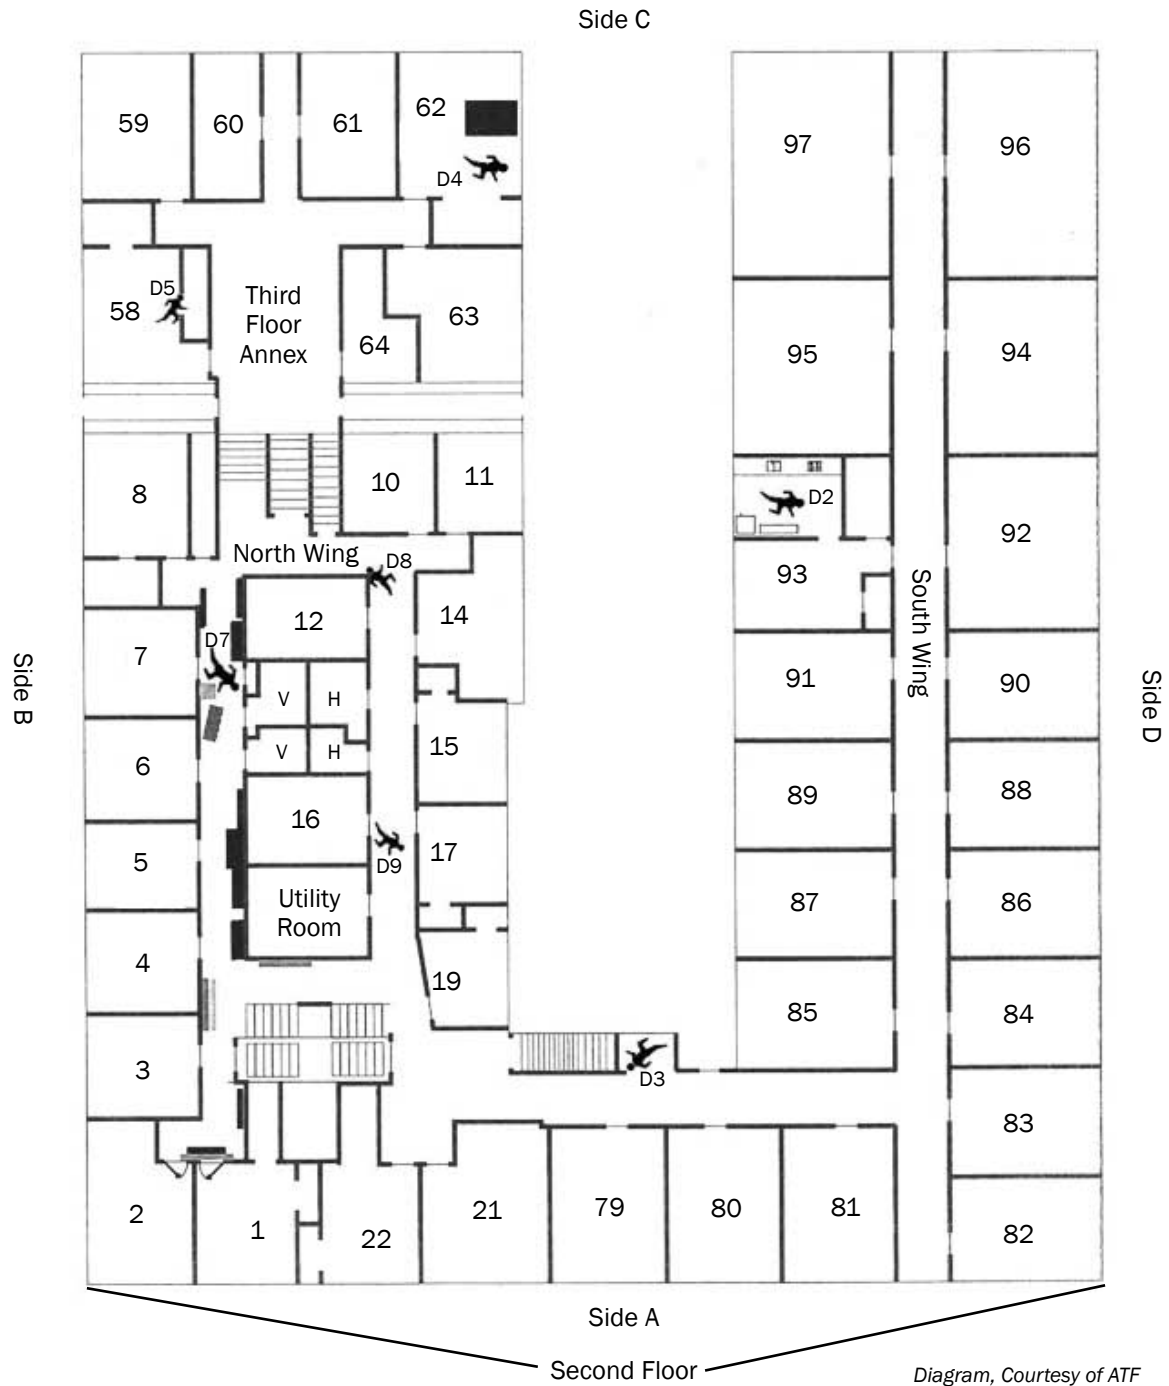
Figure 15. Fire Victim Locations: Second Floor and Third Floor Annex.

According to the IC, many of the building occupants who attempted to exit the building through the interior corridor perished in the fire. Seven of the 12 fire fatalities were found in the hallways during the postfire investigation. Figure 15 and Figure 16 show the locations where the fire victims were found.

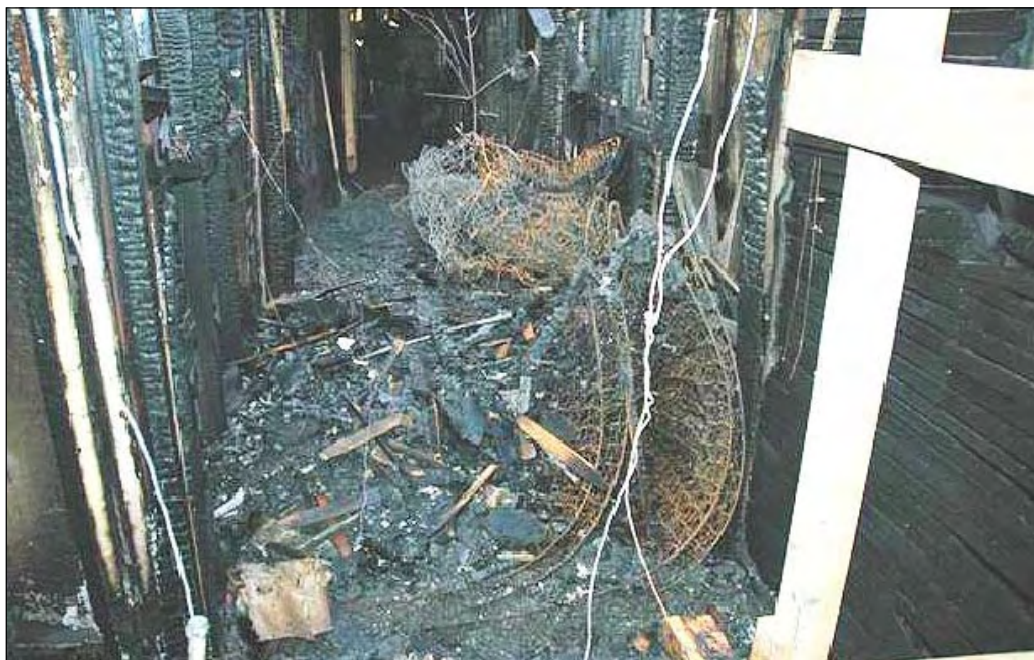
**Figure 17. Remnants of Mattresses in the Hallway of the Second Floor.**

The burn patterns along the north and south hallways of the north wing were representative of the 16 mattresses and box springs found along the second-floor hallways. Figure 17 shows the remnants of mattresses along the second-floor hallway. Some mattresses had been stacked together three deep. The mattresses supplied the fuel for the rapidly spreading fire through the hallways.

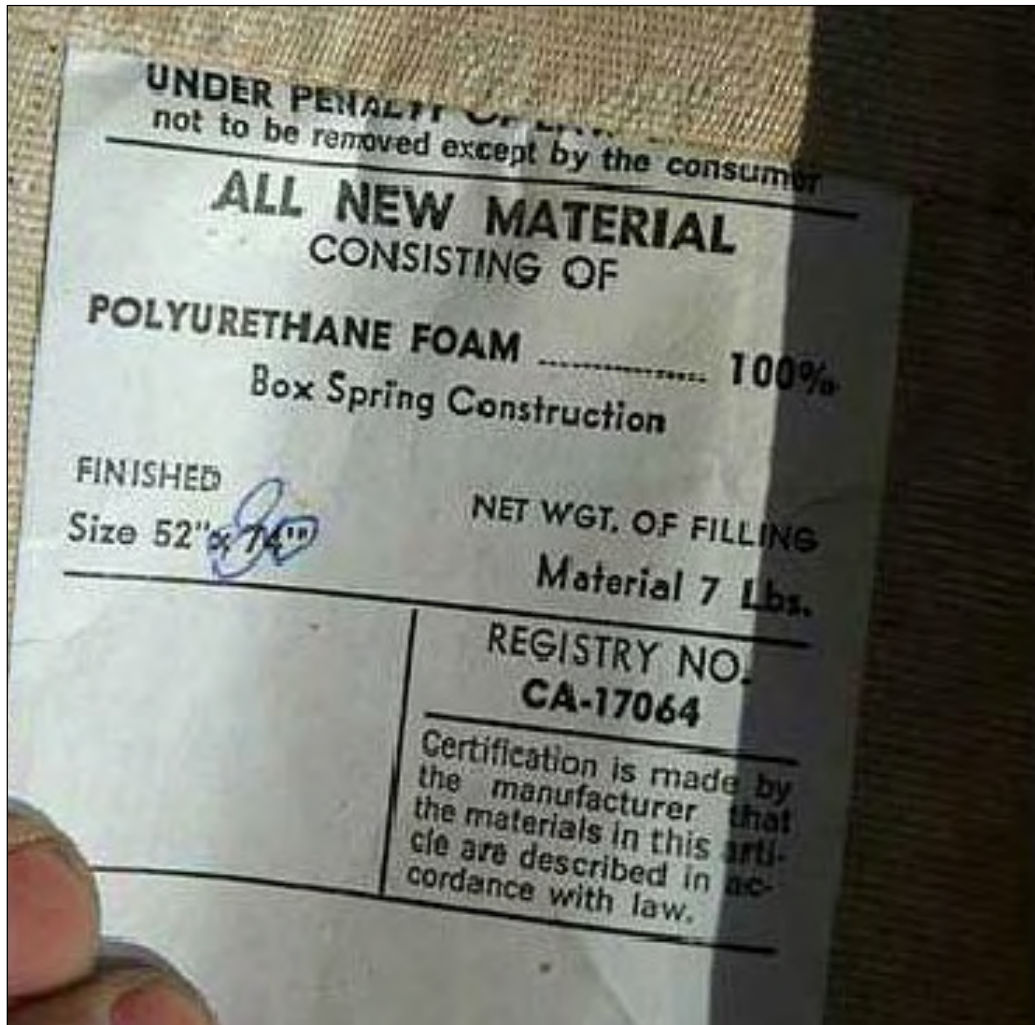
**Figure 17. Remnants of Mattresses in the Hallway of the Second Floor.**

**Fuel Load**—Several factors influenced the rapid spread of the fire. The first was fuel load. There were mattresses in the north hallway the day of the fire; the bulk of those old mattresses were ready for removal from the hotel. These were all twin institutional-grade mattresses and box springs, which measured 52 inches wide and 74 inches tall. The mattress tags read that the mattresses were 100-percent polyurethane foam, having a net weight of seven pounds of filling. Figure 18 is a photo of a mattress tag taken by ATF agents; it lists the type and quantity of padding contained in the mattresses that were stacked along the hallway walls.

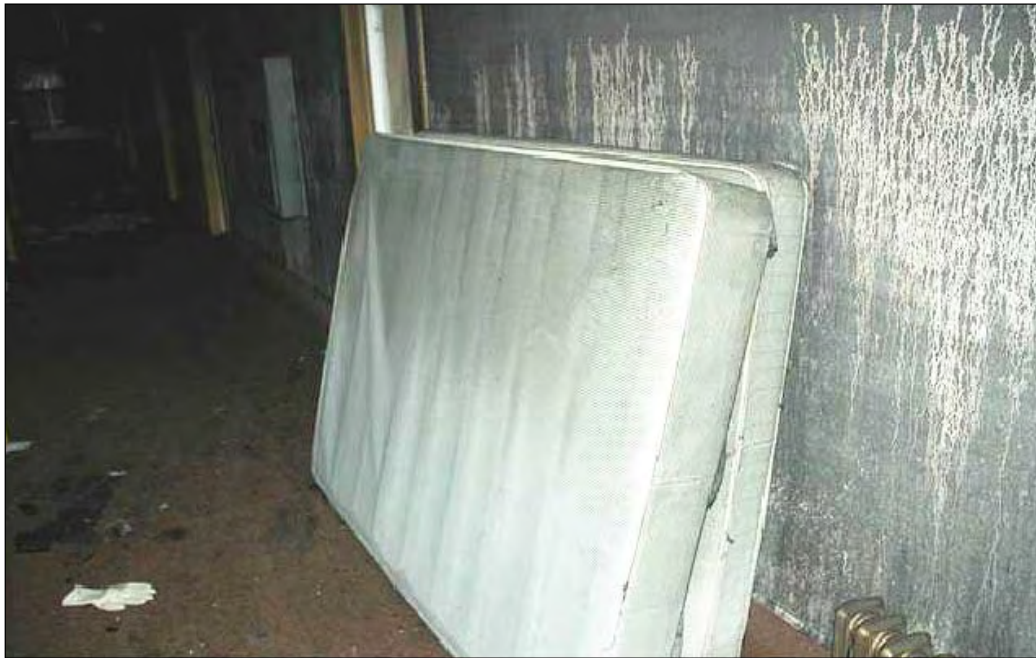
**Figure 19. Typical Mattresses That Lined the Second and Third Floor Hallways.**

The manner in which the mattresses were stacked against the wall aided in the spread of the fire. The mattresses were stacked vertically, and in some cases horizontally against the hallway wall. This placement allowed air to circulate around the mattresses, rapidly spreading the fire. Figure 19 shows the typical mattresses and how they were stacked along the walls of the hallways.
