State Fire Marshal Division
Stewart Facility
107 Jacobsen Way
Carson City, NV 89711
(775) 684-7501 • Fax (775) 684-7518

October 17, 2014

ALLEGATIONS BY VARIOUS NEVADA FIRE DEPARTMENTS THAT ELECTRIC METERS IN NV ENERGY'S REPLACEMENT PROGRAM HAVE CAUSED ELEVEN FIRES WITHIN THEIR JURISDICTIONS

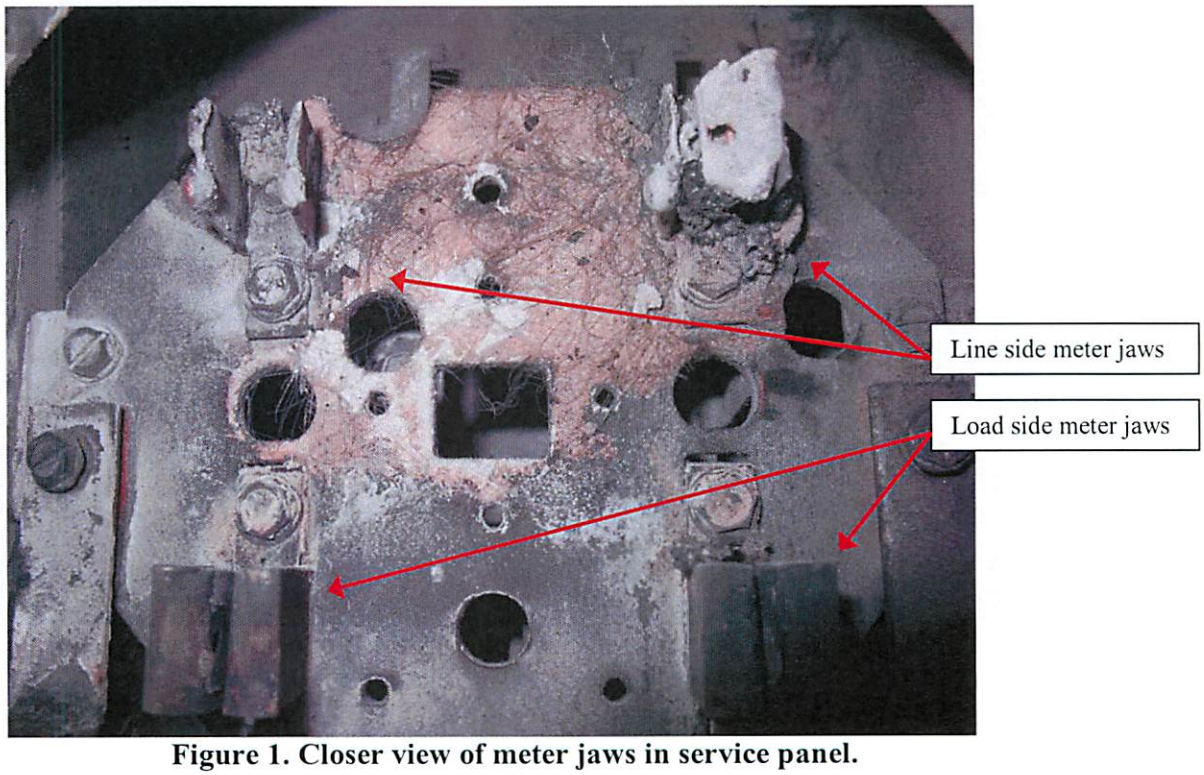
The greatest damage was centered at the line (incoming) side meter jaws at the meter loop (Photos13-14). Photo 14 is repeated below as Figure 1 with some descriptions to assist the reader. Closer views of the line and load side meter jaws are shown in Photos 15-22. The lower load side meter jaws are mostly undamaged (Photos 15-16). The upper left meter jaw is mostly missing (Photos 17-18). A large segment of that upper left jaw was found in the bottom of the panel with severe melting at the jaw clips (Photos 19-20). The upper right meter jaw has significant melting on the side towards the upper left jaw (Photos 21-22). It is important to note that there is still a portion of the meter stab still in both upper jaws. The meter "stab" is the male prong that extends from the rear of the meter and is "stabbed" into the meter jaws of the service panel to complete the connection from the utility to the main circuit breaker and the house wiring.

Figure 1. Closer view of meter jaws in service panel.

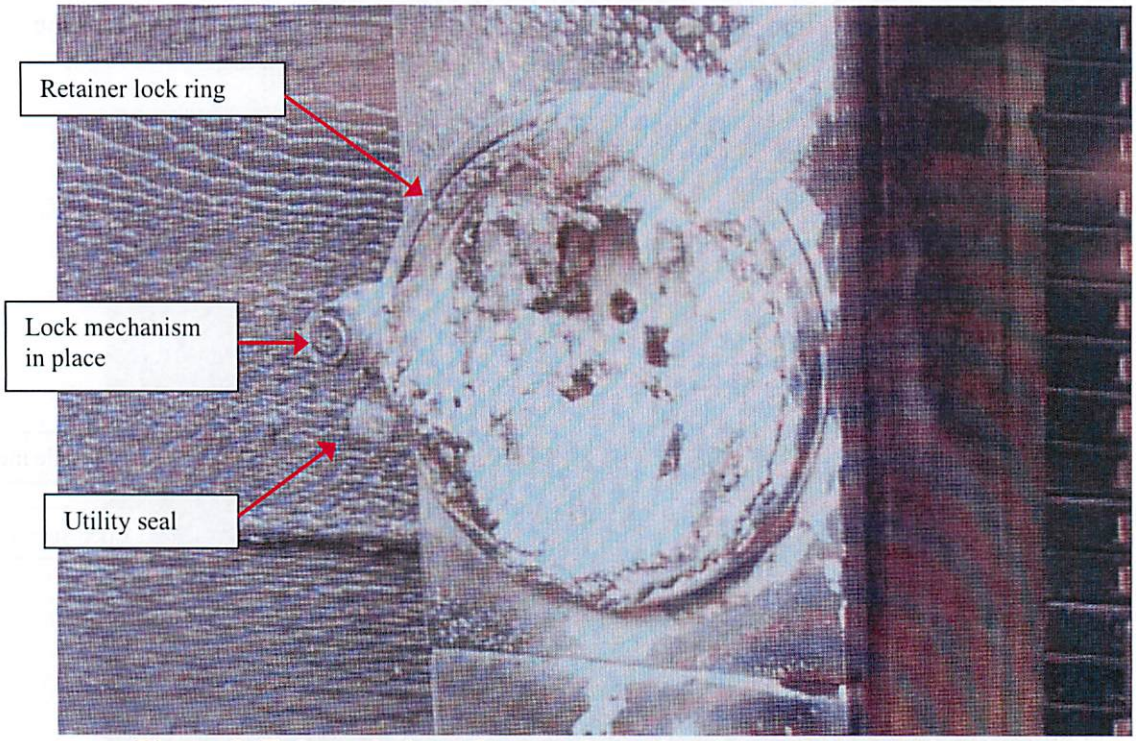
The lock ring associated with the subject meter was examined (Photos 36-37). There was no evidence of any tampering to the lock mechanism of the lock ring. Photos 38 and 39 show images of the panel and meter immediately after the incident with the meter locking ring and the seal still in position. Photo 39 is repeated as Figure 2 below with labels to assist the reader's understanding.

Figure 2. Enlarged view of scene photo showing lock ring and seal in place.

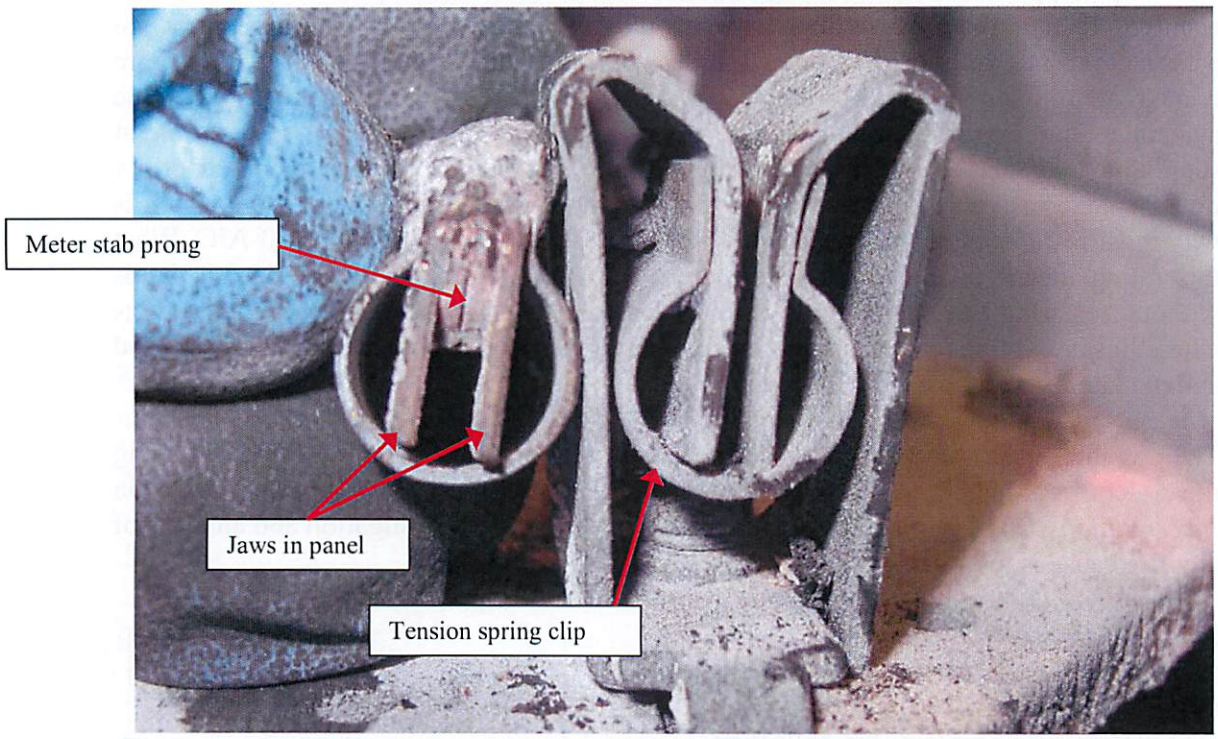
Figure 3. Melted meter jaw and stab from upper left meter stab position shown next to lower jaw.

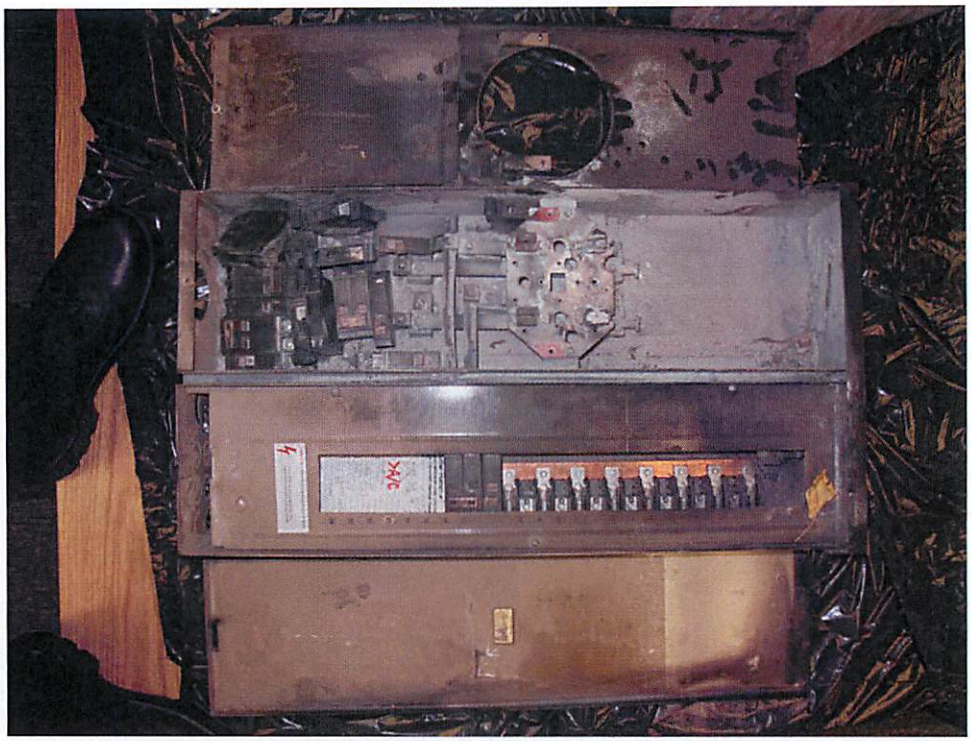
3. Front view of service panel and load center with covers removed.

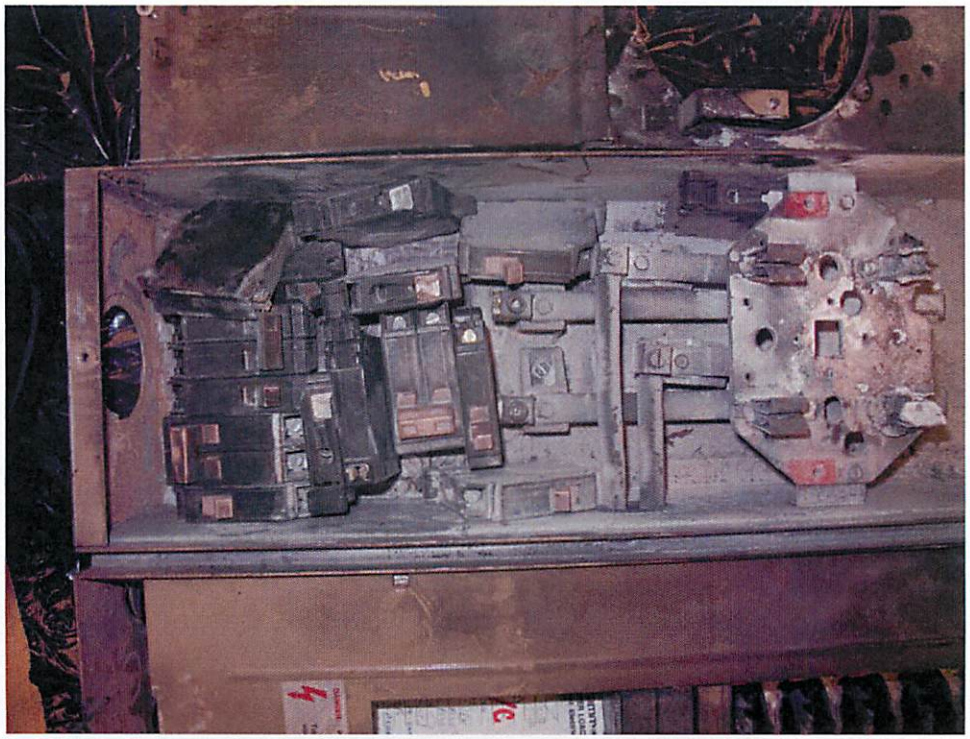
4. Circuit breakers found loose in utility section below meter jaws.

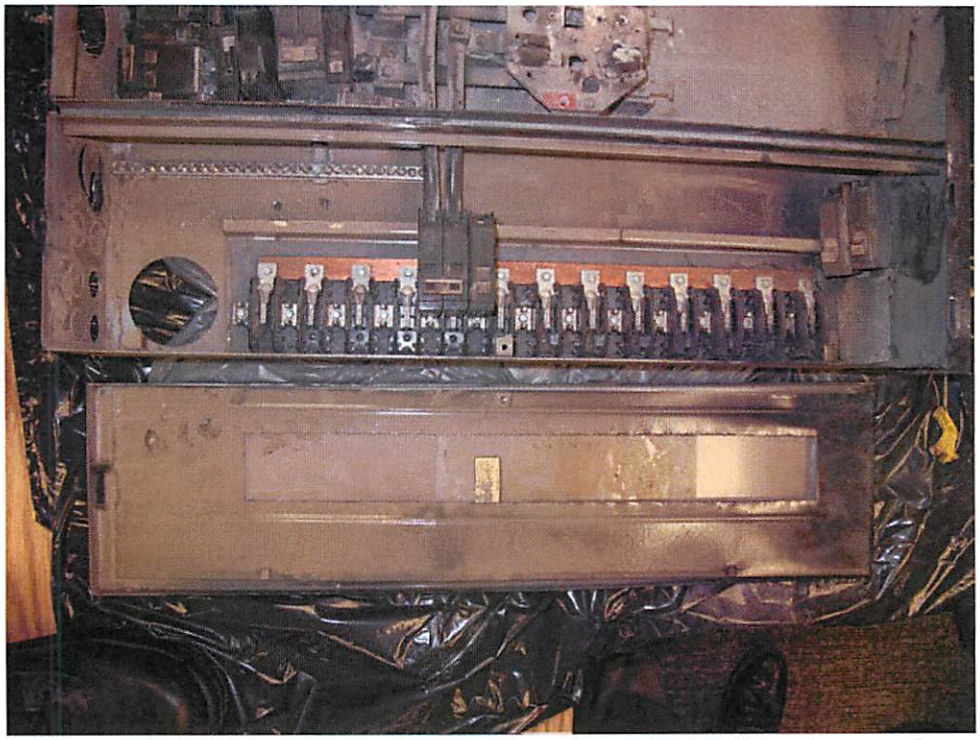
8. Bus assembly at rear of load center portion of service panel.

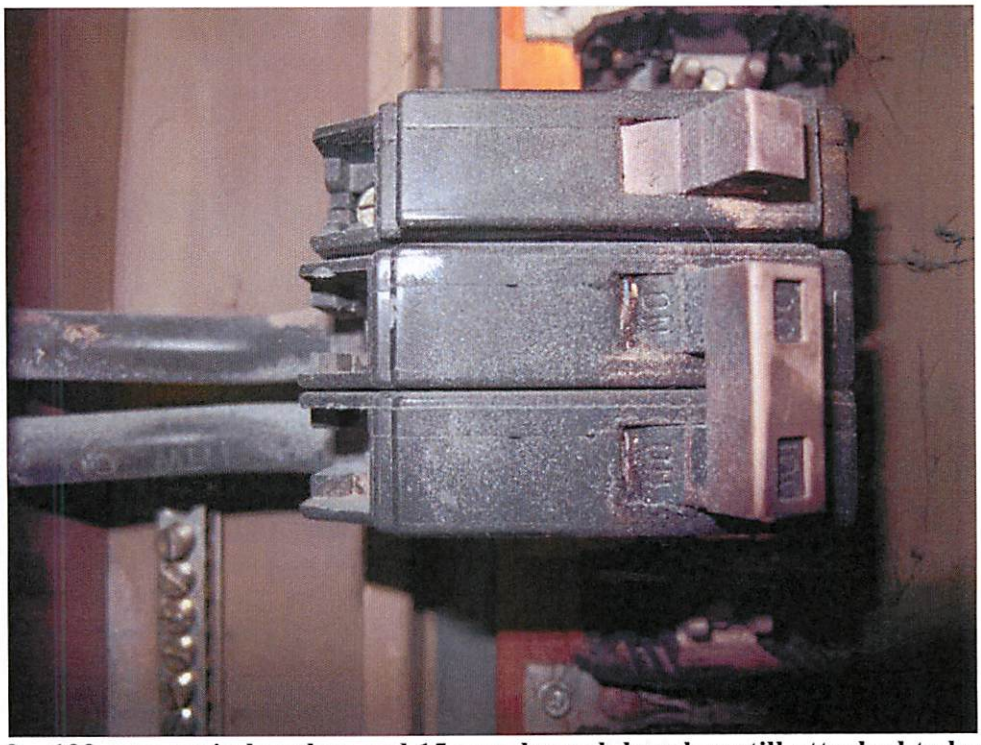
9. 100 amp main breaker and 15 amp branch breaker still attached to buses.

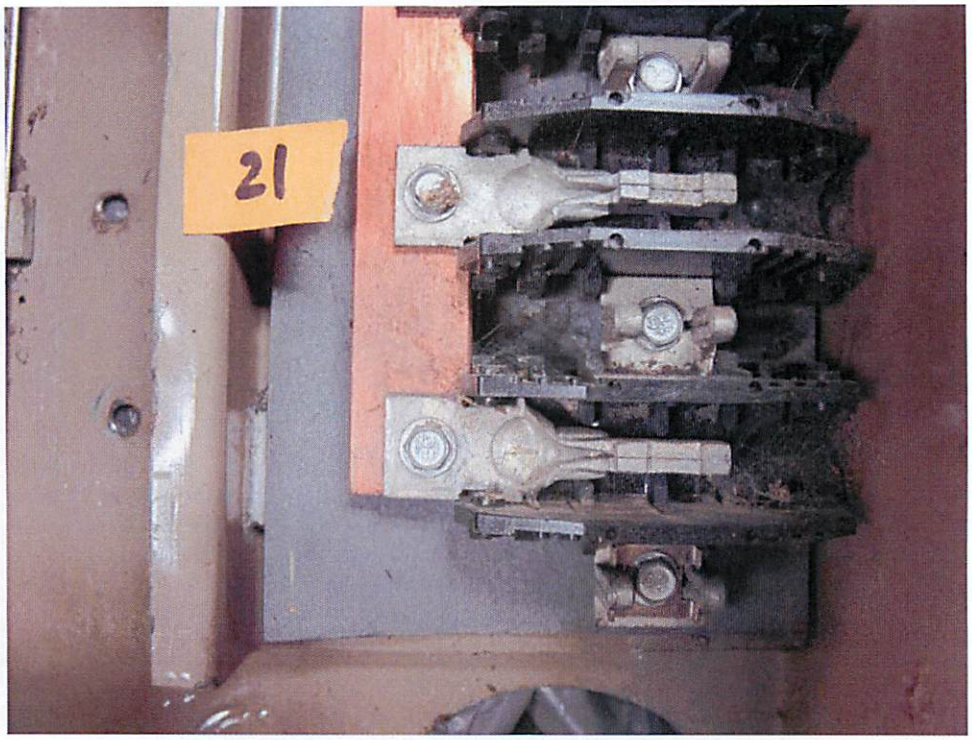
10. Space 21 labeled in load center side of panel.

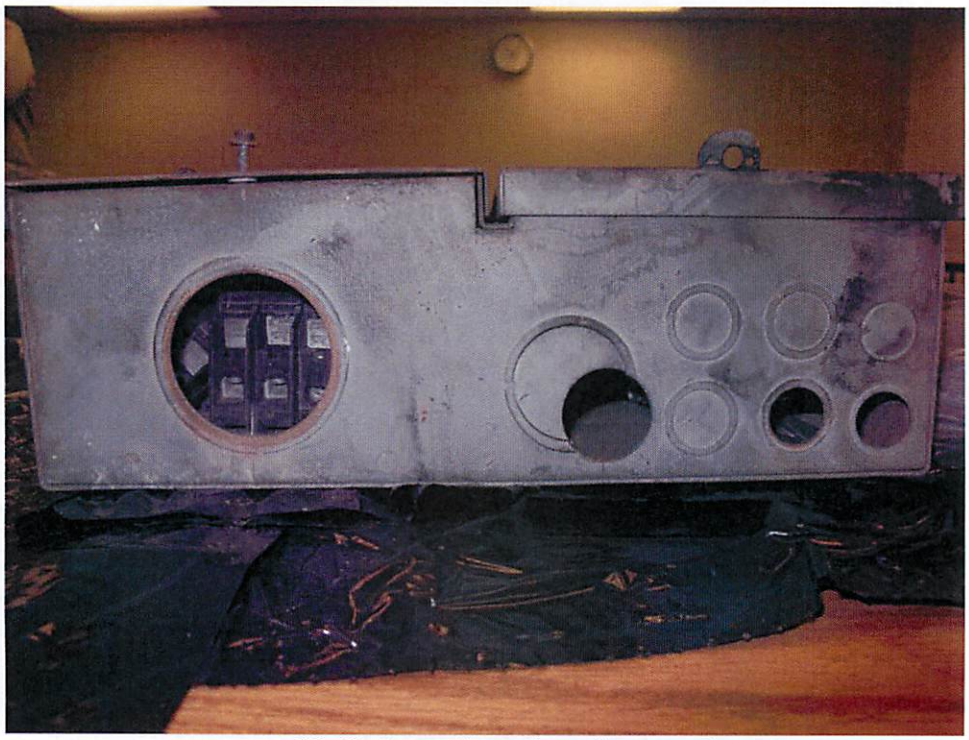
11. Bottom view of service panel.

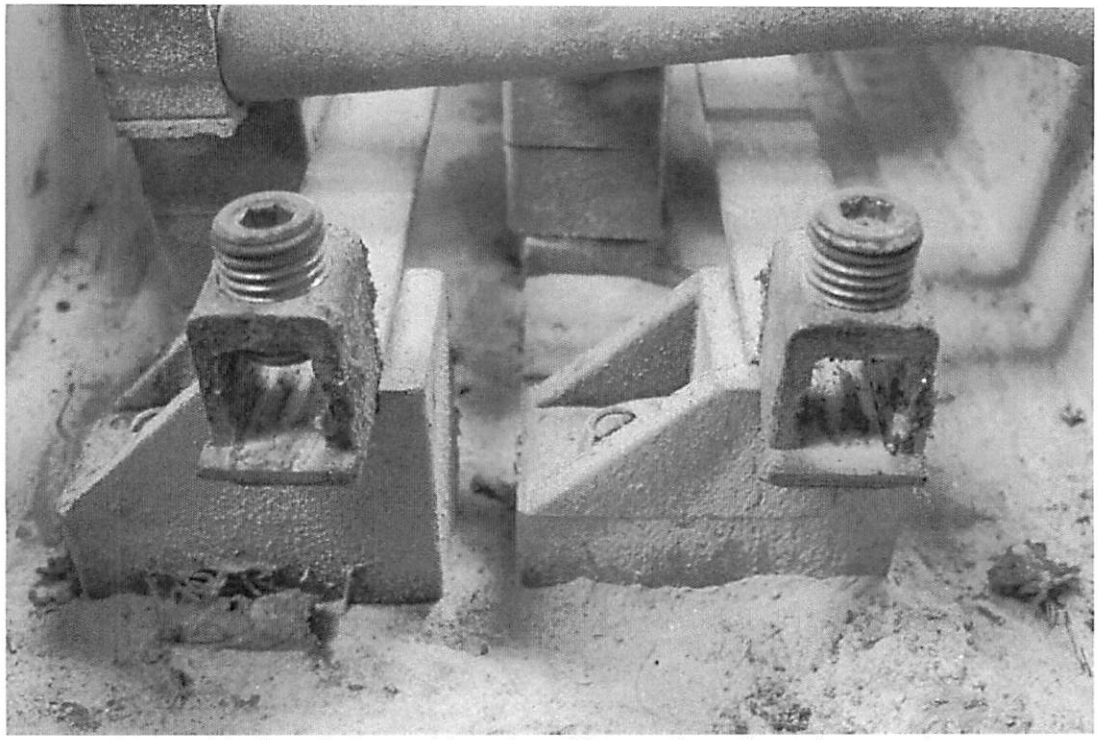
12. Supply lateral lugs in utility section of service panel.

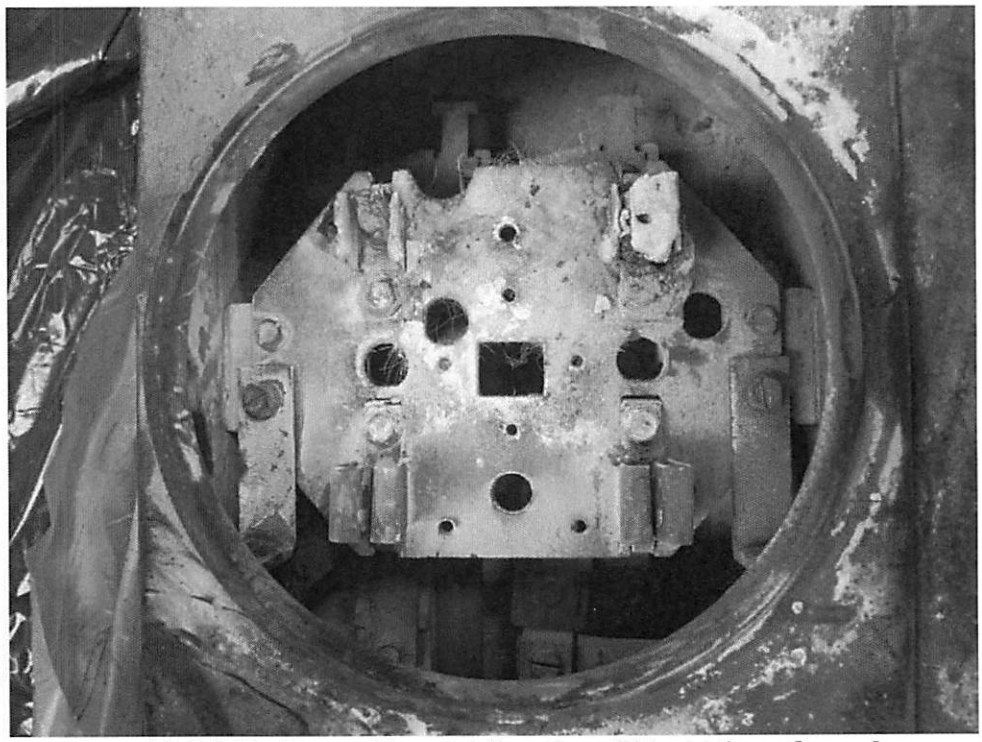
13. Meter loop and meter jaws in utility section of panel.

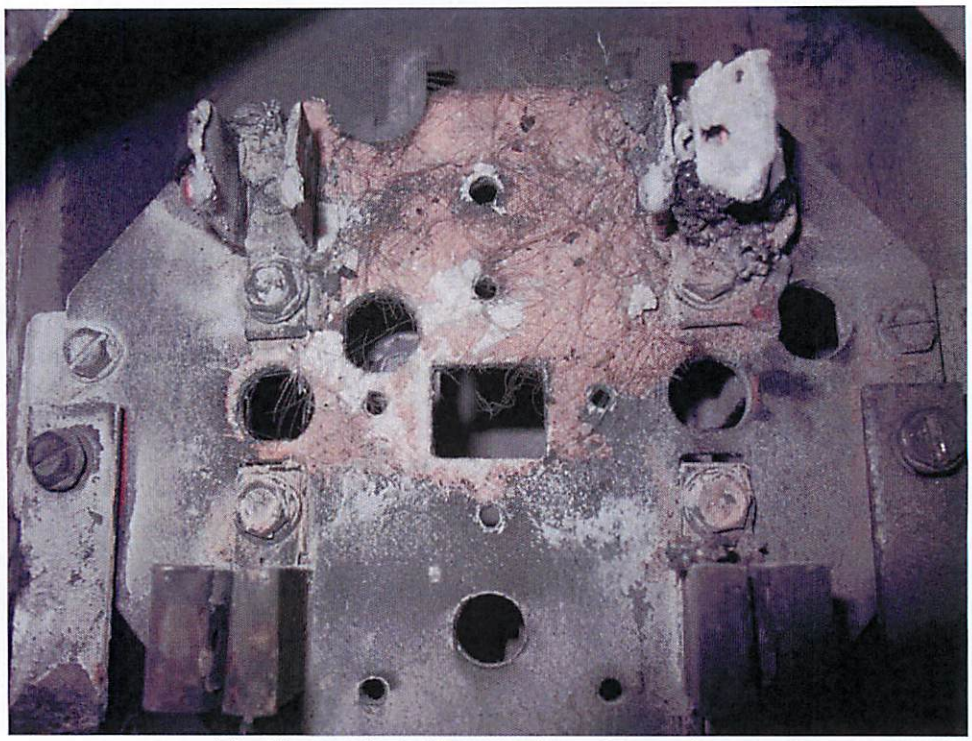
14. Closer view of meter jaws in service panel.

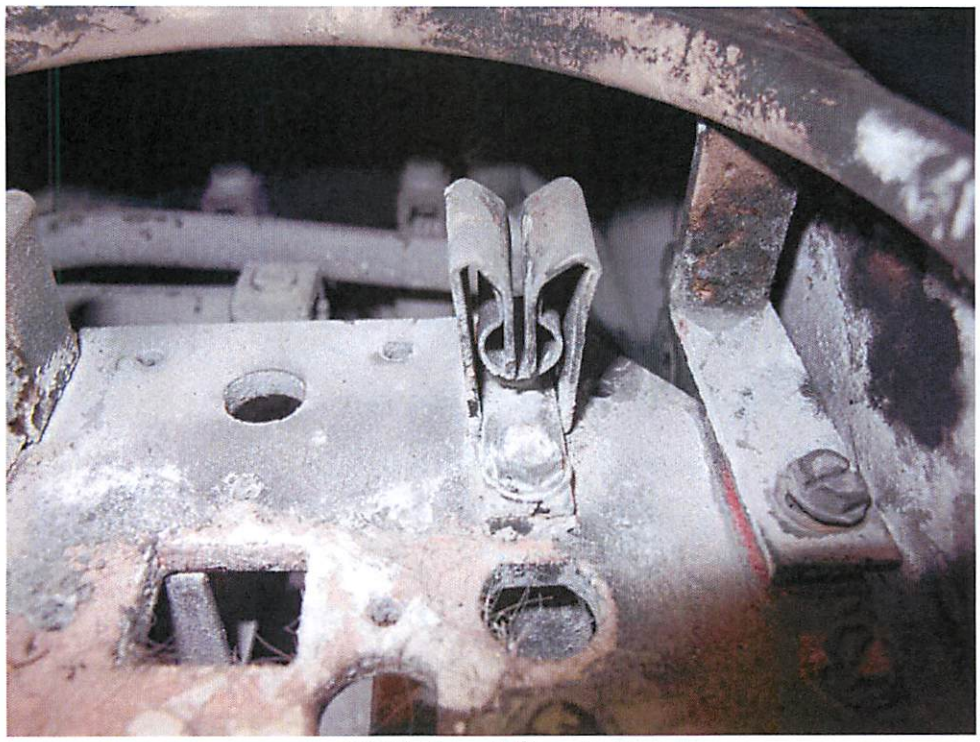
16. Bottom left meter jaw.

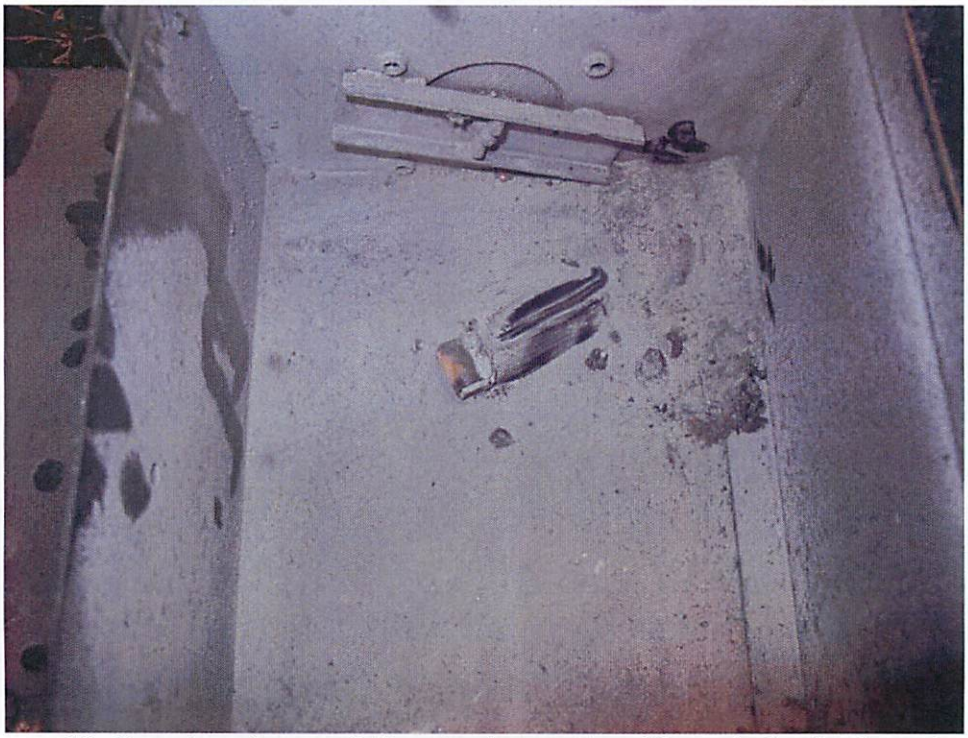
19. Remains of upper left meter jaw as found loose in back of panel.

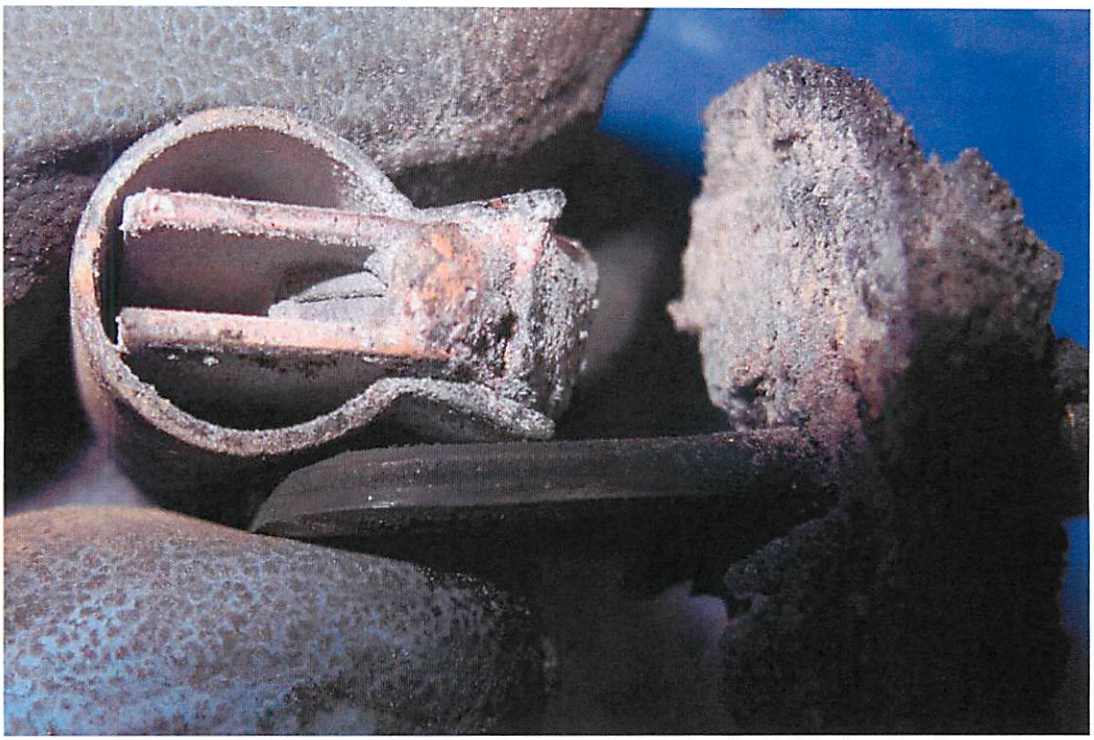
20. Remains of upper left meter jaw that were found in back of panel.

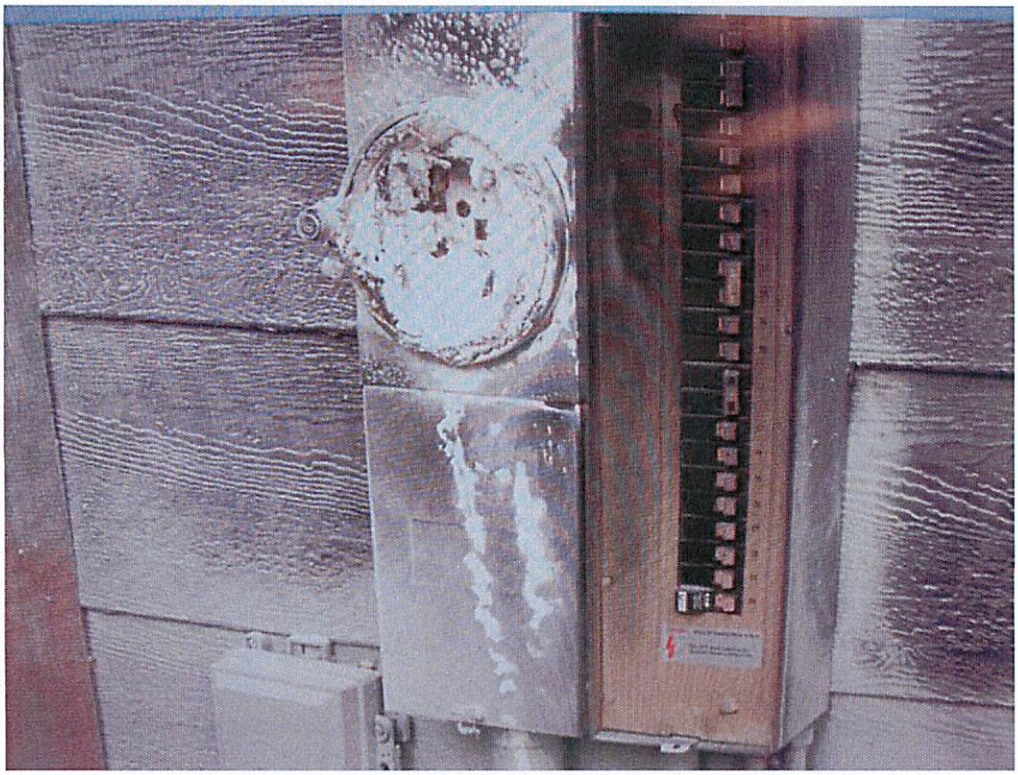
38. Scene photo showing panel and base of meter still in place.

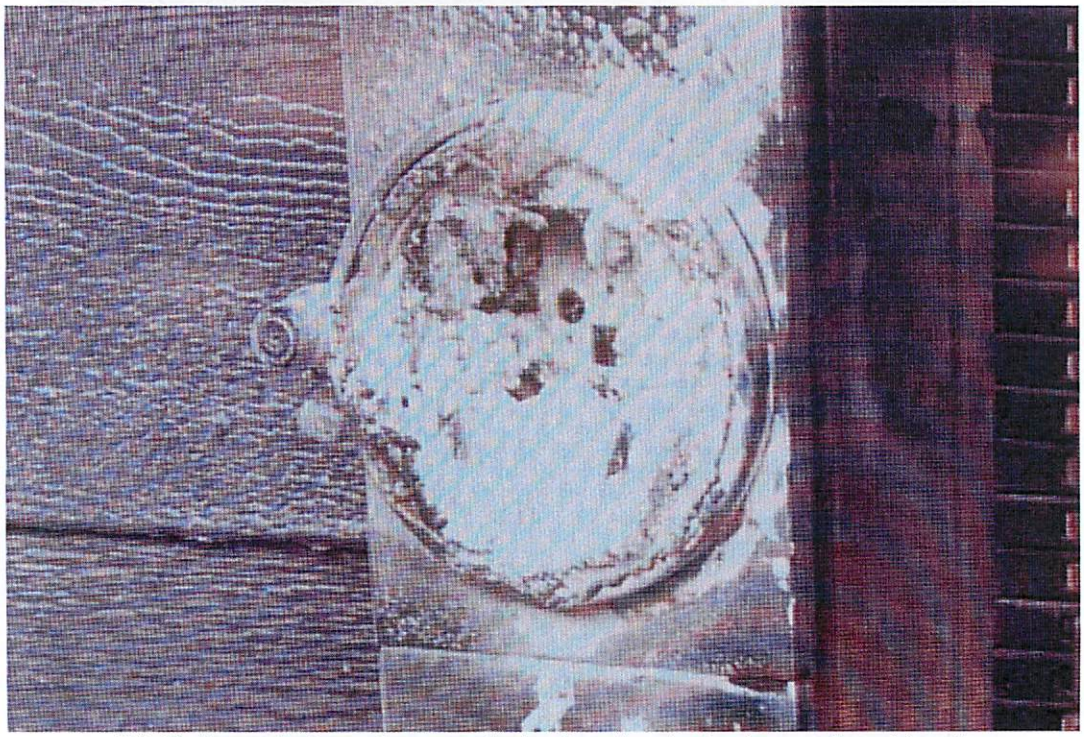
39. Enlarged view of scene photo showing lock ring and seal in place.

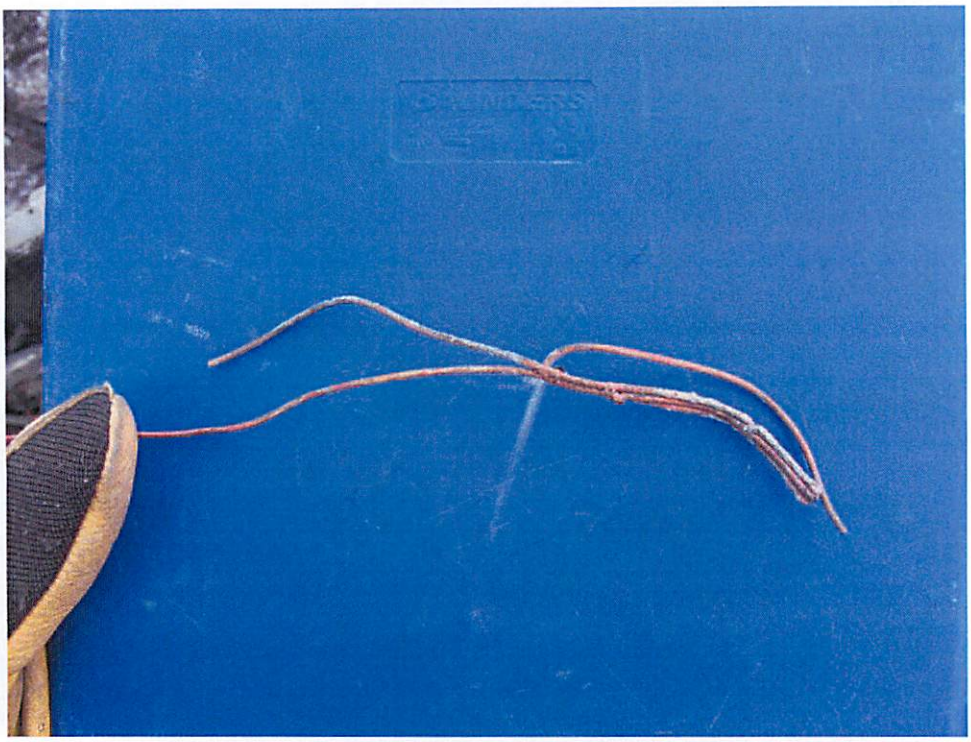
15. Melting on branch circuit conductors from attic space.

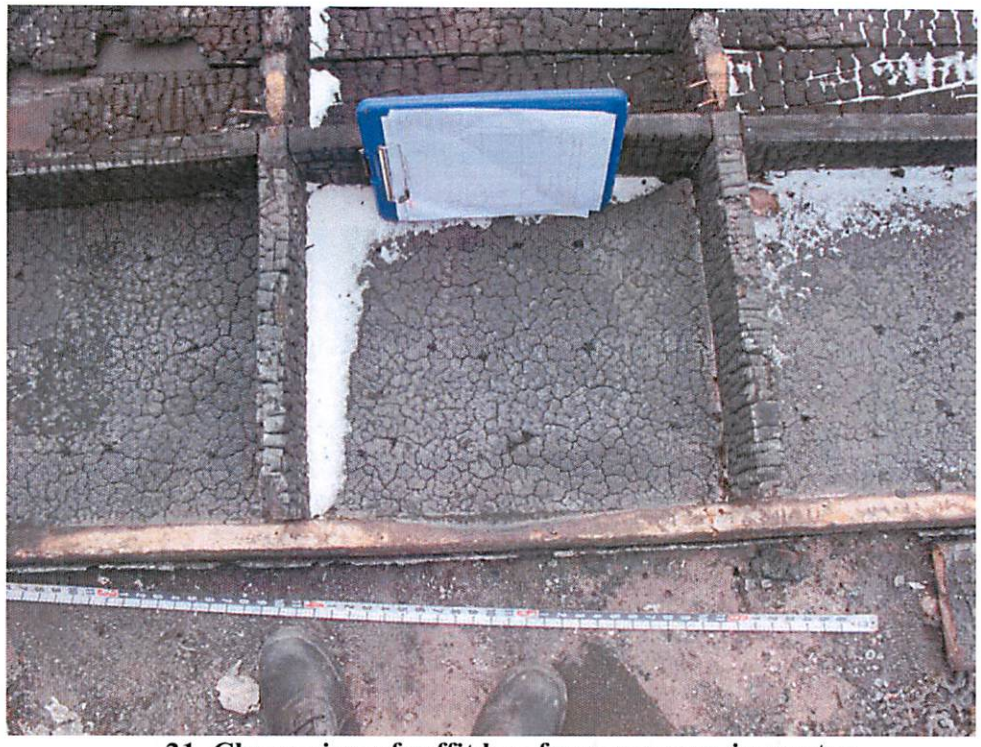
21. Closer view of soffit bay from over service meter.

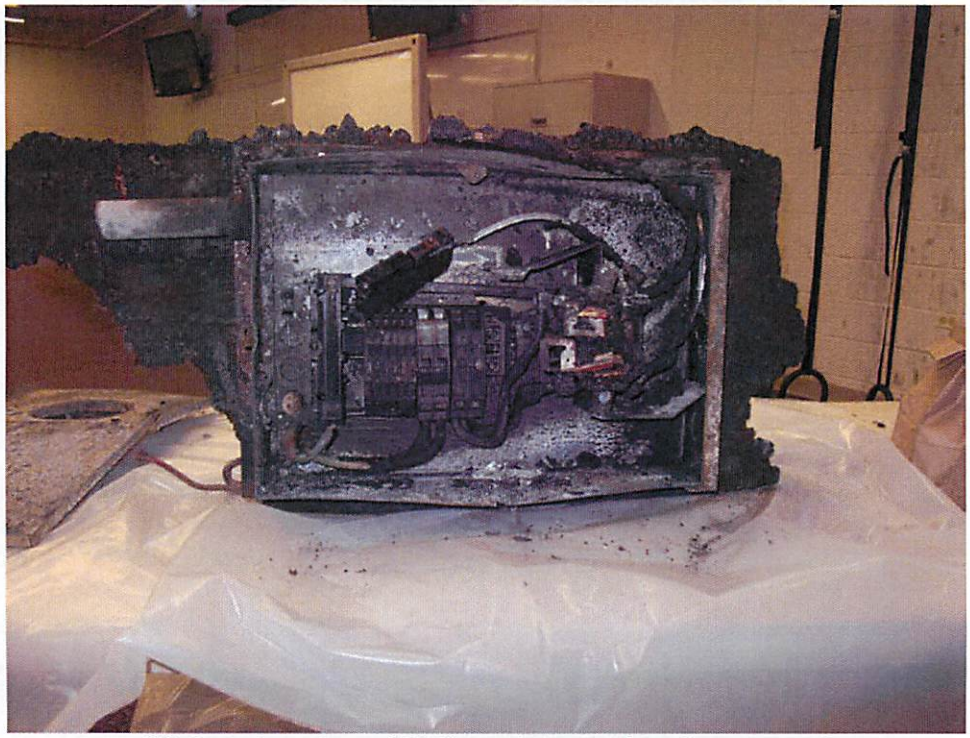
28. Interior view of SES service panel and meter socket.

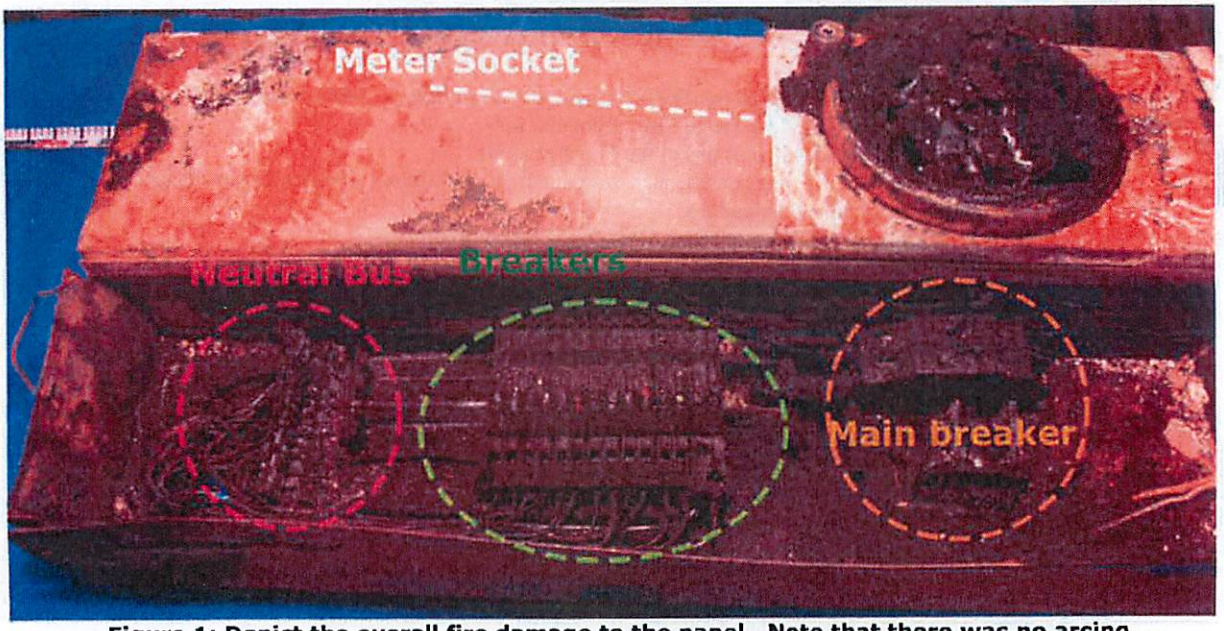
Figure 1: Depict the overall fire damage to the panel. Note that there was no arcing found within the panel, downstream of the meter.

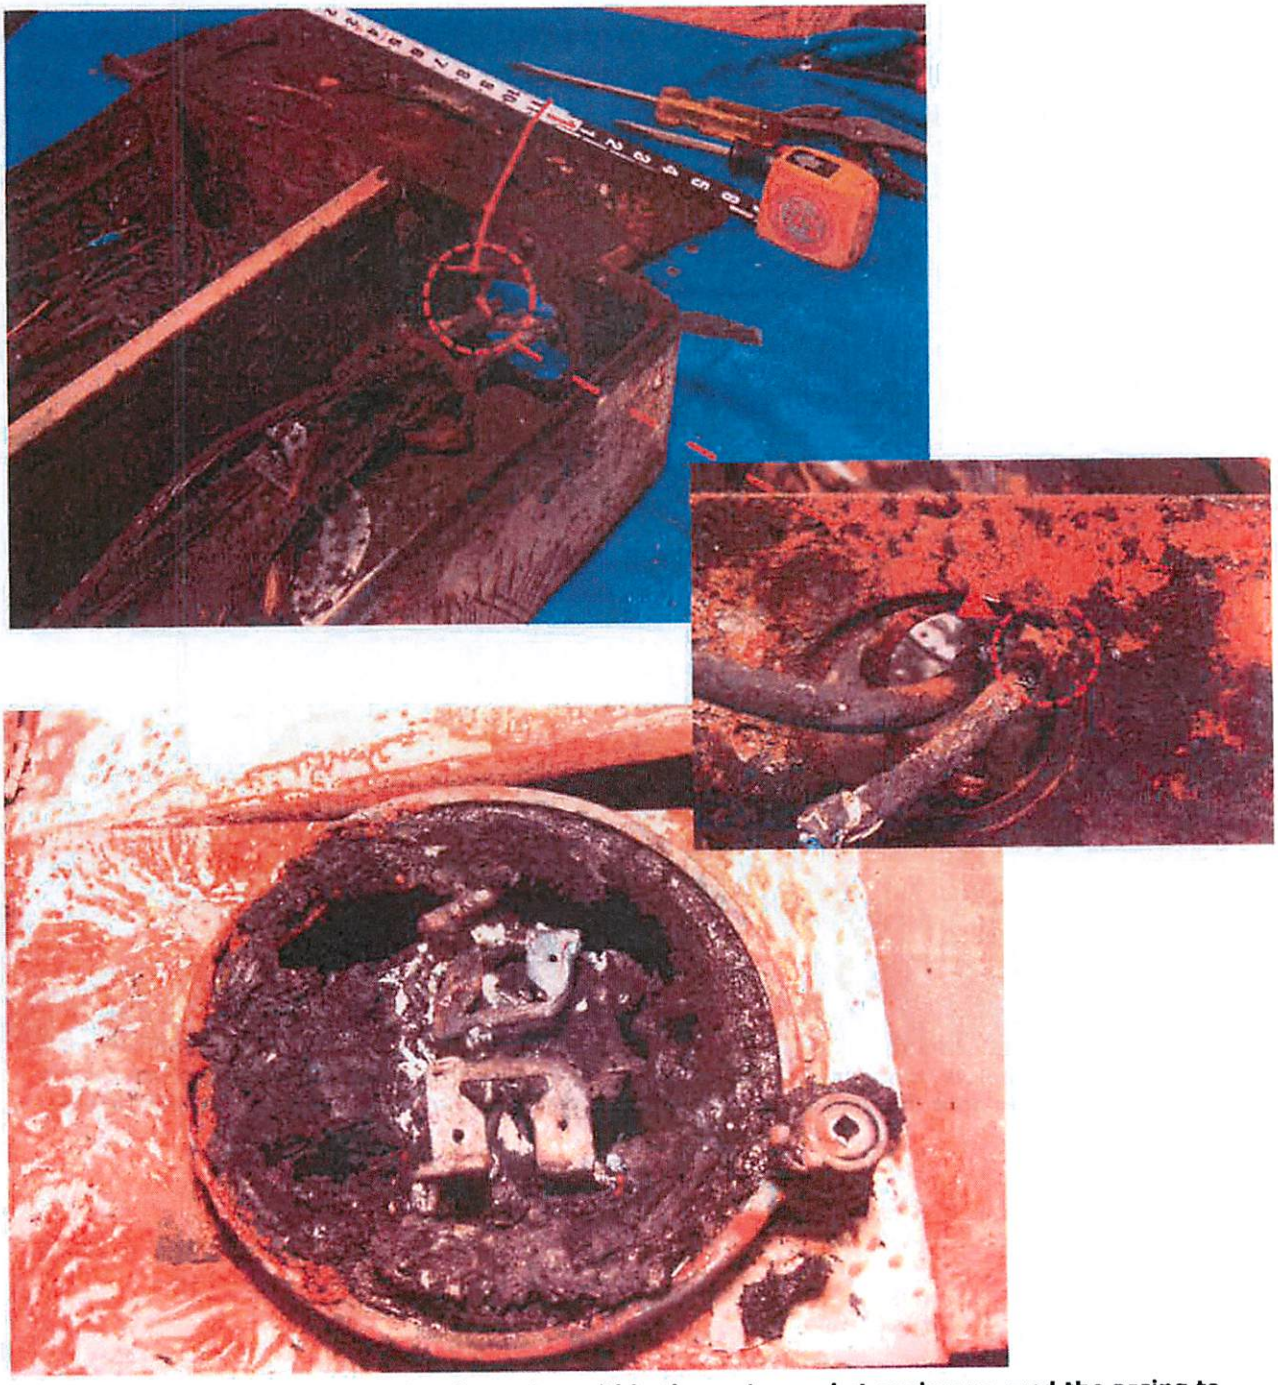
Figures 2 through 4 further depict the overall fire damage to the service entrance section, arcing in the meter socket/meter remains and arcing to the service entrance conductor/panel at the bottom of the panel.

Figures 2 through 4: Depict the arcing within the meter socket enclosure, and the arcing to the bottom of the panel where the power entered the panel.

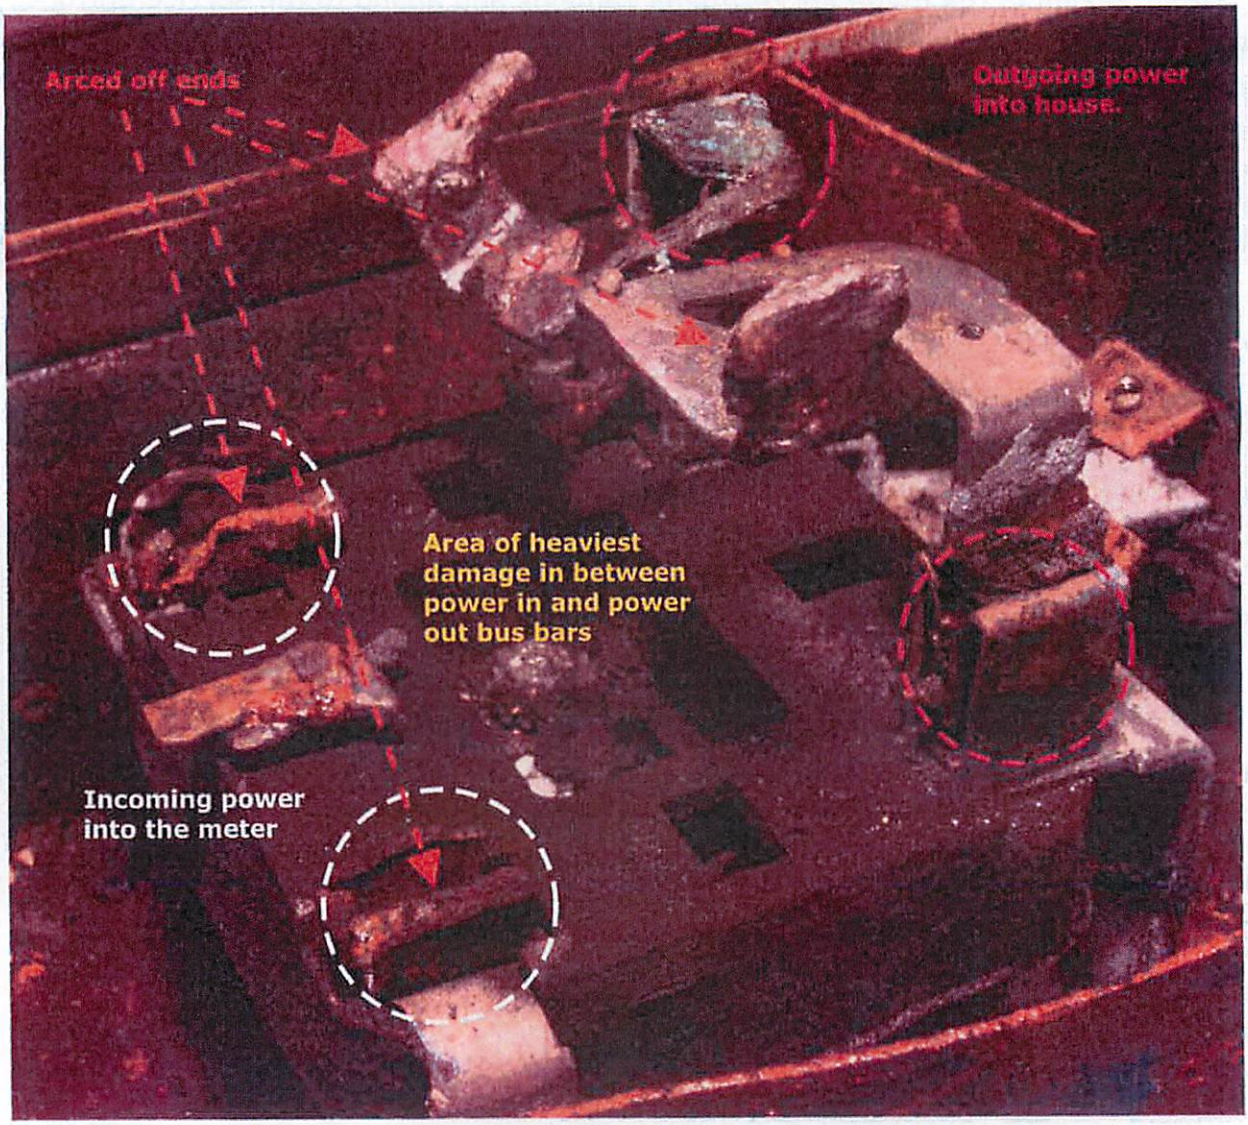
Figure 5: Depicts the overall fire damage to the meter remains within the socket enclosure. Please also note that the meter was adequately seeded into the meter socket enclosure.

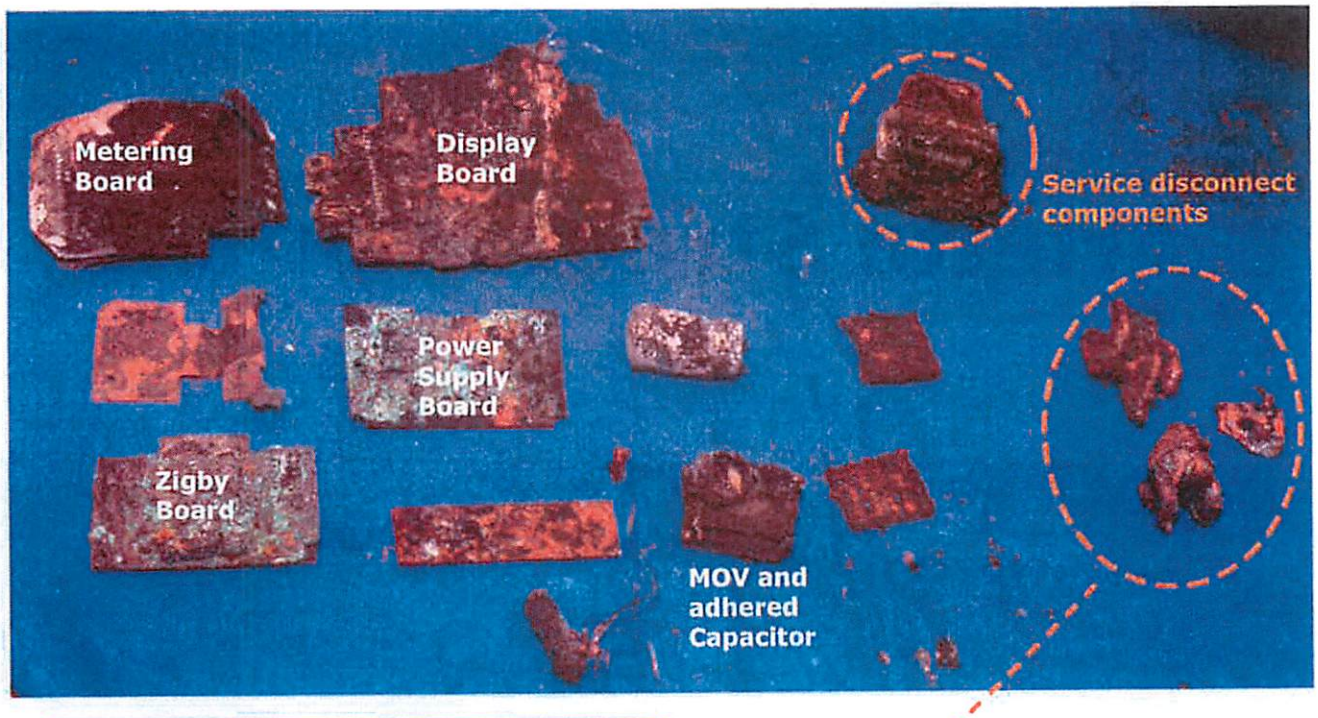
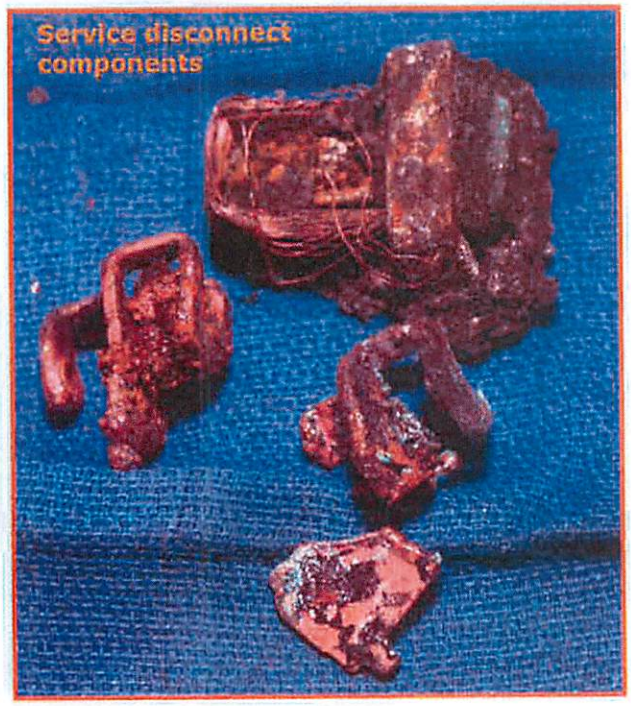
Figures 6 and 7: Depict the overall fire damage to the components associated with the meter.

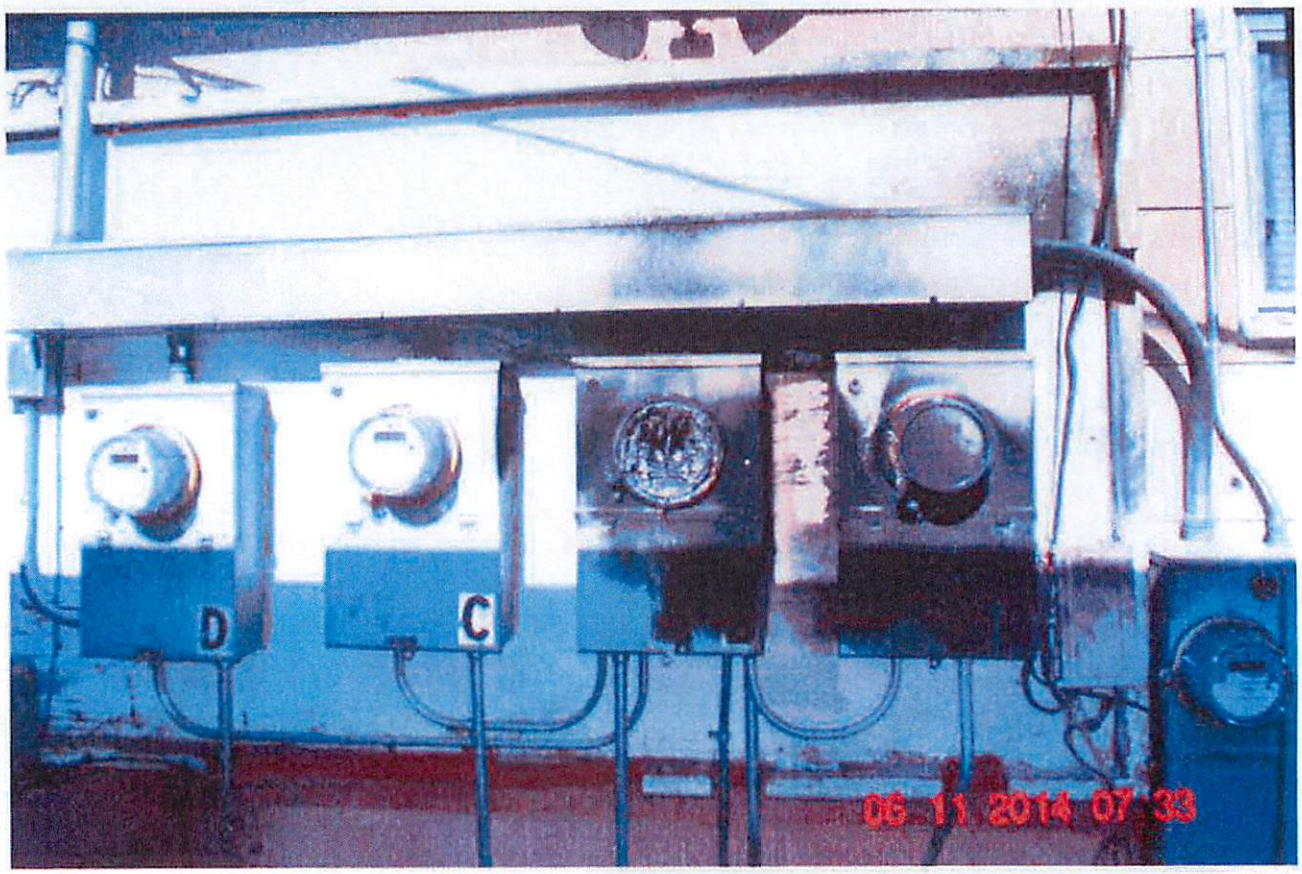
Figure 8: Depicts the localized fire damage to the meter in Apartment B.
