State Fire Marshal Division
Stewart Facility
107 Jacobsen Way
Carson City, NV 89711
(775) 684-7501 • Fax (775) 684-7518

October 17, 2014

ALLEGATIONS BY VARIOUS NEVADA FIRE DEPARTMENTS THAT ELECTRIC METERS IN NV ENERGY'S REPLACEMENT PROGRAM HAVE CAUSED ELEVEN FIRES WITHIN THEIR JURISDICTIONS

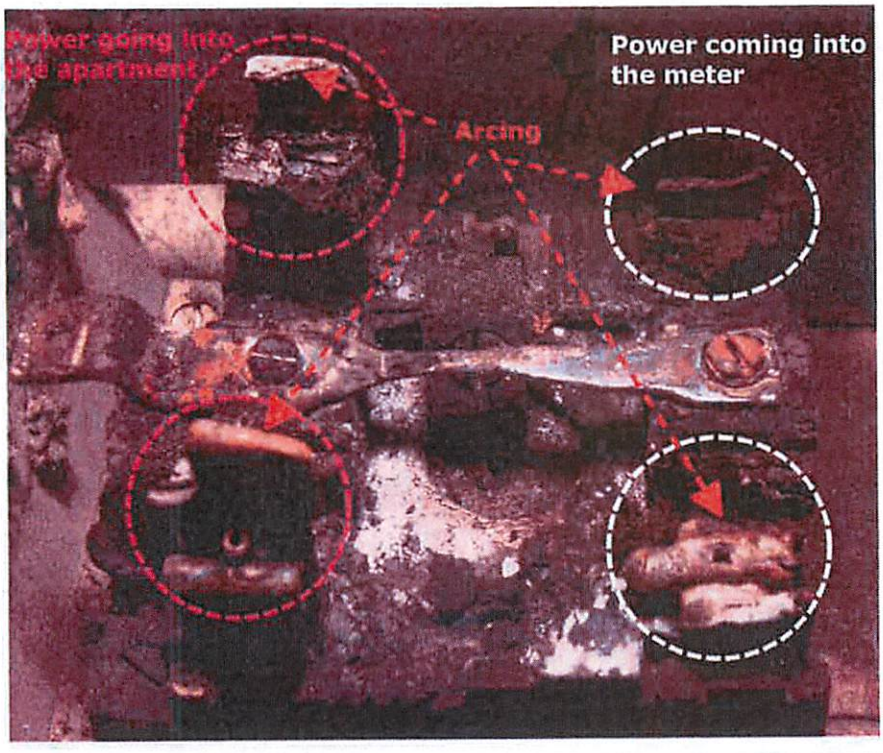
The Arletta Street meter fire was also examined. The meter displayed similar characteristics to the Rhinestone meter incident with one main exception -- the majority of the bus bars were melted away/missing from the Arletta incident meter. Figures 9 and 10 depict the overall fire damage to the meter and associated electrical panel.

Figure 9: Depicts the meter remains within the meter socket enclosure.

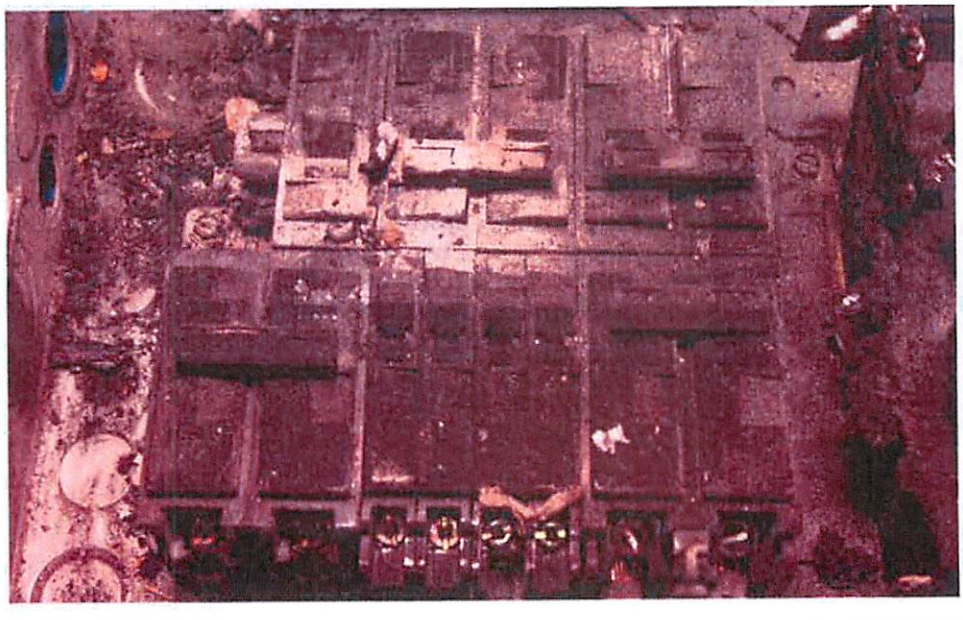
Figure 10: Depicts the circuit breaker panel. Note that none of the breakers are in the tripped position.

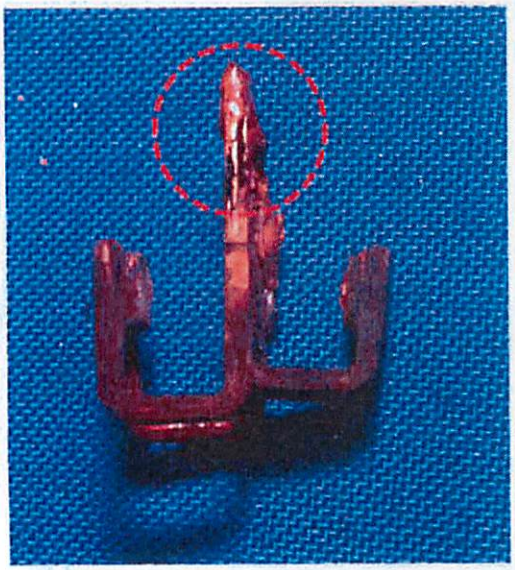
The meter associated with the Arletta Street meter fire was fully seeded into the electrical socket. Additionally, the electrical disconnect portion of the meter displayed extreme melting. See Figures 11 and 12.

Figure 11 depicts the blades associated with the meter which are fully seeded into the socket enclosure.

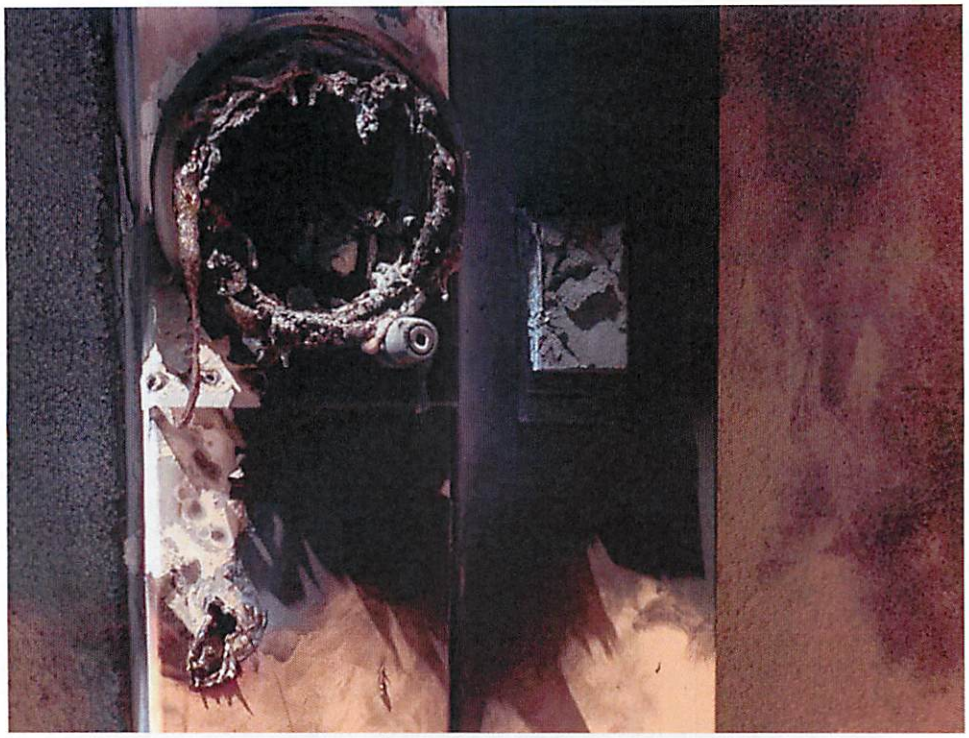
2. Closer view of meter and utility section.

3. Closer view of meter.

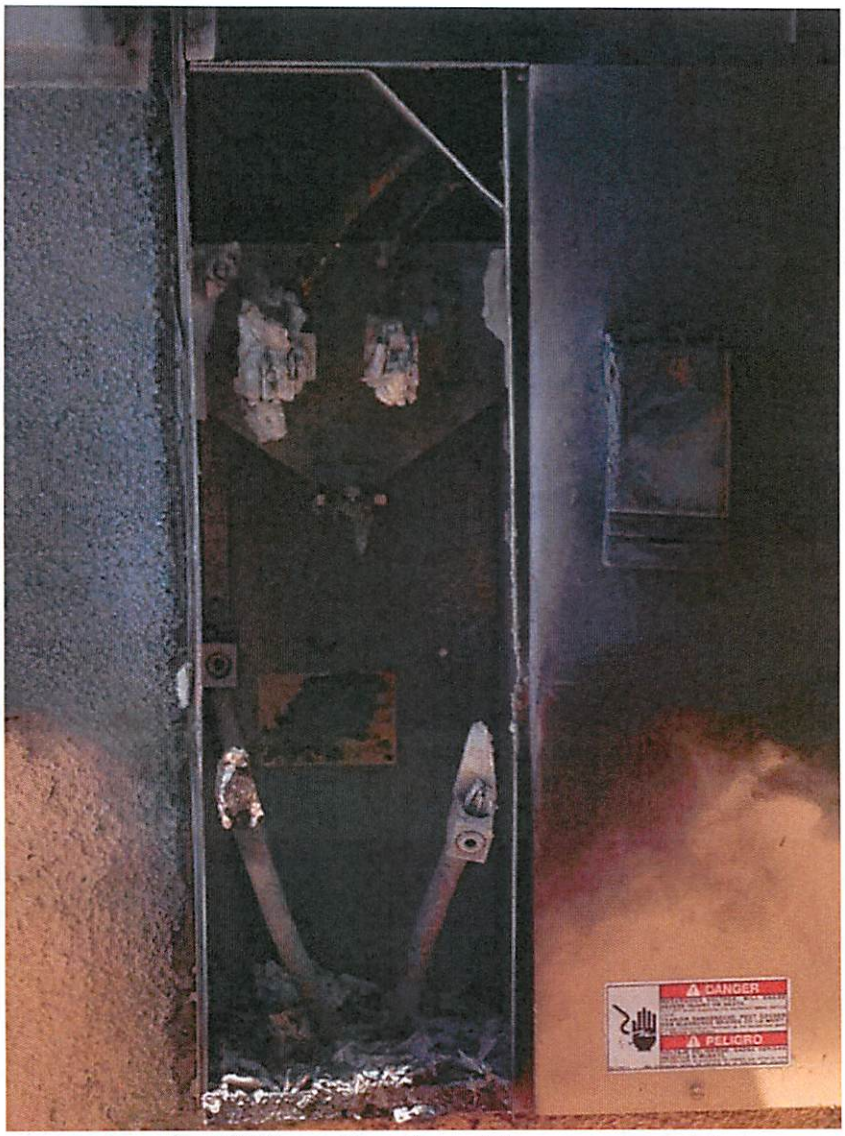
4. Utility pull section with cover removed.

5. Utility pull section as presented at evidence exam.

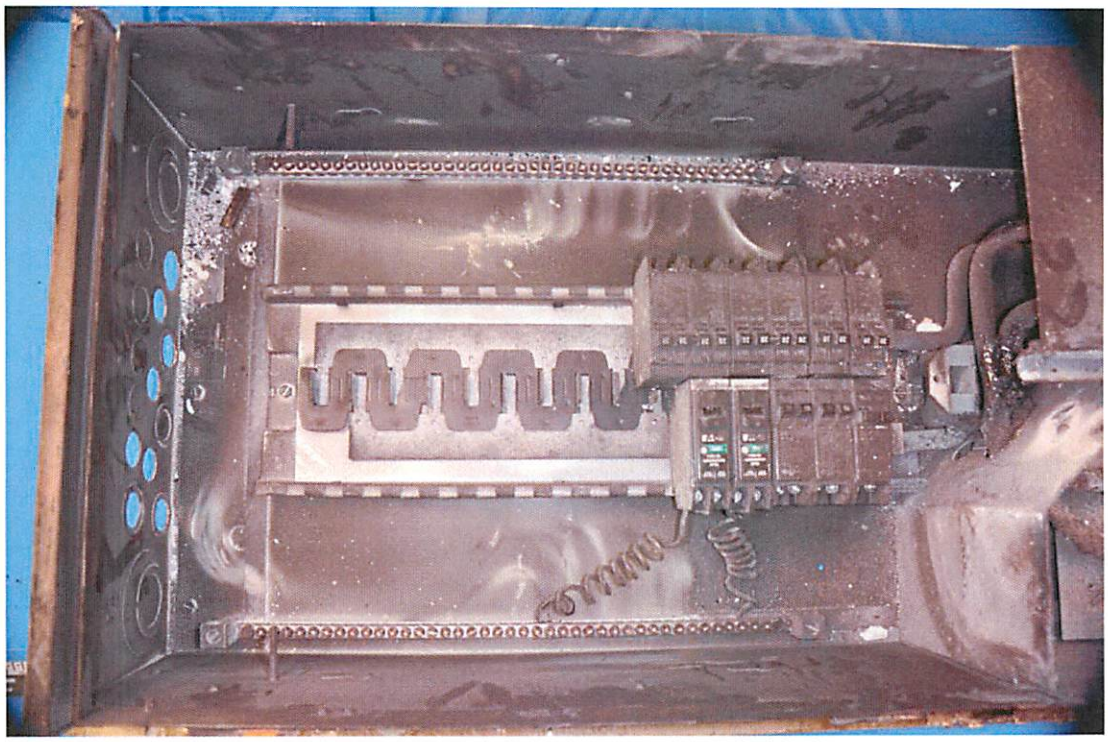
The utility section on the left lower side had significant melting of the panel sides and covers consistent with arcing (Photo 9).

7. Branch circuit breakers and load side buses.

8. Main circuit breaker.

9. Arcing at utility side covers.

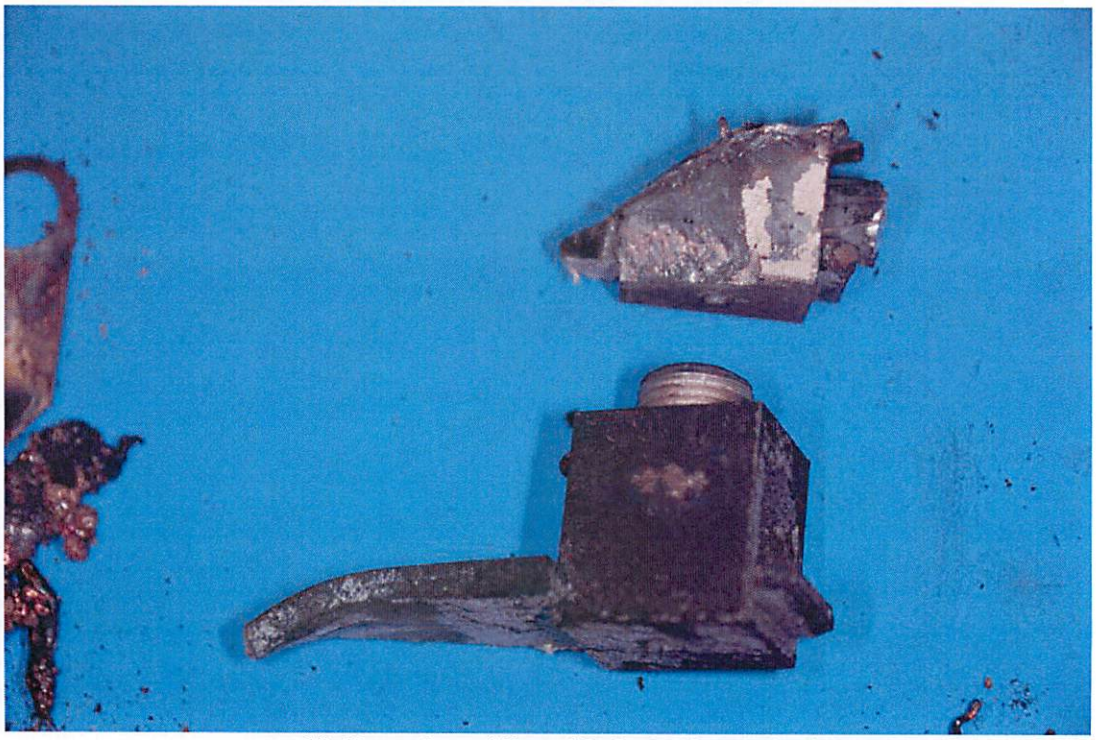
10. Remains of line side lateral terminals.

11. Line side lateral terminals placed at approximate original position.

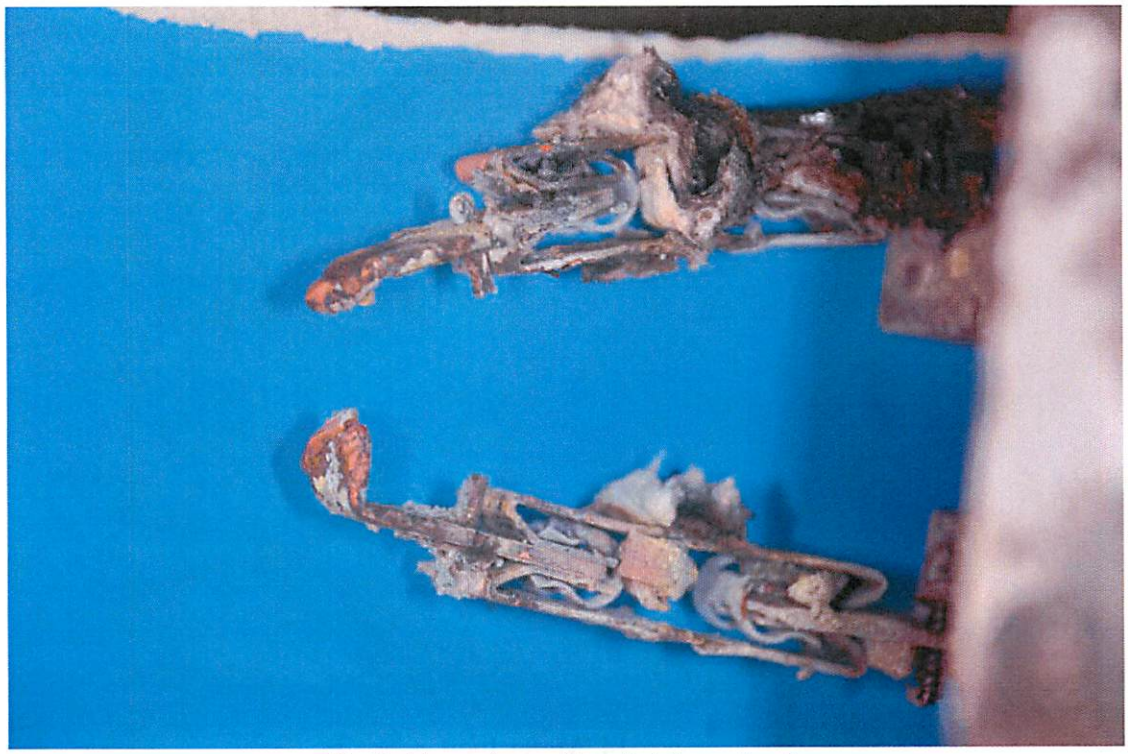
12. Bottom view of load side meter jaws.

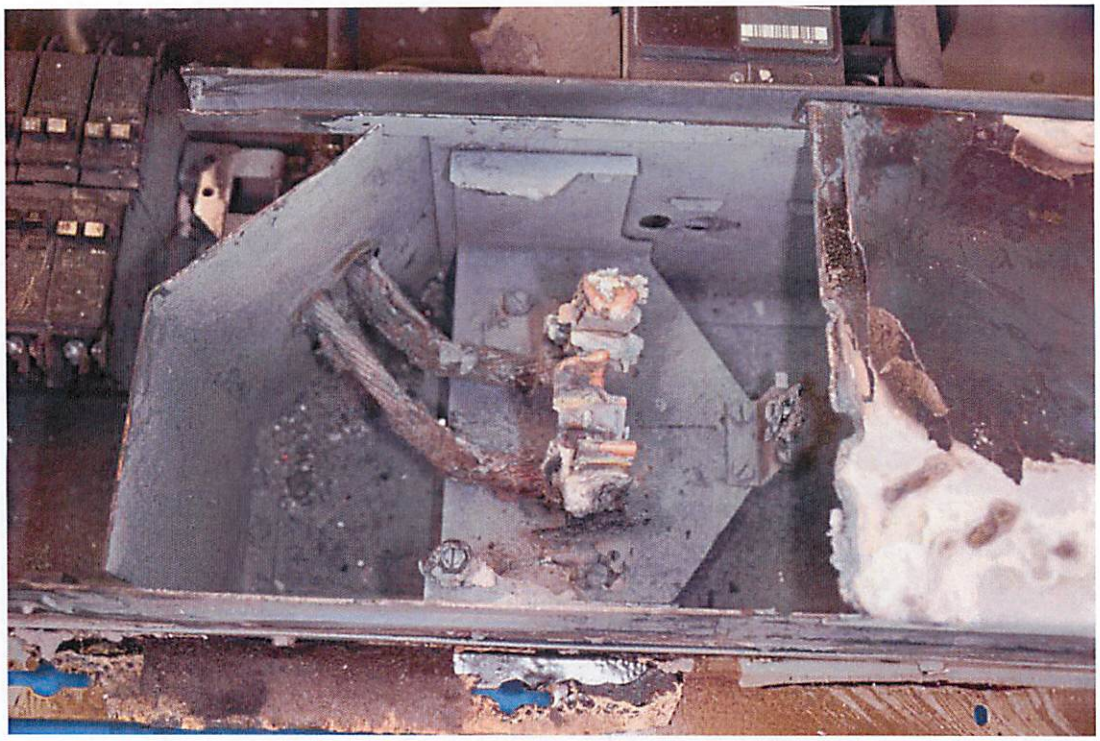
13. Load side meter jaws and conductors.

14. Meter loop.

15. Remains of line side meter jaws and spring clips.

16. Side view of line side meter jaws and clips.

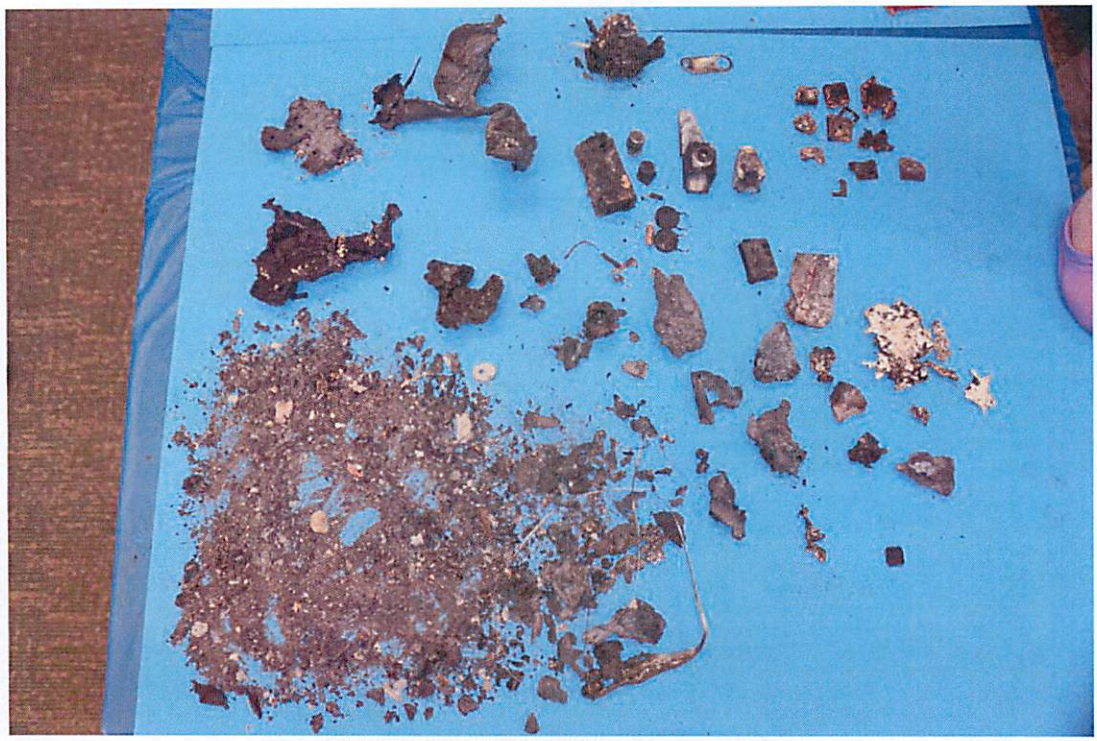
17. Parts of meter sifted from debris.

18. MOVs, capacitors, circuit board etc.

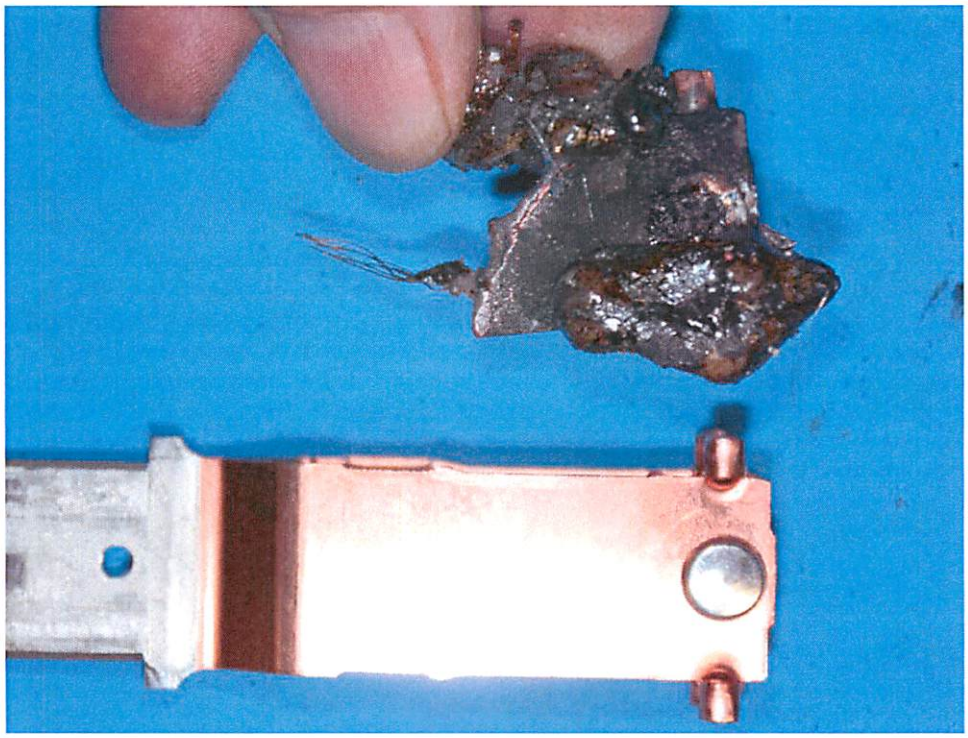
Very little remained of the internal buses and contacts (Photos 26-27), making a positive determination of any failure cause very unlikely.

26. Moveable contact assembly from subject next to exemplar.

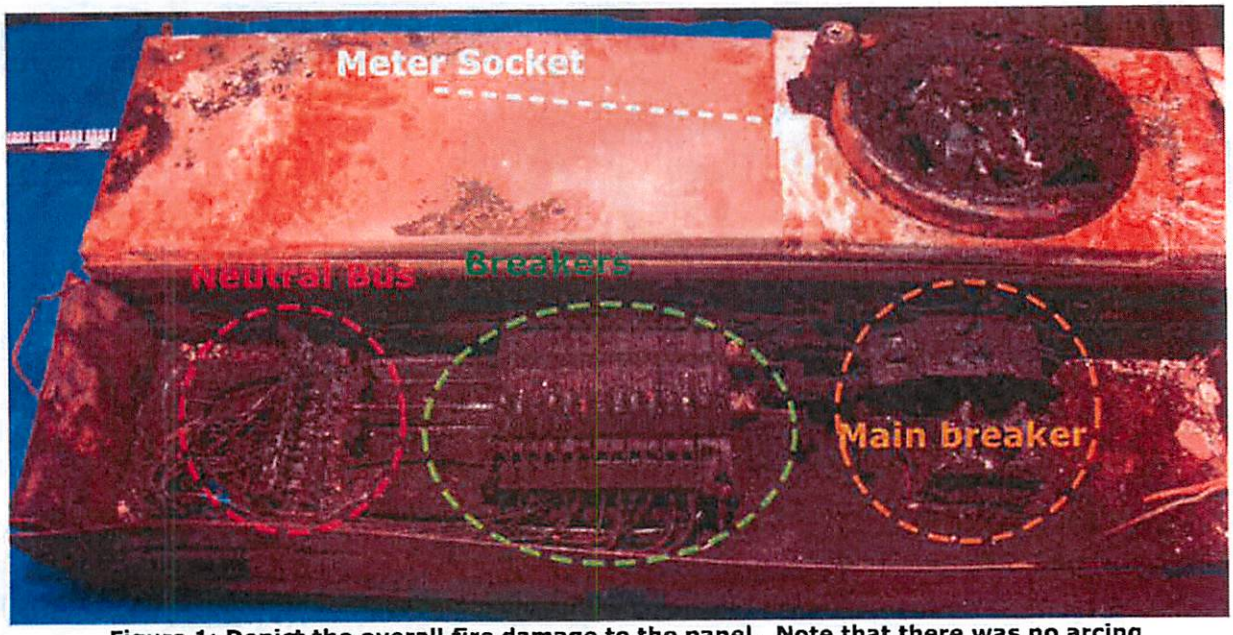
Figure 1: Depict the overall fire damage to the panel. Note that there was no arcing found within the panel, downstream of the meter.

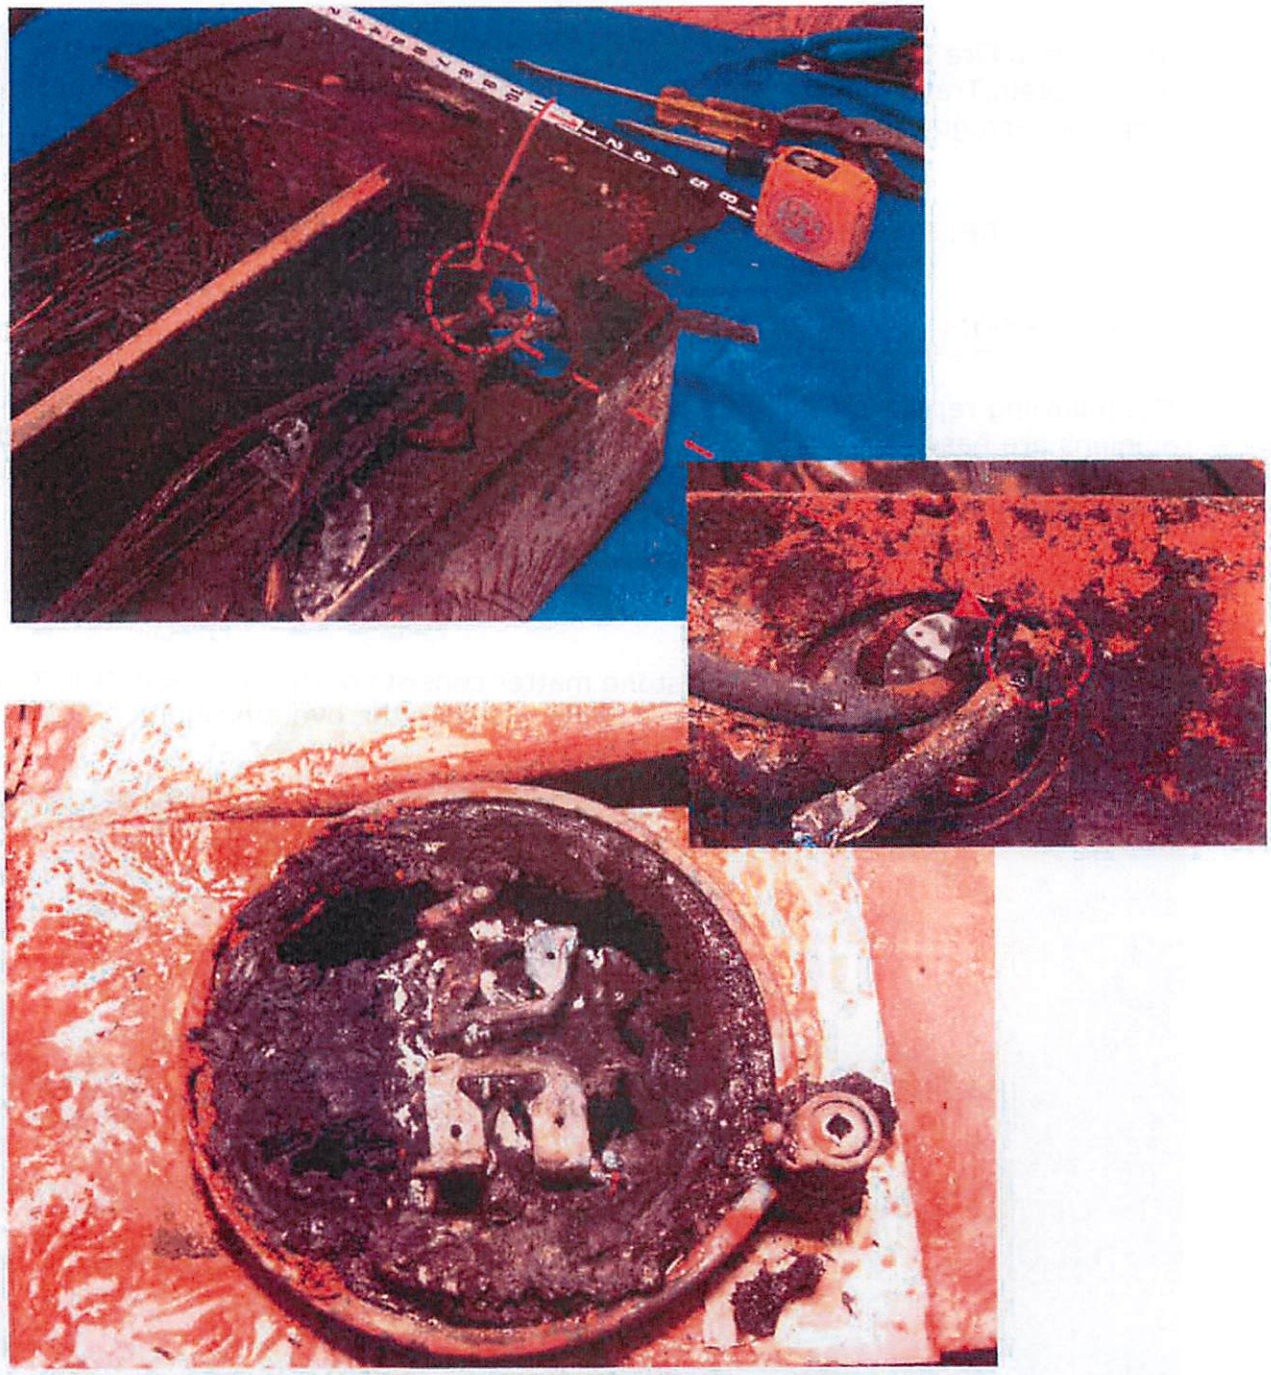
Figures 2 through 4 further depict the overall fire damage to the service entrance section, arcing in the meter socket/meter remains and arcing to the service entrance conductor/panel at the bottom of the panel.

Figures 2 through 4: Depict the arcing within the meter socket enclosure, and the arcing to the bottom of the panel where the power entered the panel.

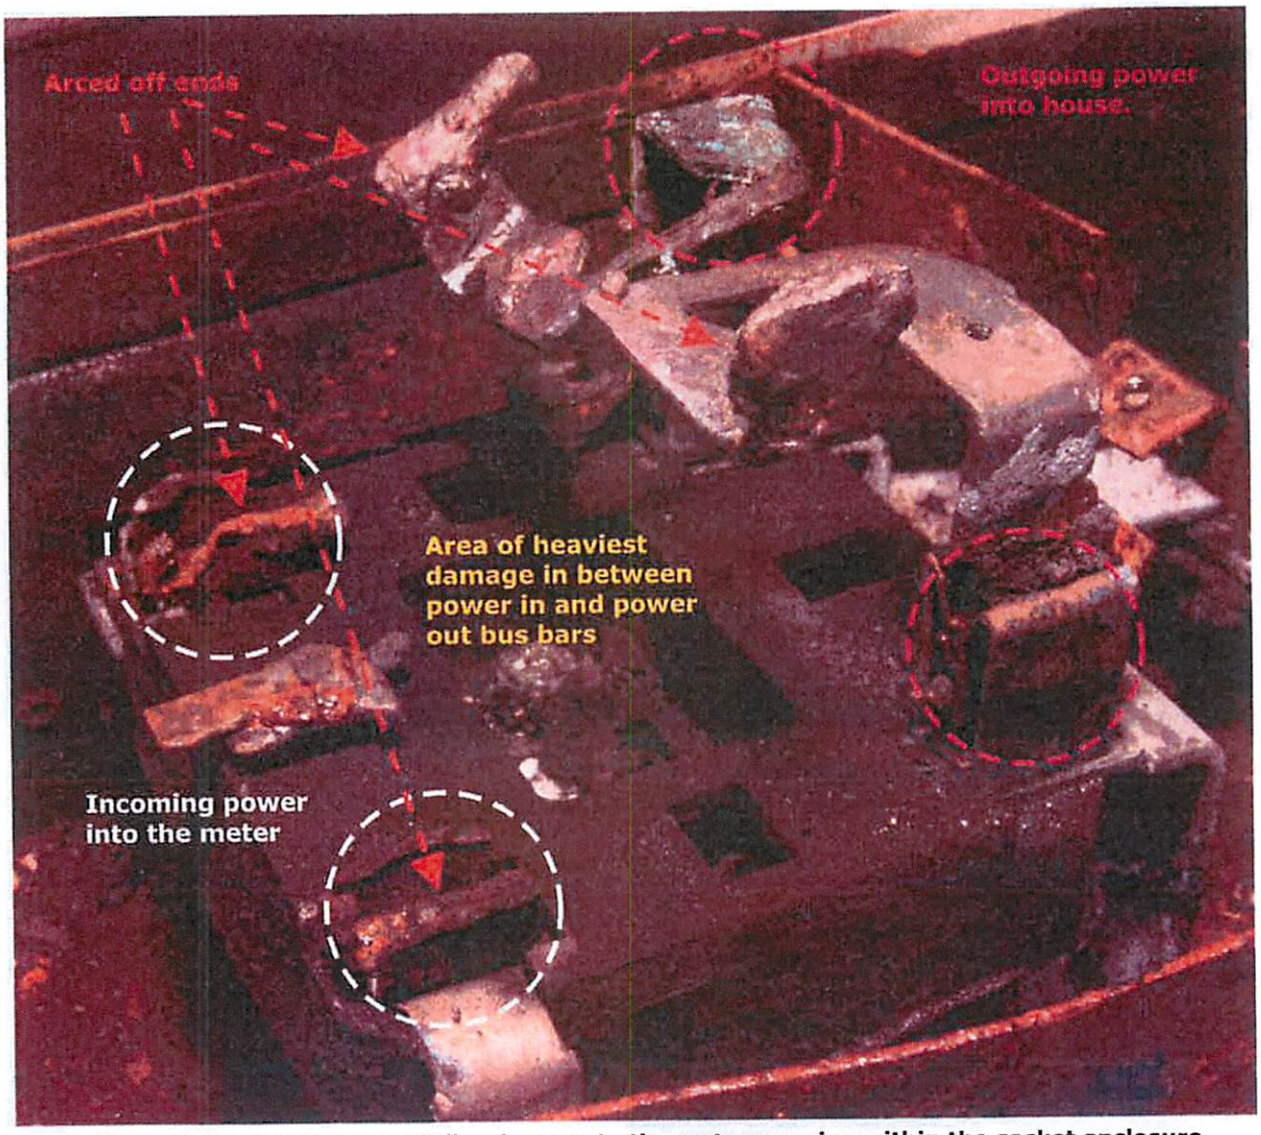
Figure 5: Depicts the overall fire damage to the meter remains within the socket enclosure. Please also note that the meter was adequately seeded into the meter socket enclosure.

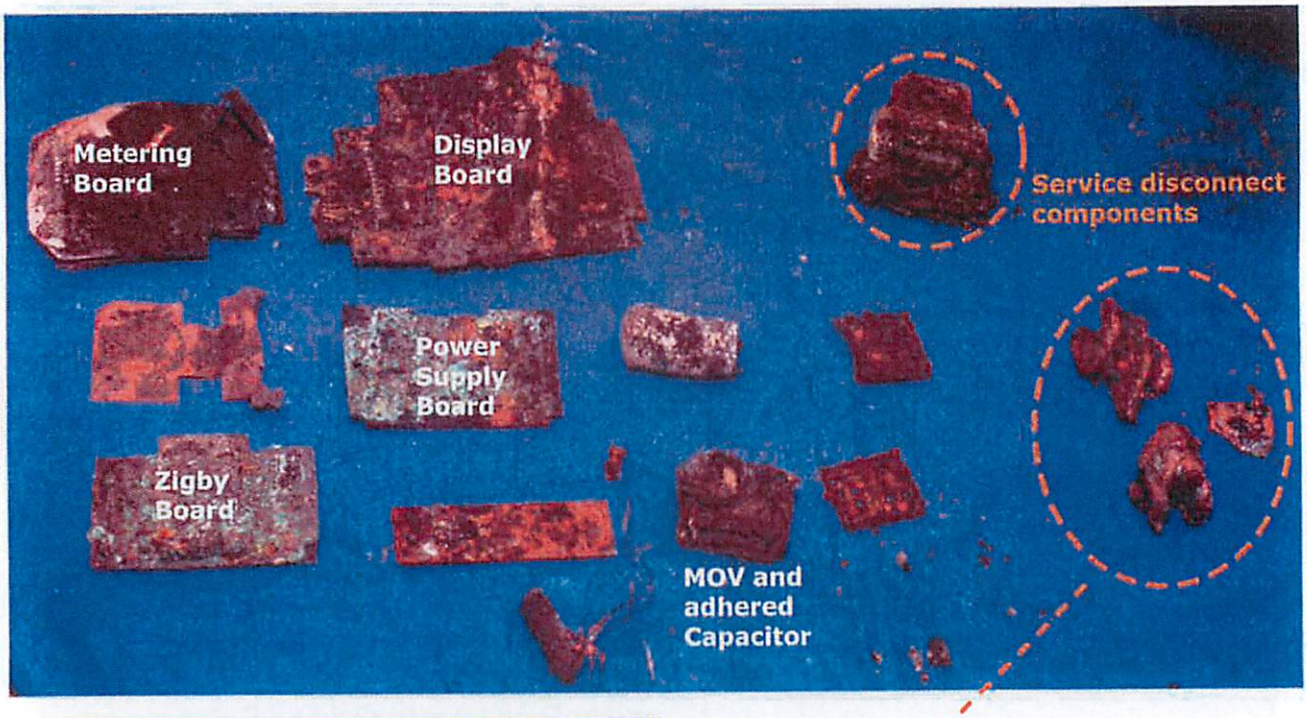
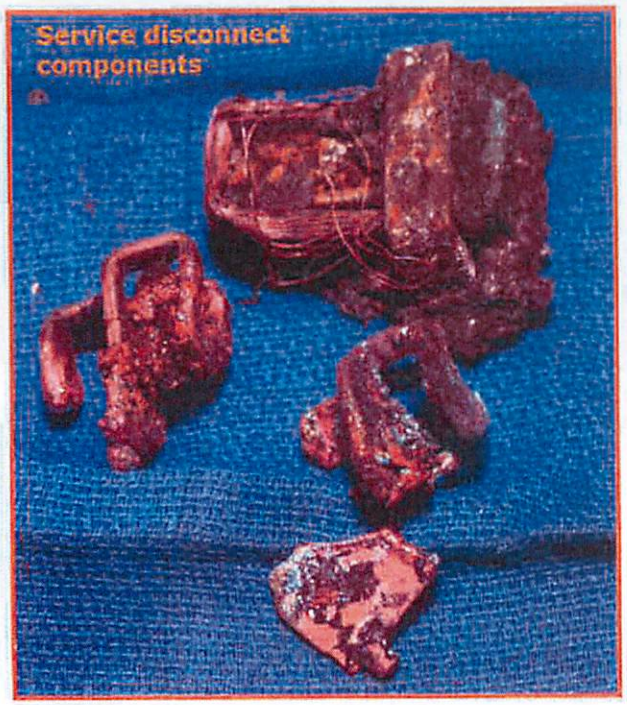
Figures 6 and 7: Depict the overall fire damage to the components associated with the meter.

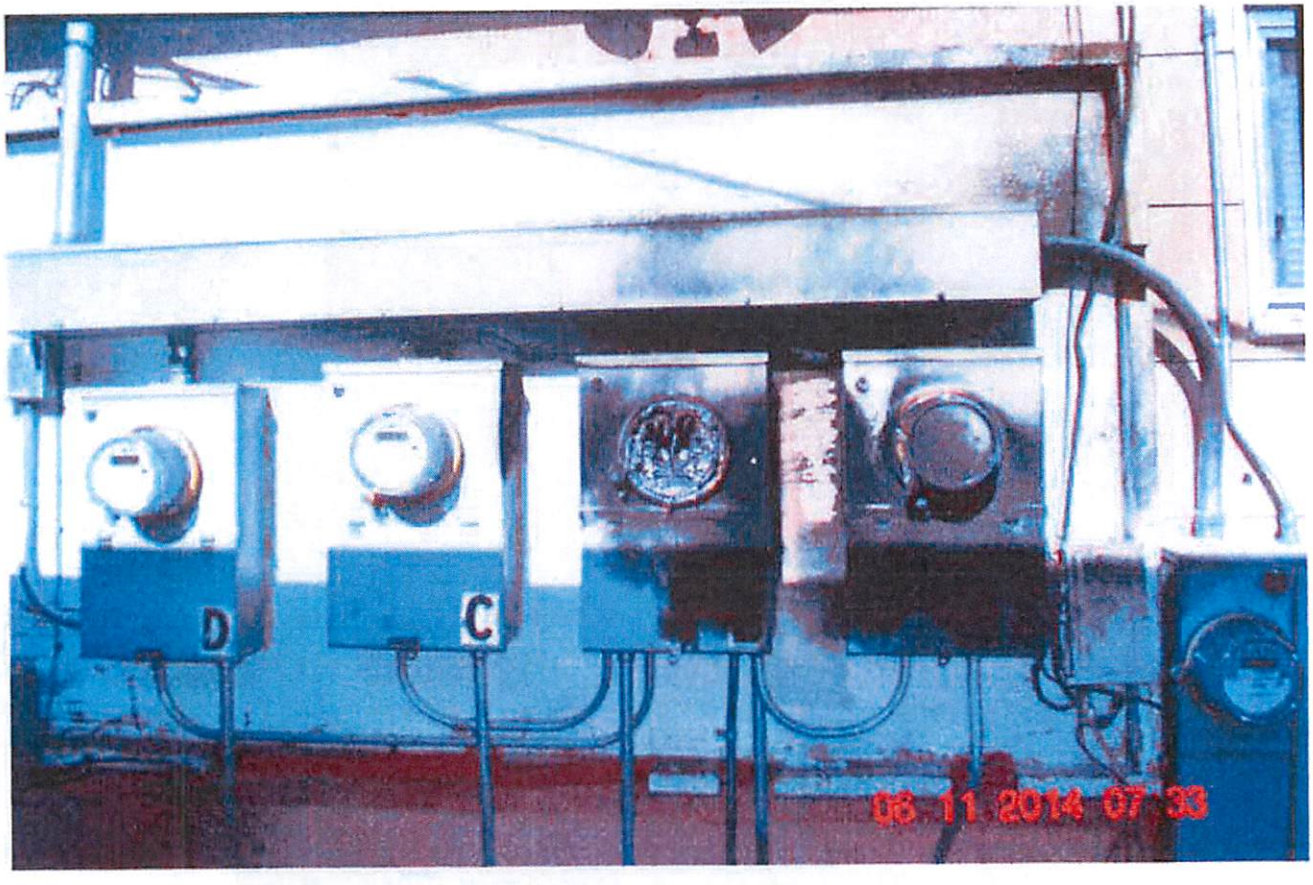
Figure 8: Depicts the localized fire damage to the meter in Apartment B.

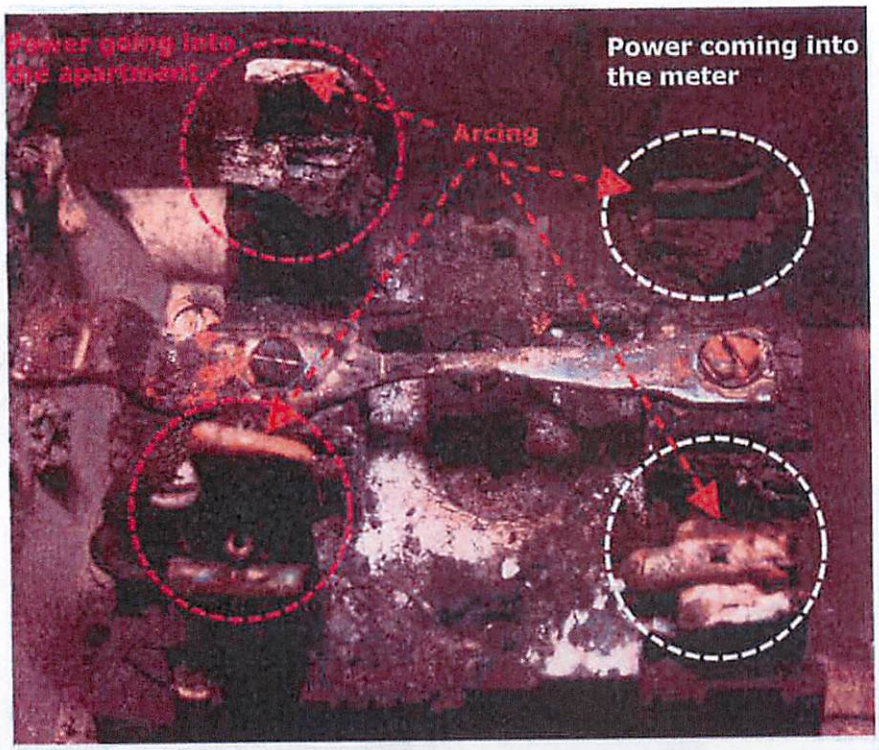
The Arletta Street meter fire was also examined. The meter displayed similar characteristics to the Rhinestone meter incident with one main exception -- the majority of the bus bars were melted away/missing from the Arletta incident meter. Figures 9 and 10 depict the overall fire damage to the meter and associated electrical panel.

Figure 9: Depicts the meter remains within the meter socket enclosure.

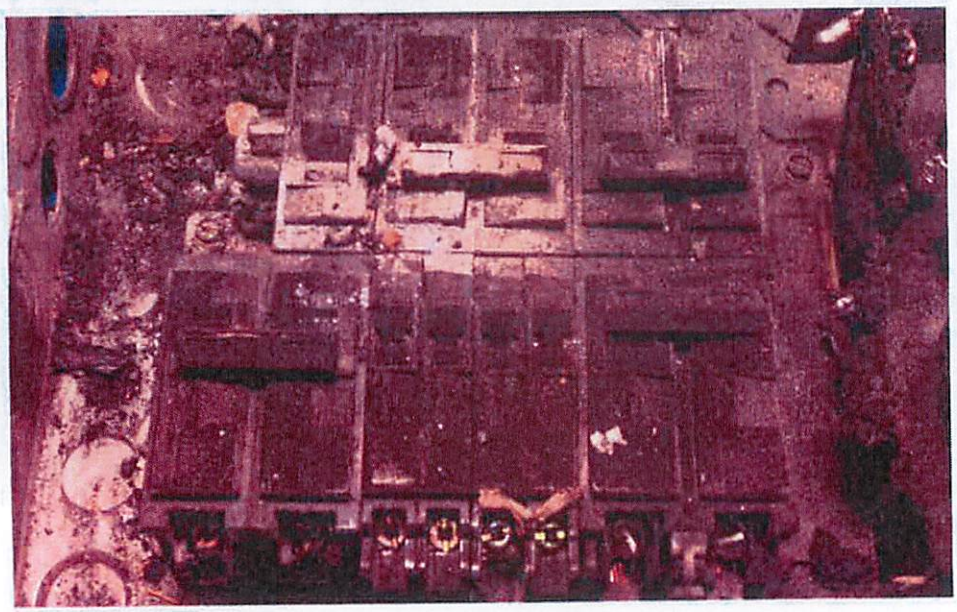
Figure 10: Depicts the circuit breaker panel. Note that none of the breakers are in the tripped position.

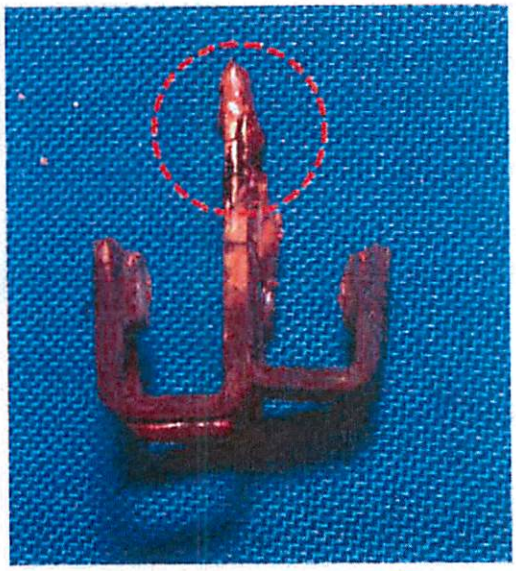
The meter associated with the Arletta Street meter fire was fully seeded into the electrical socket. Additionally, the electrical disconnect portion of the meter displayed extreme melting. See Figures 11 and 12.

Figure 11 depicts the blades associated with the meter which are fully seeded into the socket enclosure.

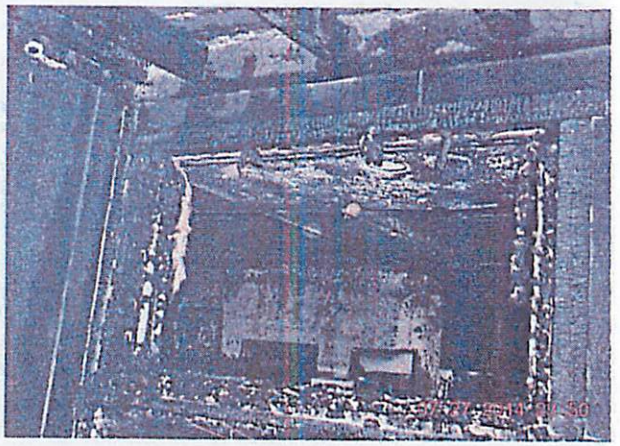
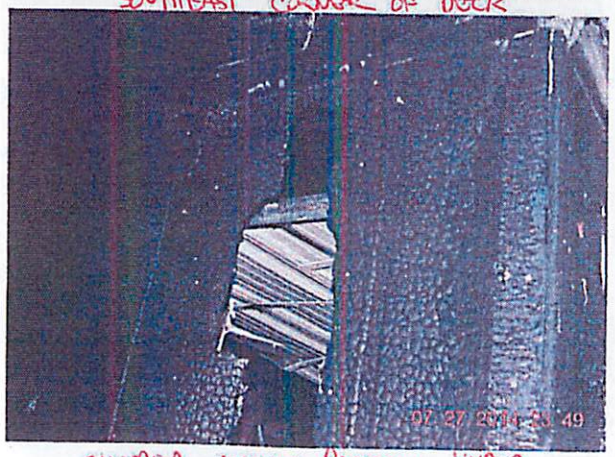
CHARRED VERTICAL PATTERN UNDER SOUTHEAST CORNER OF DECK

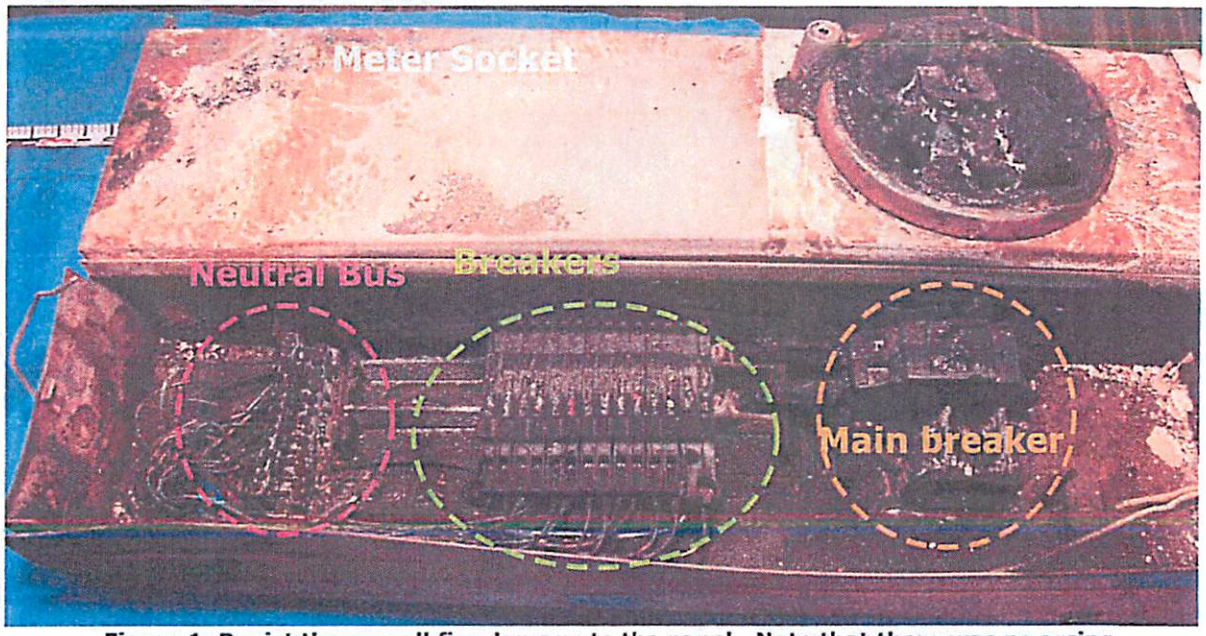
Figure 1: Depict the overall fire damage to the panel. Note that there was no arcing found within the panel, downstream of the meter.

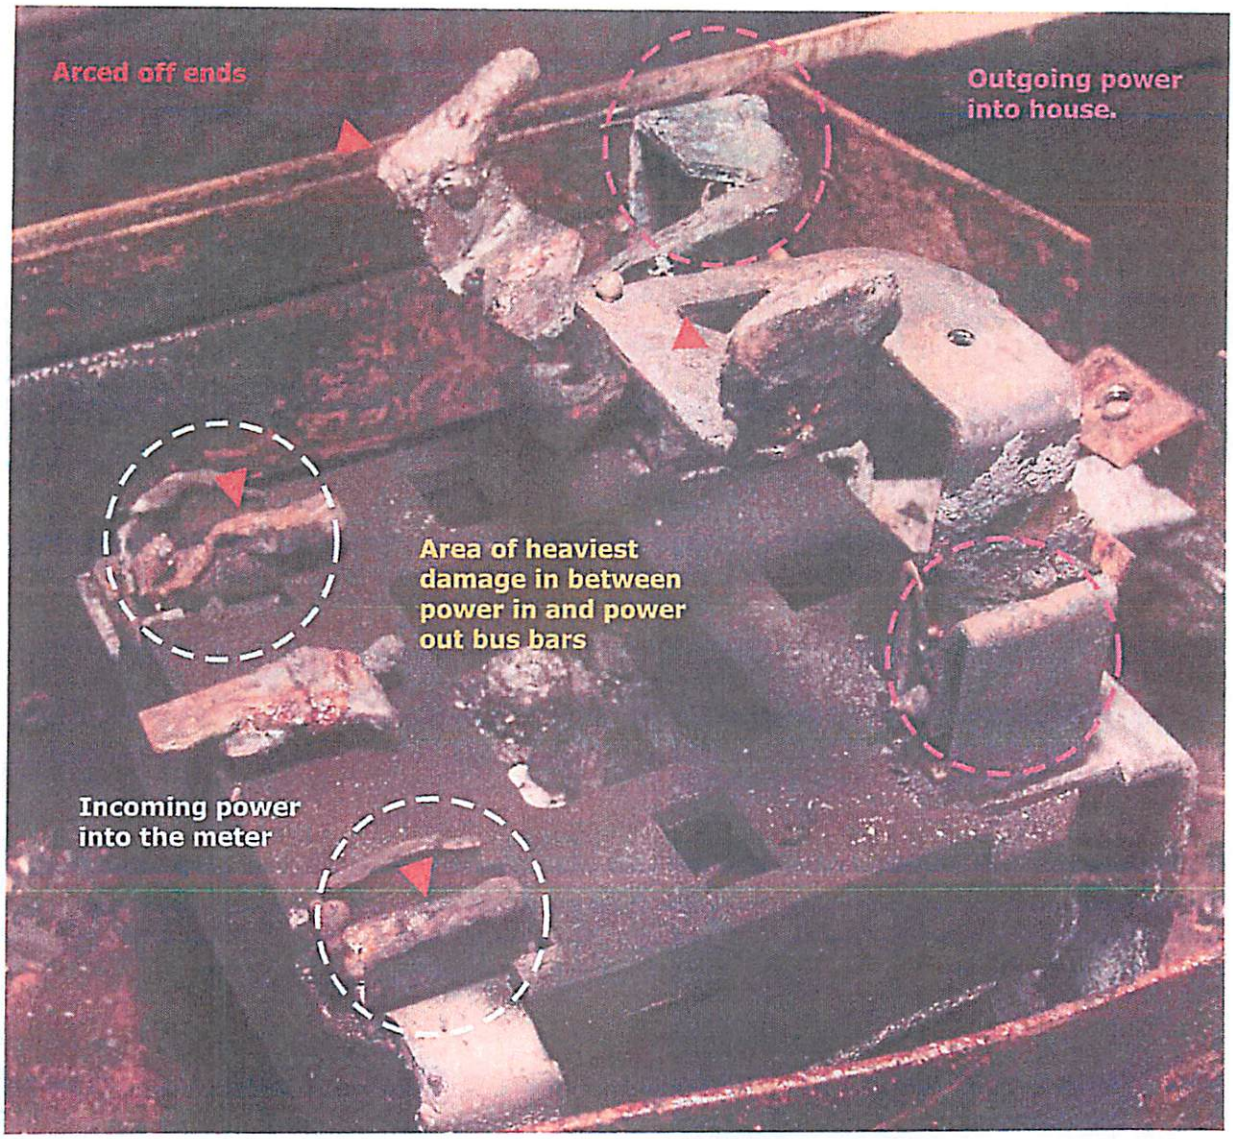
Figure 5: Depicts the overall fire damage to the meter remains within the socket enclosure. Please also note that the meter was adequately seeded into the meter socket enclosure.

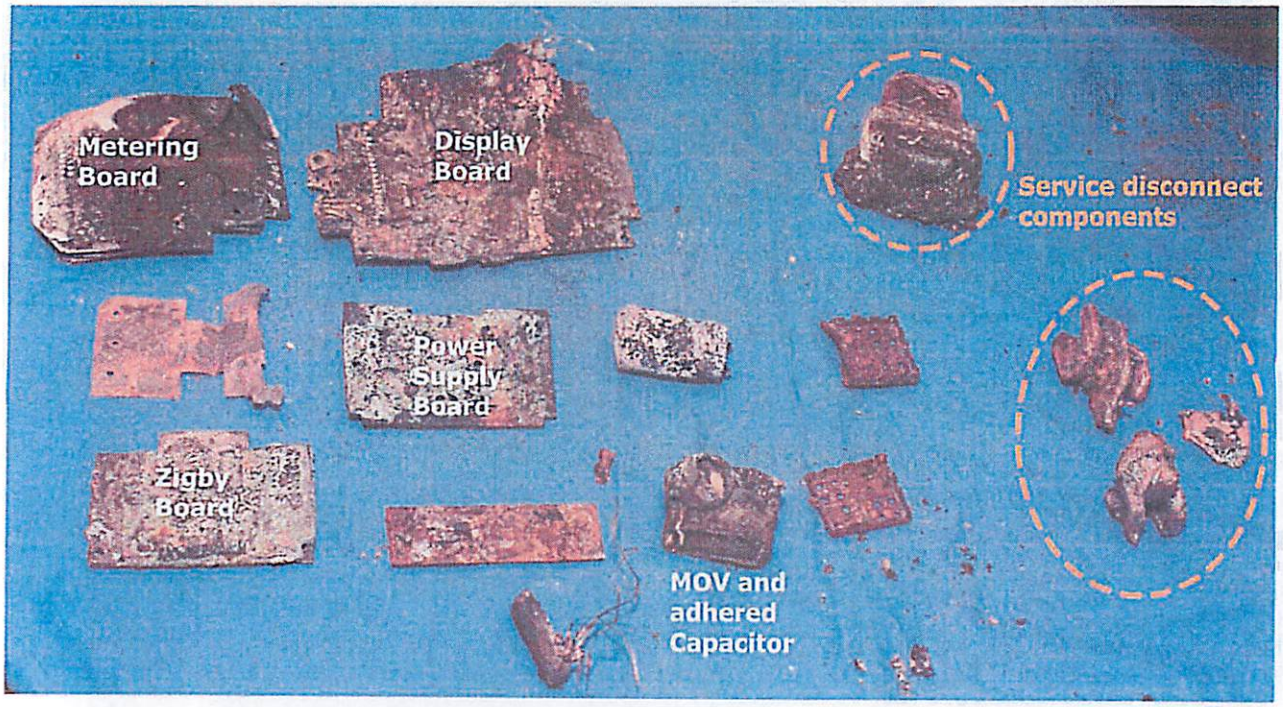
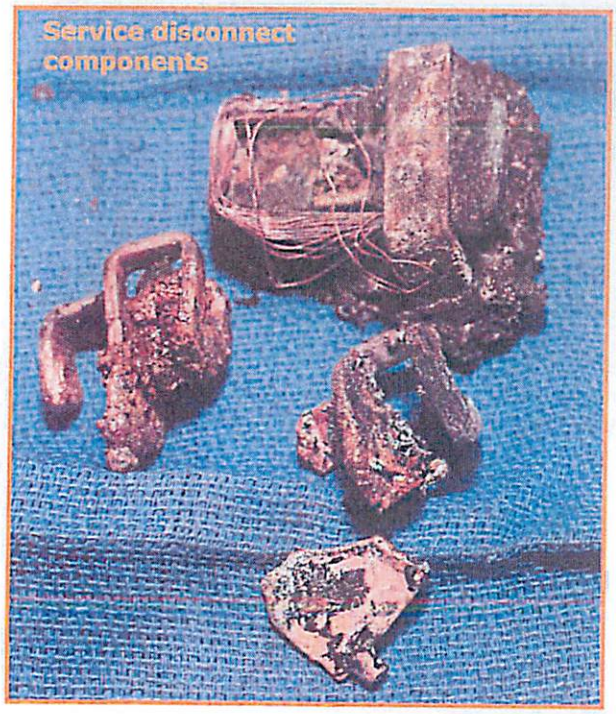
Figures 6 and 7: Depict the overall fire damage to the components associated with the meter.

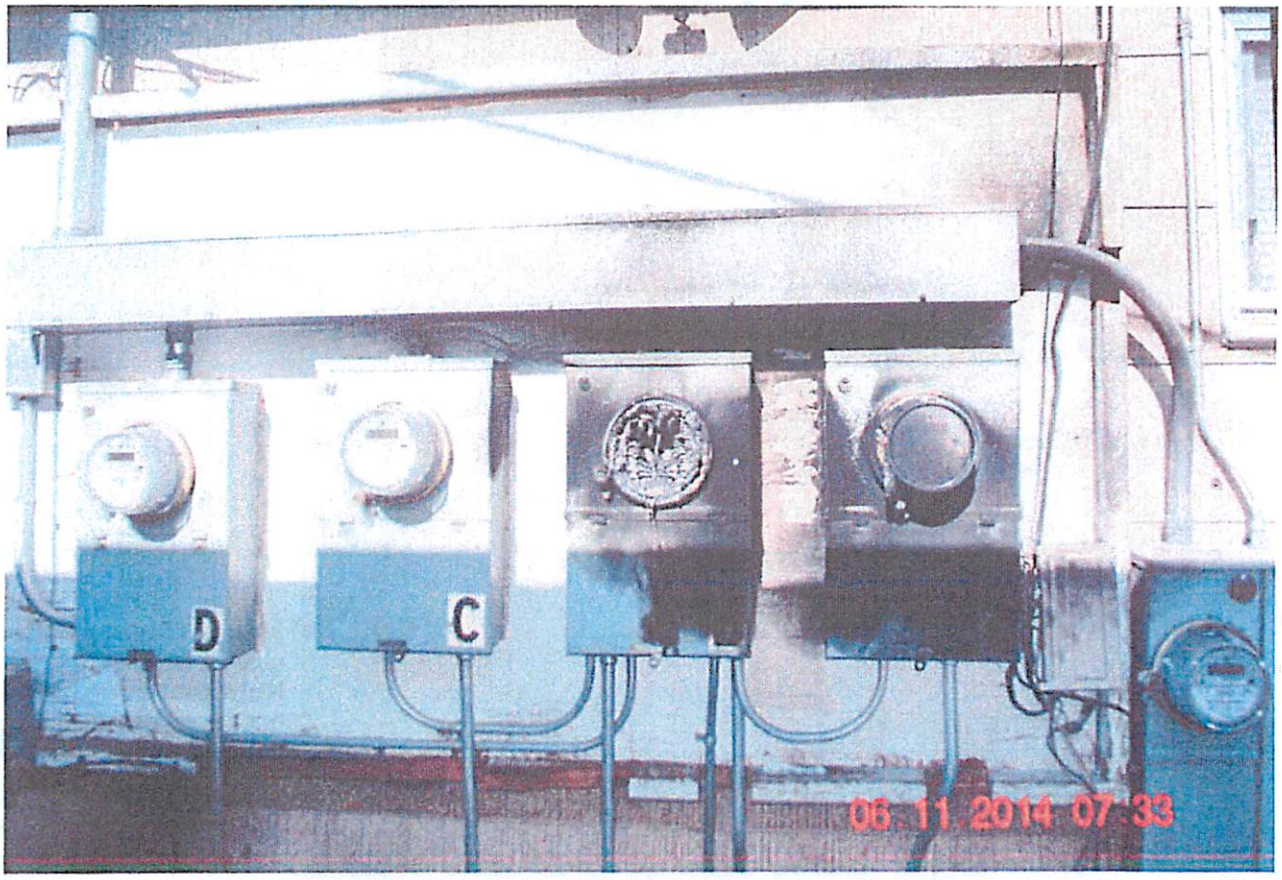
Figure 8: Depicts the localized fire damage to the meter in Apartment B.

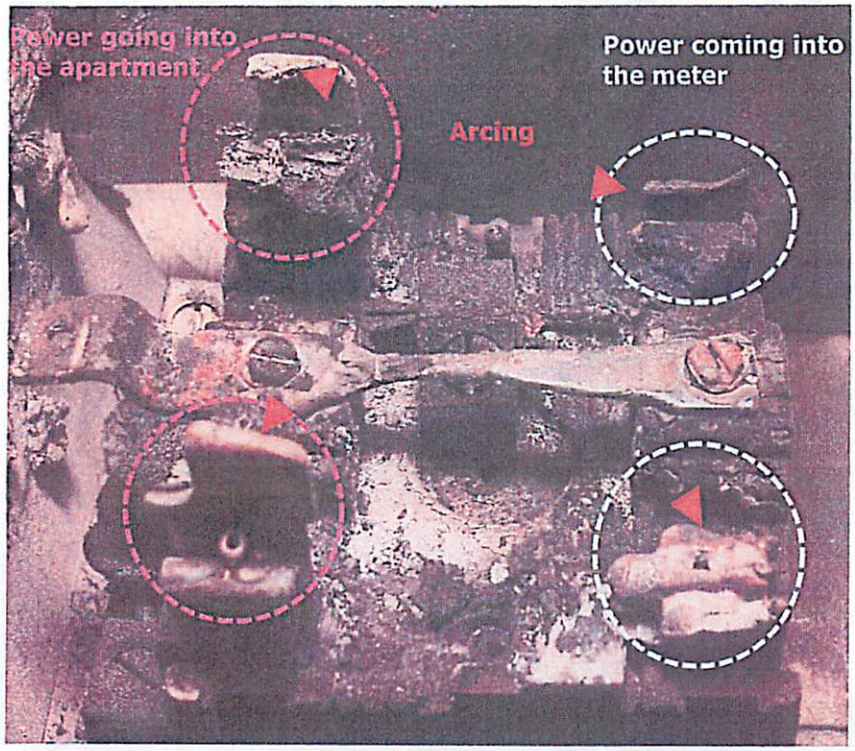
The Arletta Street meter fire was also examined. The meter displayed similar characteristics to the Rhinestone meter incident with one main exception -- the majority of the bus bars were melted away/missing from the Arletta incident meter. Figures 9 and 10 depict the overall fire damage to the meter and associated electrical panel.

Figure 9: Depicts the meter remains within the meter socket enclosure.
