State Fire Marshal Division
Stewart Facility
107 Jacobsen Way
Carson City, NV 89711
(775) 684-7501 • Fax (775) 684-7518

October 17, 2014

ALLEGATIONS BY VARIOUS NEVADA FIRE DEPARTMENTS THAT ELECTRIC METERS IN NV ENERGY'S REPLACEMENT PROGRAM HAVE CAUSED ELEVEN FIRES WITHIN THEIR JURISDICTIONS

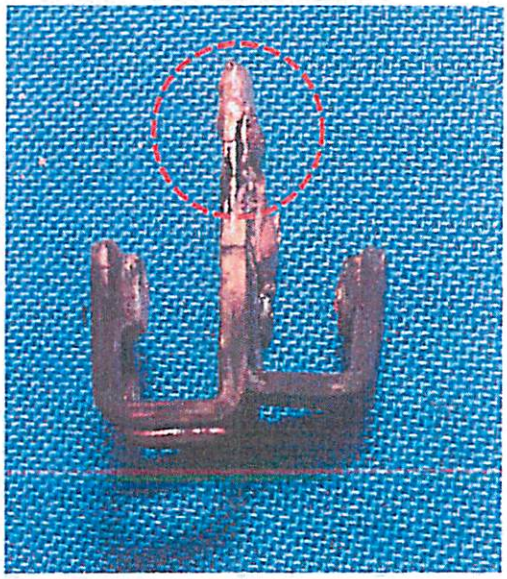
The meter associated with the Arletta Street meter fire was fully seeded into the electrical socket. Additionally, the electrical disconnect portion of the meter displayed extreme melting. See Figures 11 and 12.

Figure 11 depicts the blades associated with the meter which are fully seeded into the socket enclosure.

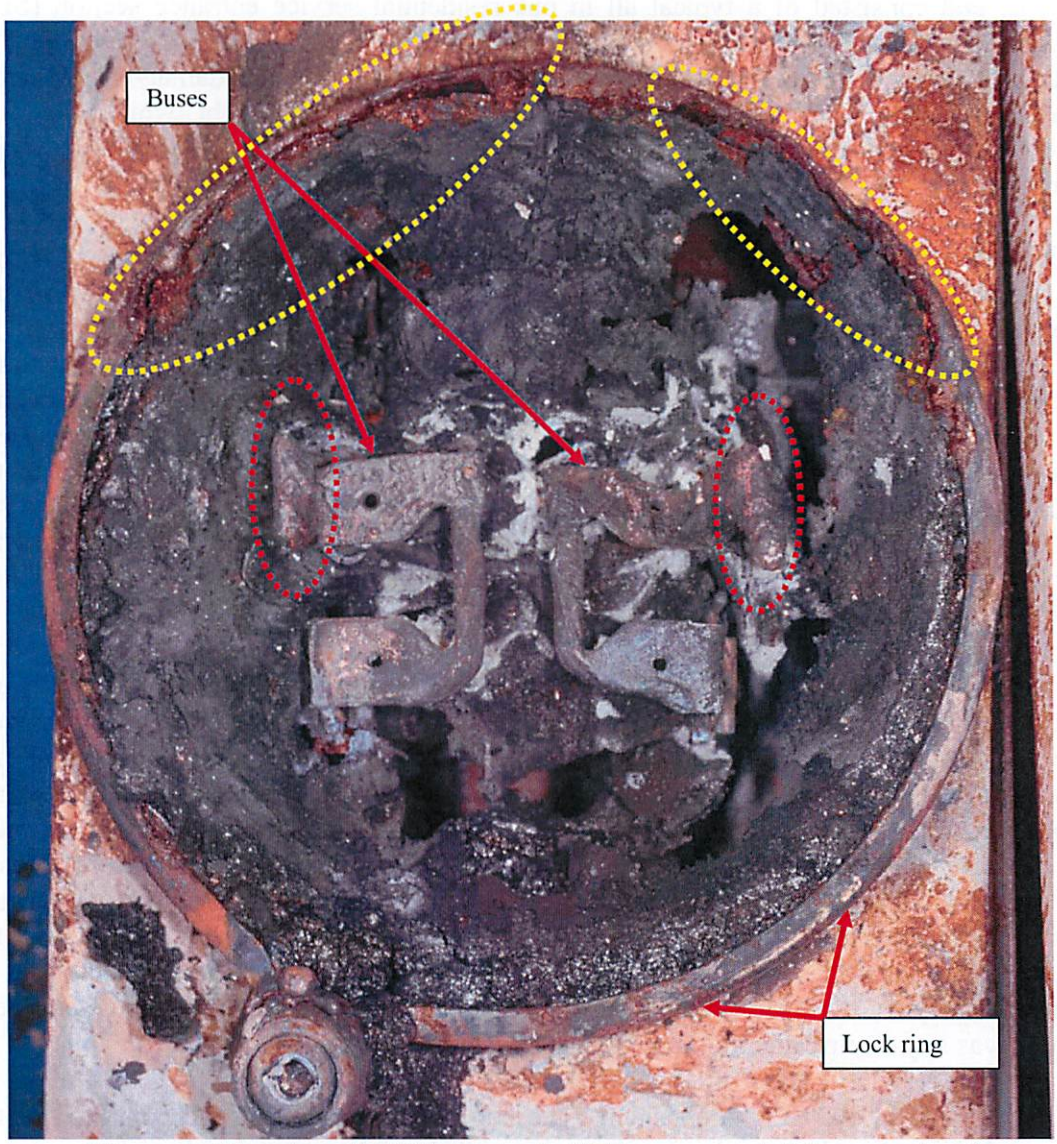
Figure 1. Remains of utility meter in SES as presented for examination.

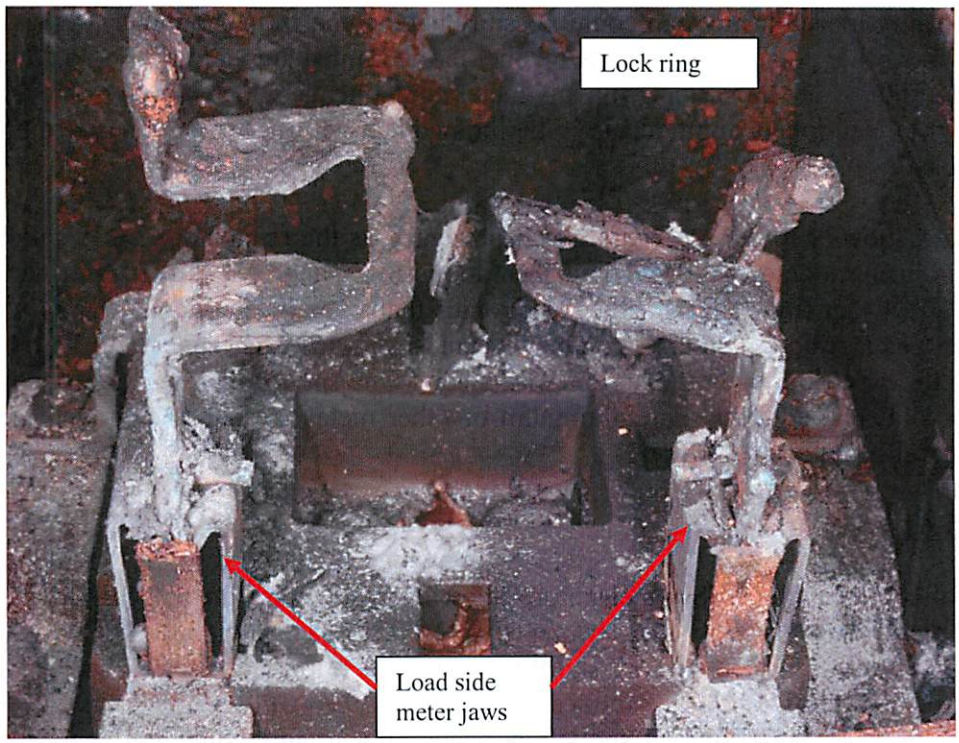
Figure 2. Remains of buses from metering circuit board within electric meter.

Photos 16 and 17 are closer views of the remains of the meter buses. Photo 16 is repeated as Figure 2 above showing where the buses become "stabs" and are inserted into the meter jaws on the load or bottom side.

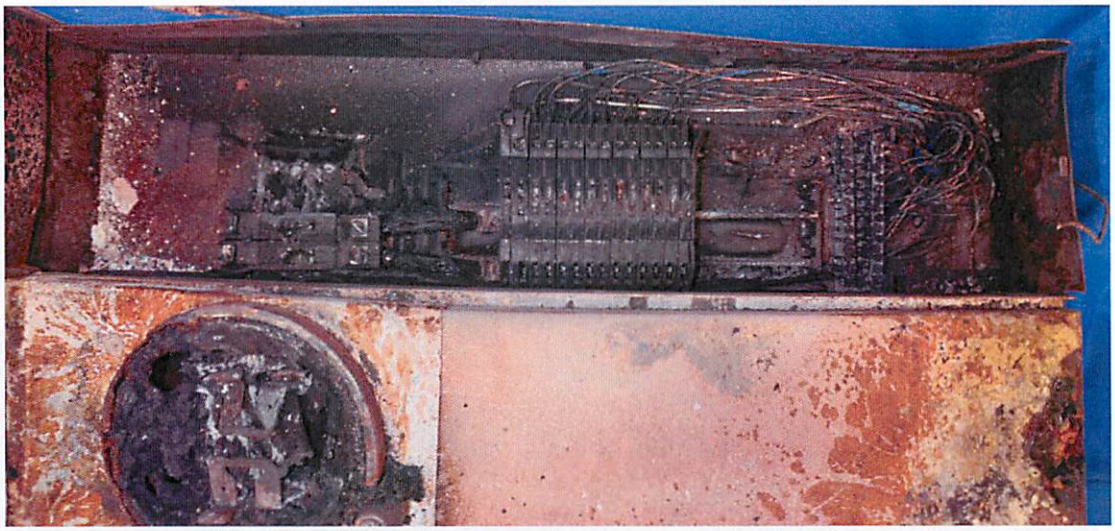
8. Circuit breakers and home run conductors in panel.

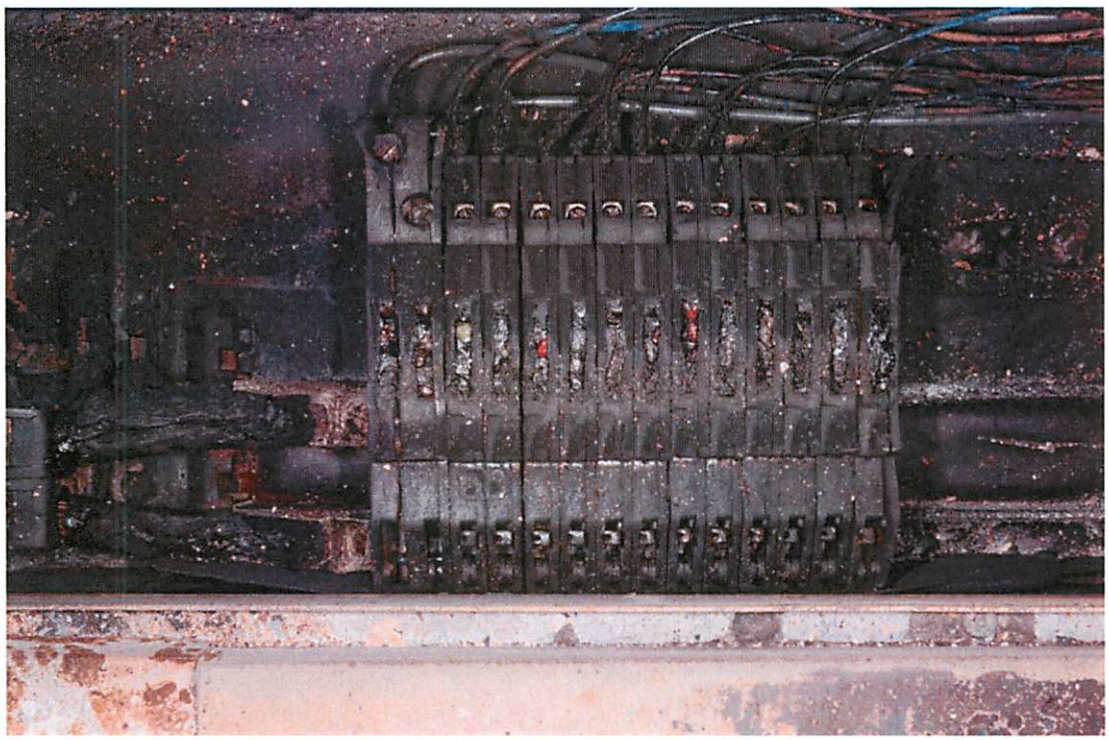
9. Closer view of branch circuit breakers.

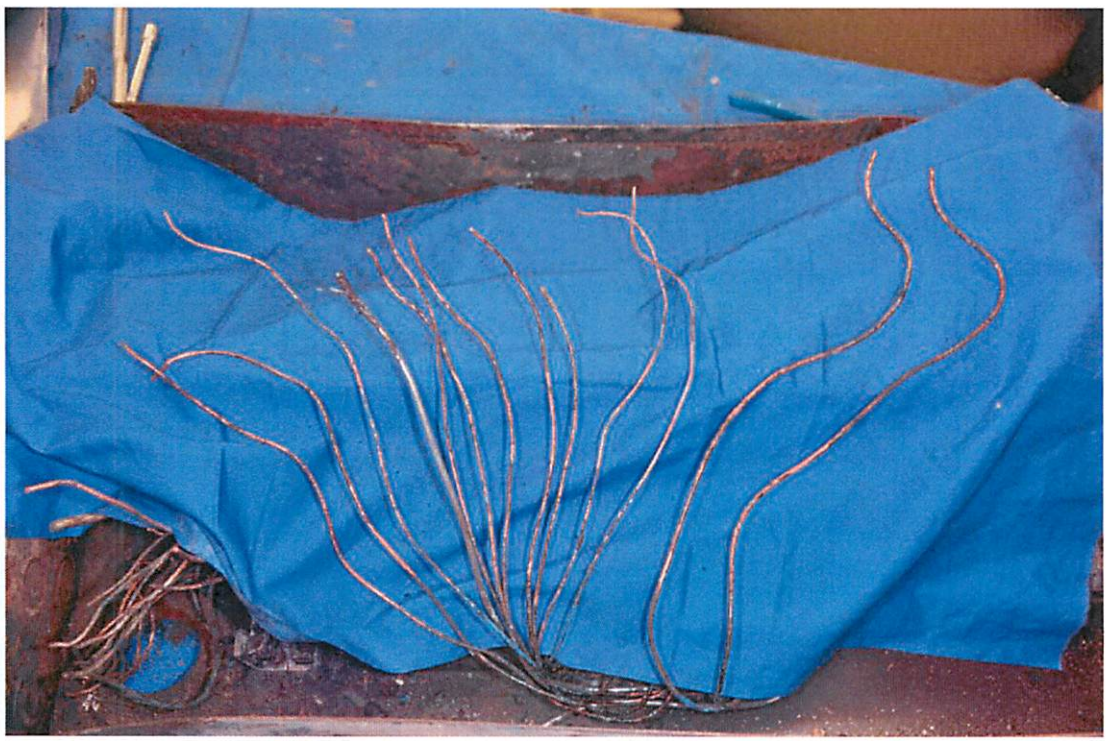
10. Home run conductors laid out for examination.

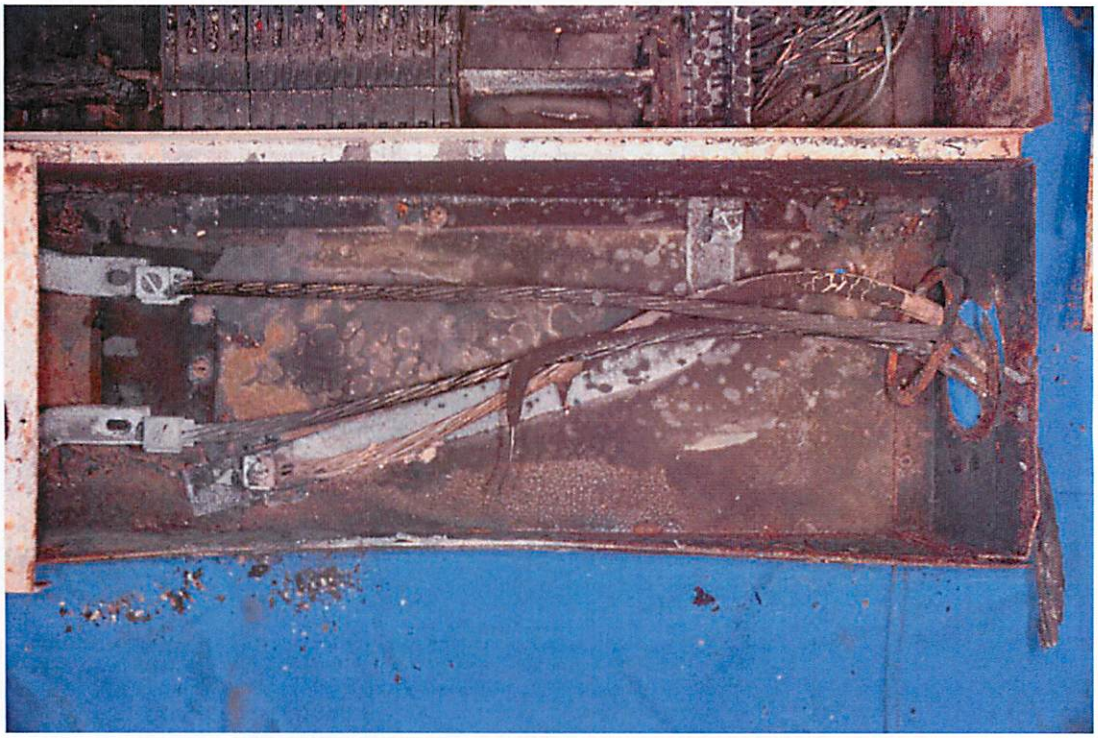
11. Utility lateral conductors in utility pull section.

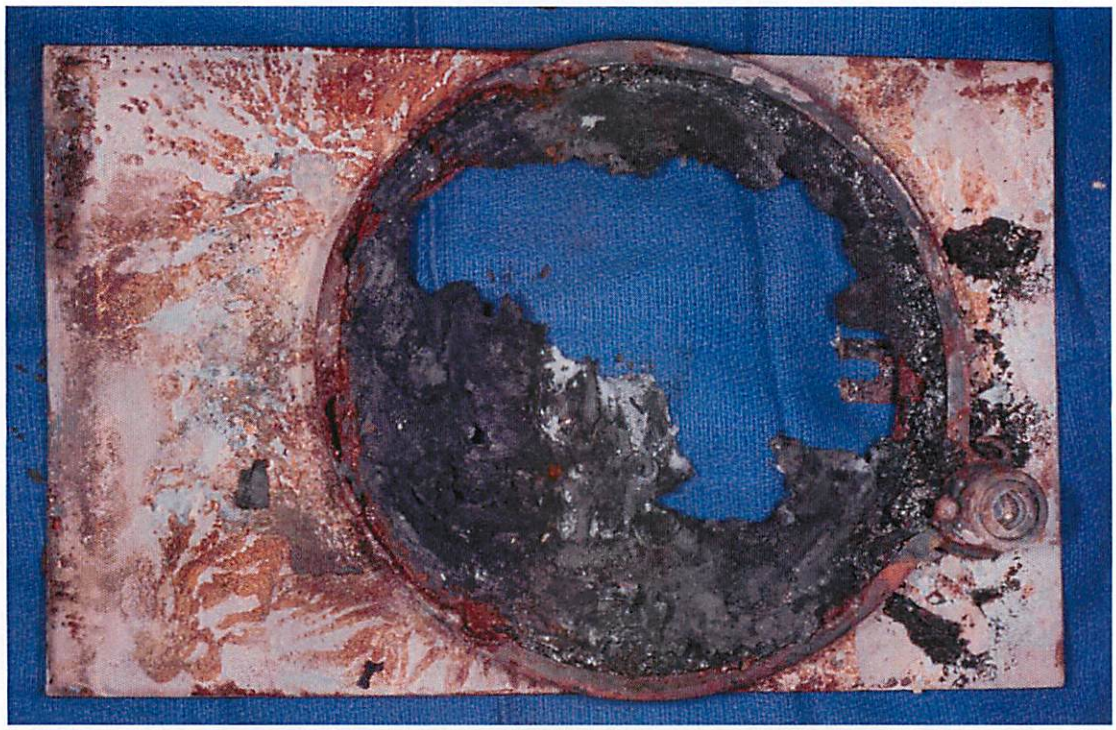
14. Front view of meter loop with meter base and lock ring still in place.

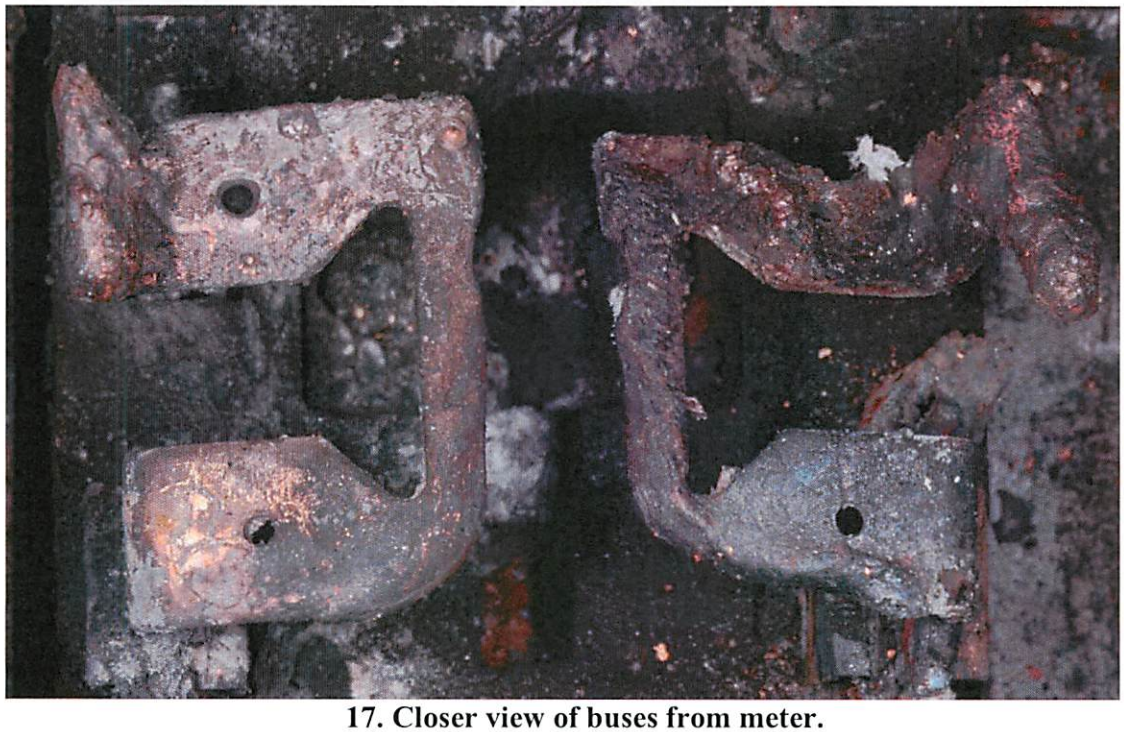
17. Closer view of buses from meter.

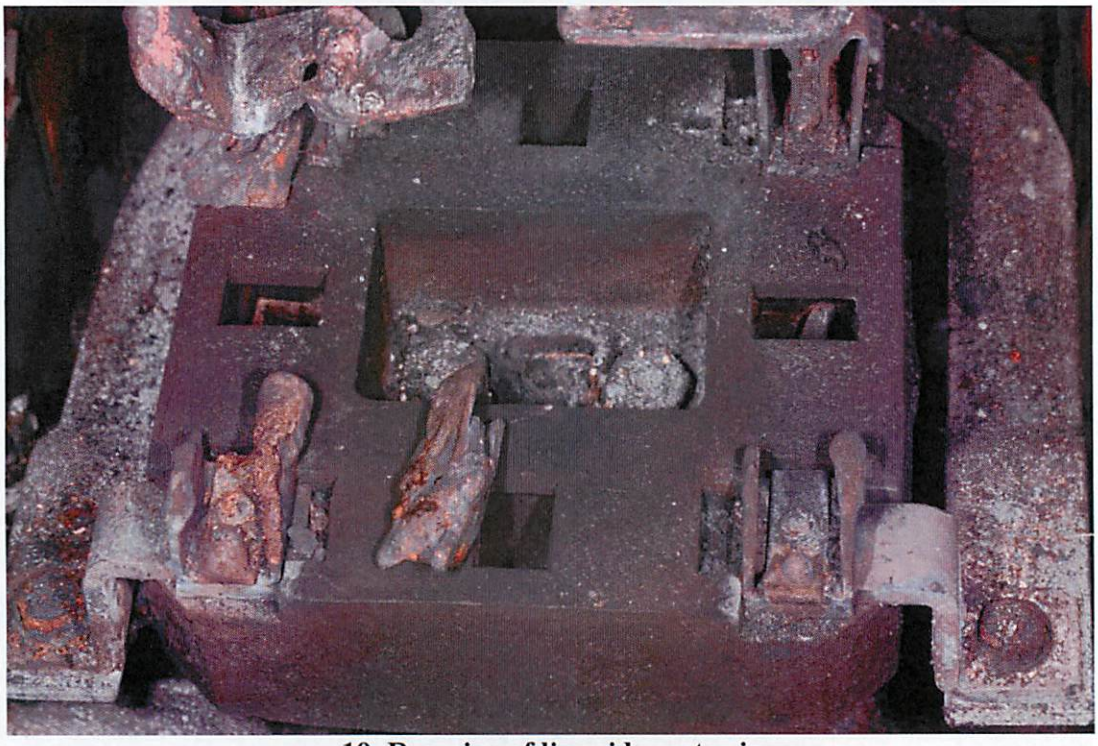
19. Remains of line side meter jaws.

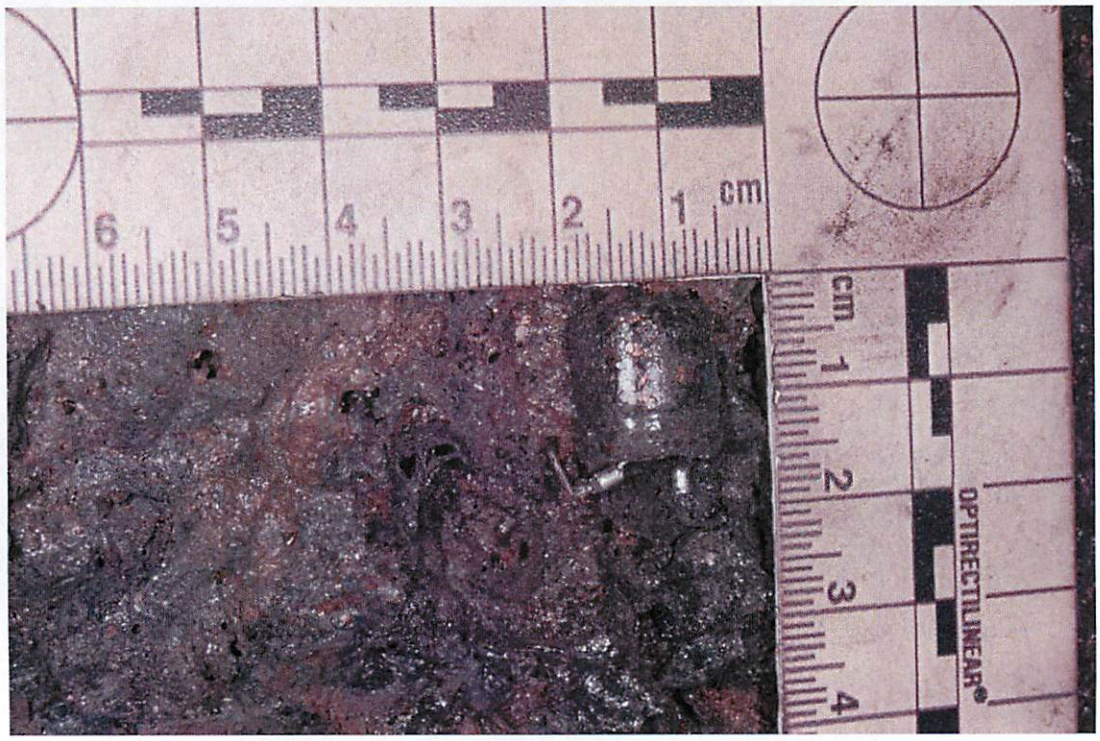
27. Capacitor found in melted mass not from meter.

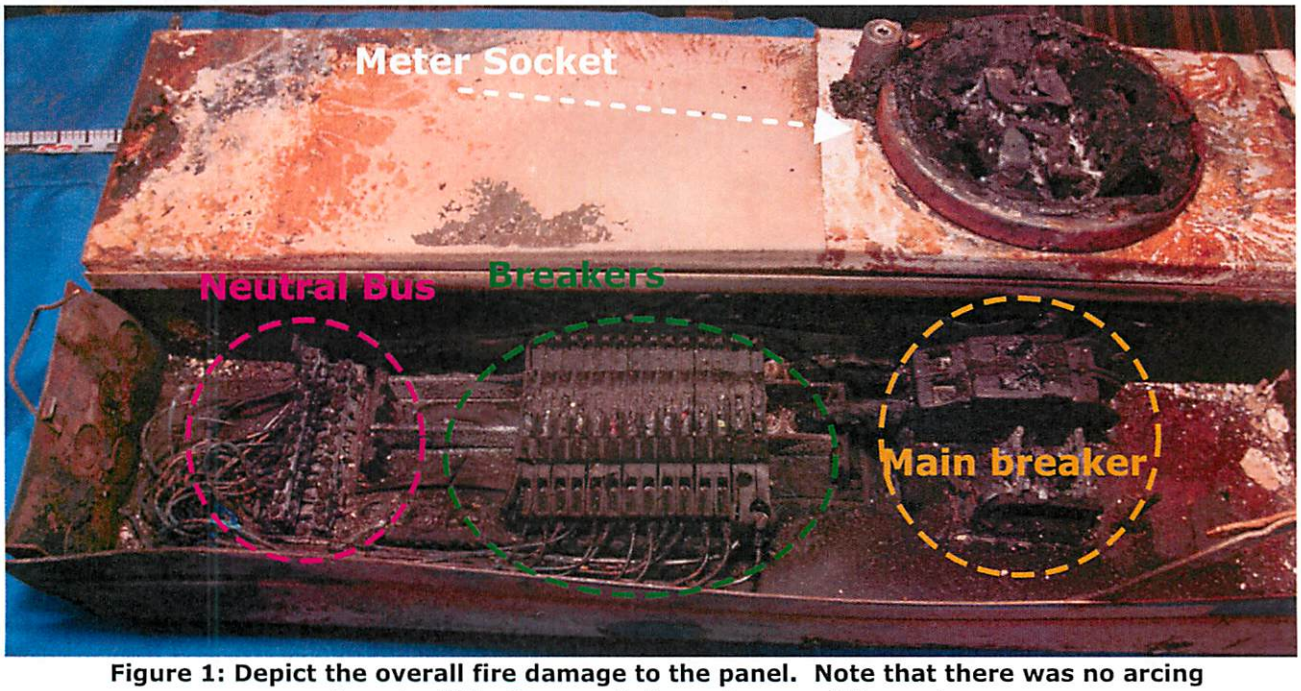
Figure 1: Depict the overall fire damage to the panel. Note that there was no arcing found within the panel, downstream of the meter.

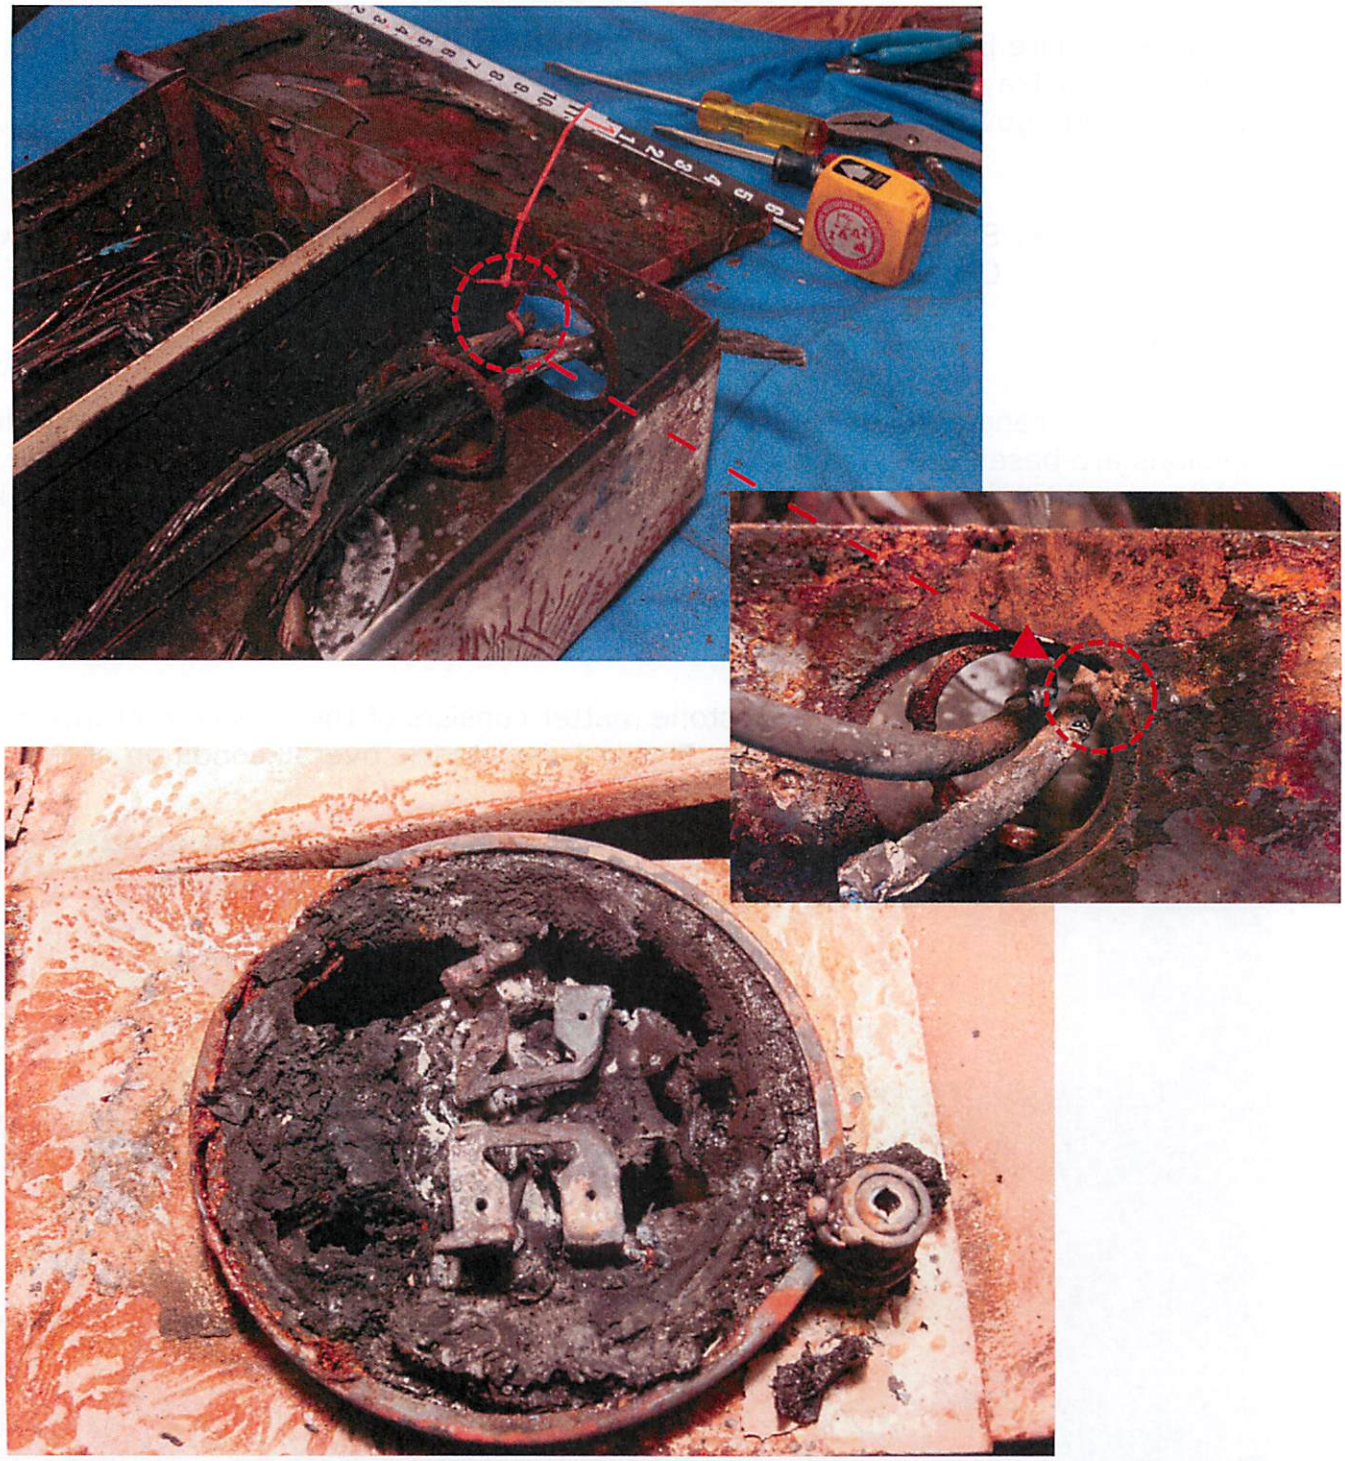
Figures 2 through 4 further depict the overall fire damage to the service entrance section, arcing in the meter socket/meter remains and arcing to the service entrance conductor/panel at the bottom of the panel.

Figures 2 through 4: Depict the arcing within the meter socket enclosure, and the arcing to the bottom of the panel where the power entered the panel.

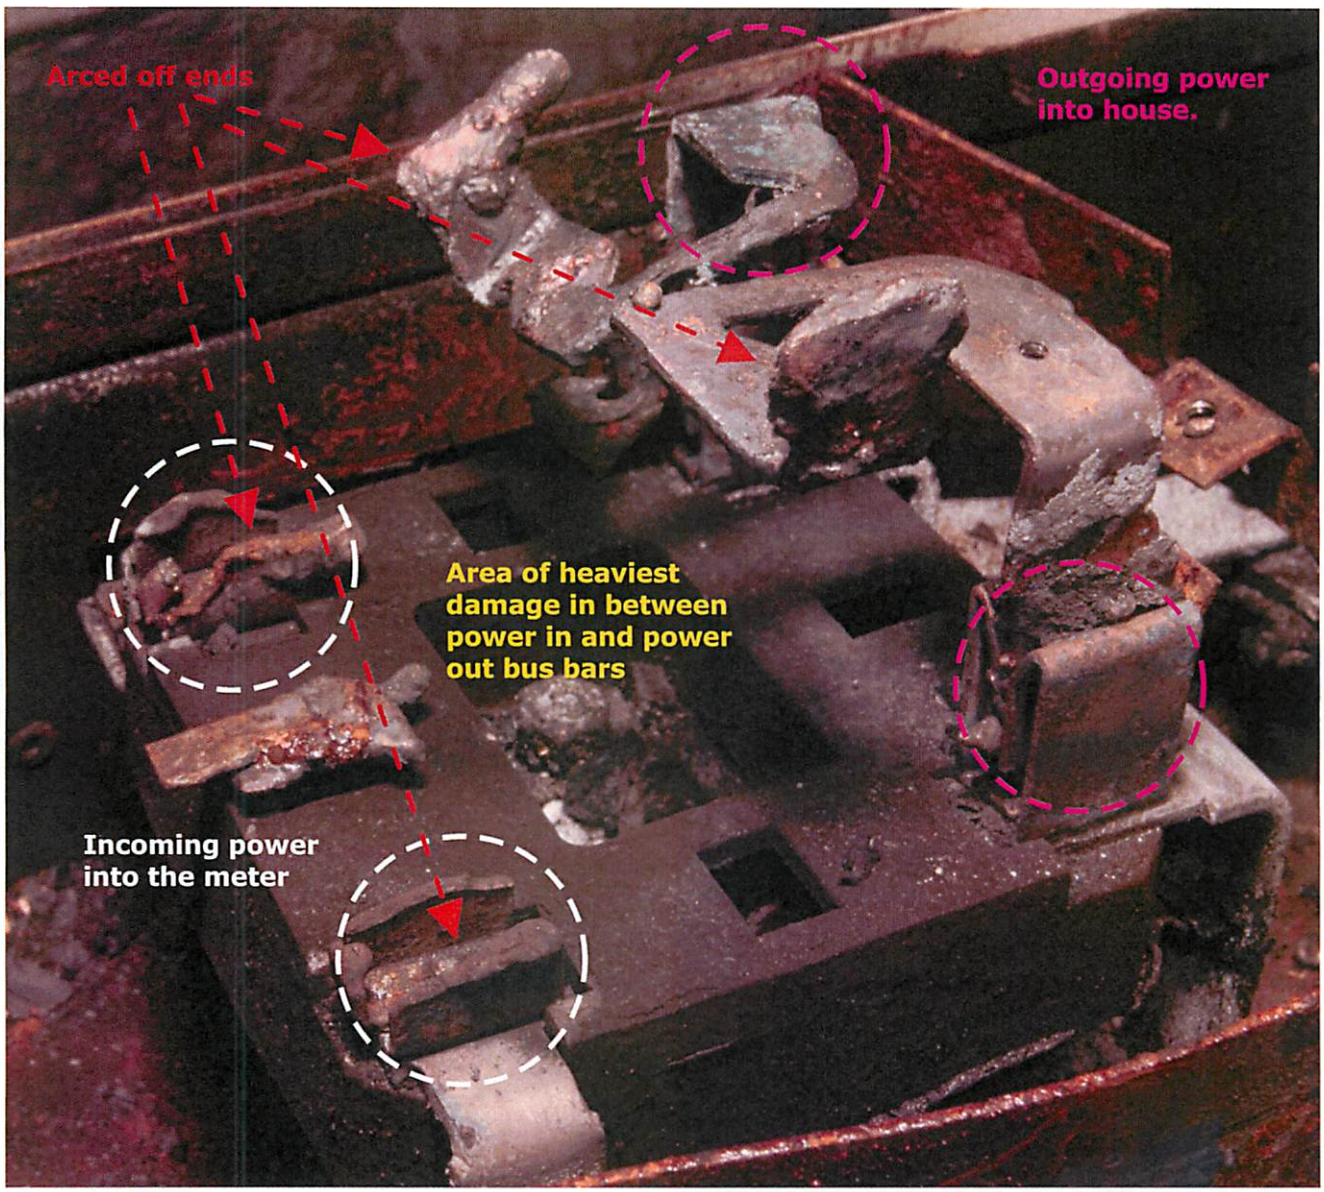
Figure 5: Depicts the overall fire damage to the meter remains within the socket enclosure. Please also note that the meter was adequately seeded into the meter socket enclosure.

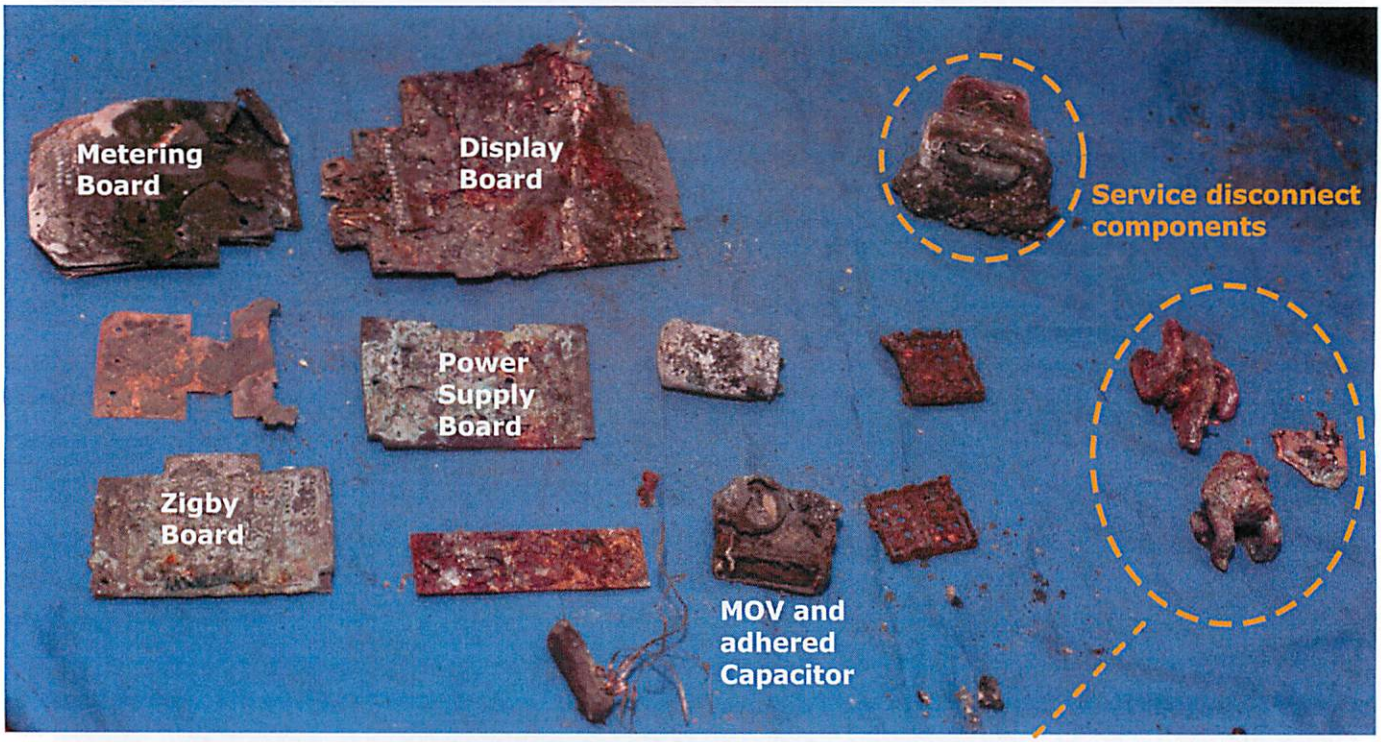
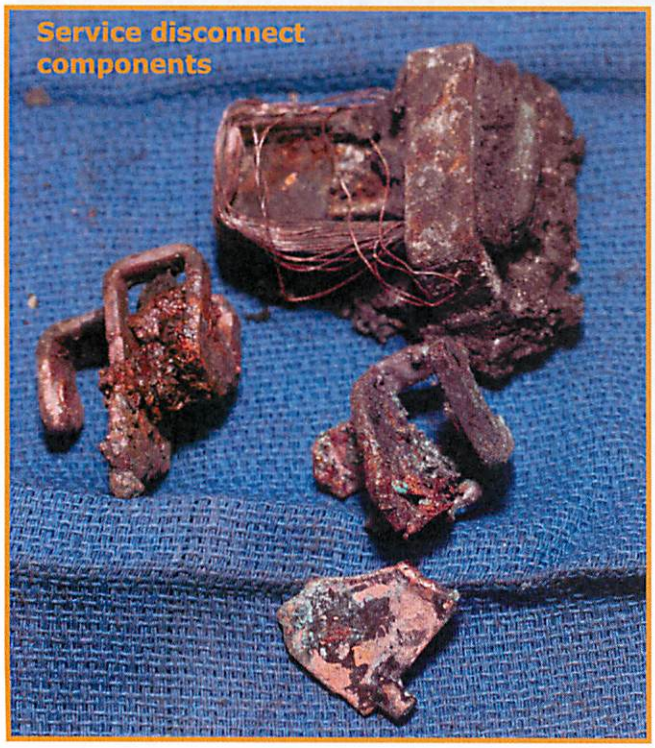
Figures 6 and 7: Depict the overall fire damage to the components associated with the meter.

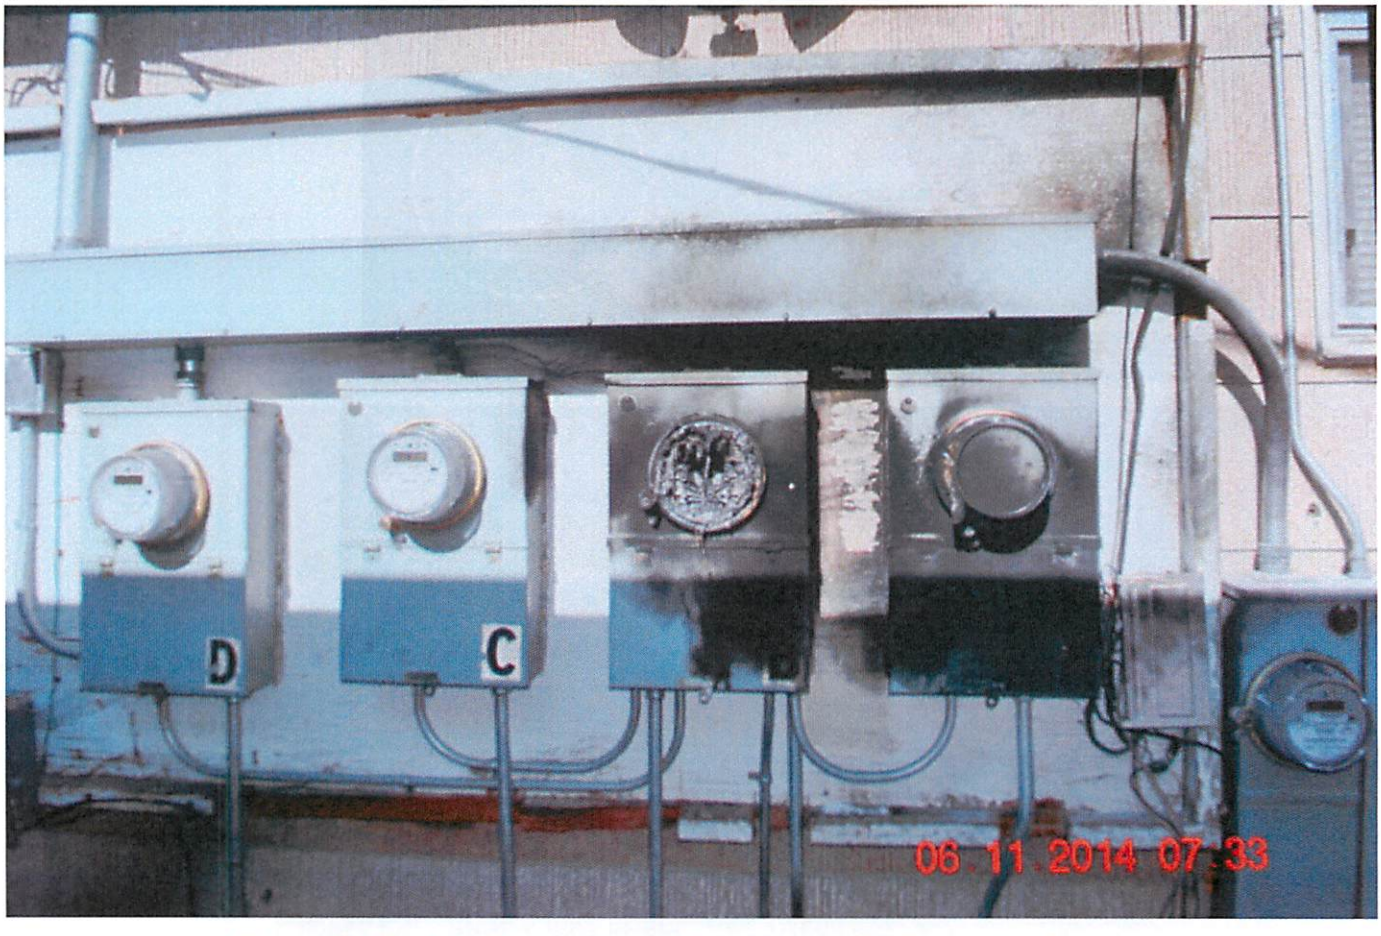
Figure 8: Depicts the localized fire damage to the meter in Apartment B.

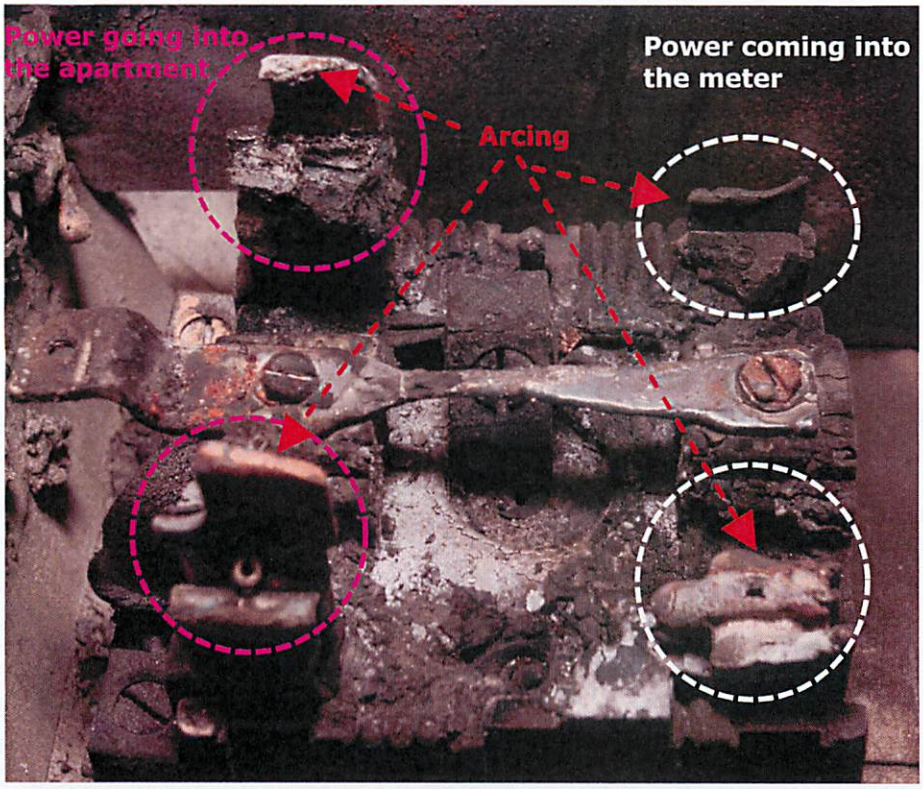
The Arletta Street meter fire was also examined. The meter displayed similar characteristics to the Rhinestone meter incident with one main exception -- the majority of the bus bars were melted away/missing from the Arletta incident meter. Figures 9 and 10 depict the overall fire damage to the meter and associated electrical panel.

Figure 9: Depicts the meter remains within the meter socket enclosure.

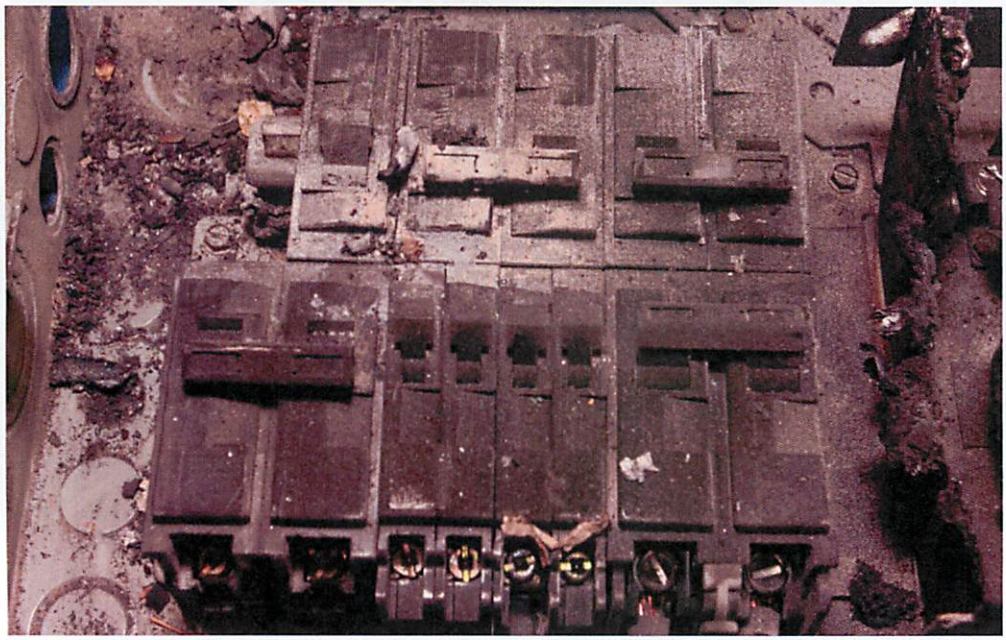
Figure 10: Depicts the circuit breaker panel. Note that none of the breakers are in the tripped position.

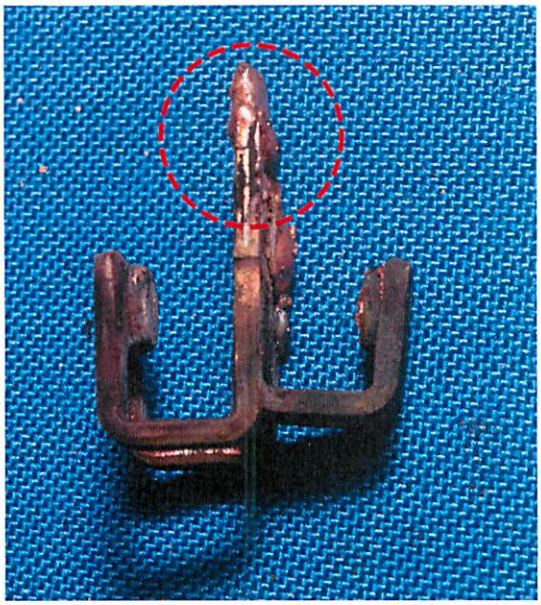
Figure 12 depicts the electrical bus bar associated with the electronic service disconnect. Note the heavy melting to the bus bar.
