# Twelve-Fatality Hotel Arson

Reno, Nevada

USFA-TR-164/May 2008

# **TWELVE-FATALITY HOTEL ARSON RENO, NEVADA**

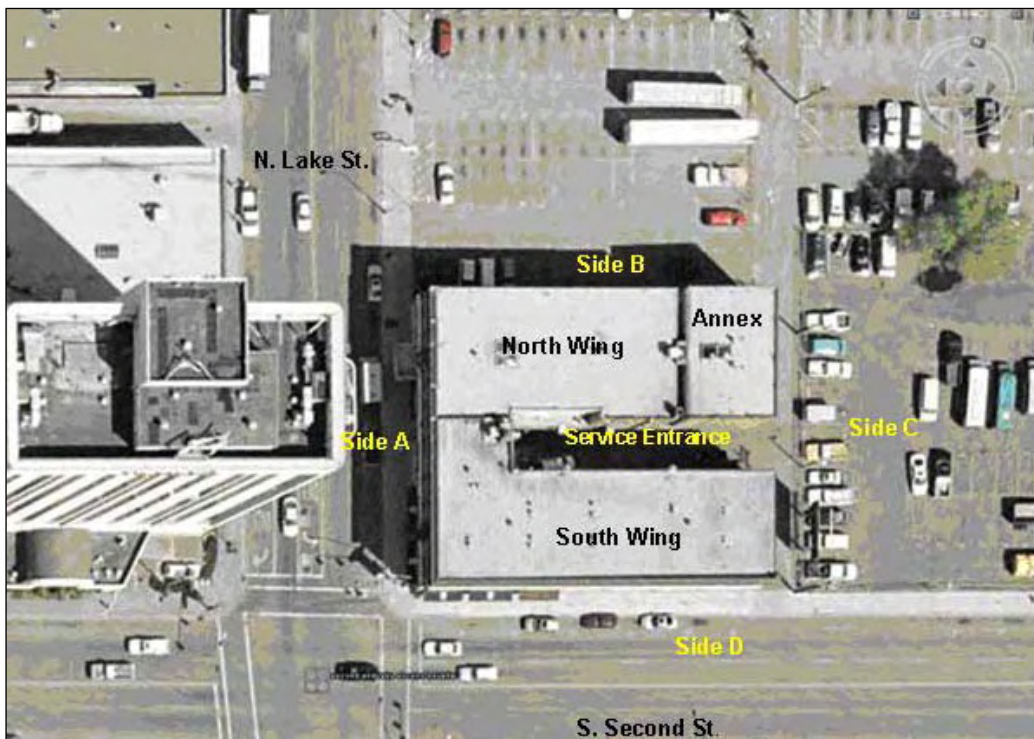
**Figure 1. Overhead View of Mizpah Hotel before the Fire.**

During tactical operations, the RFD uses a lettering system to identify the different sides of the building. Side A of a building is normally the address side or main entrance of the building. Working clockwise, each side of the building received a letter designation i.e., B, C, and D. Figure 1 is an overhead view of the Mizpah Hotel, which illustrates the building layout, geographical orientation, and side designations.

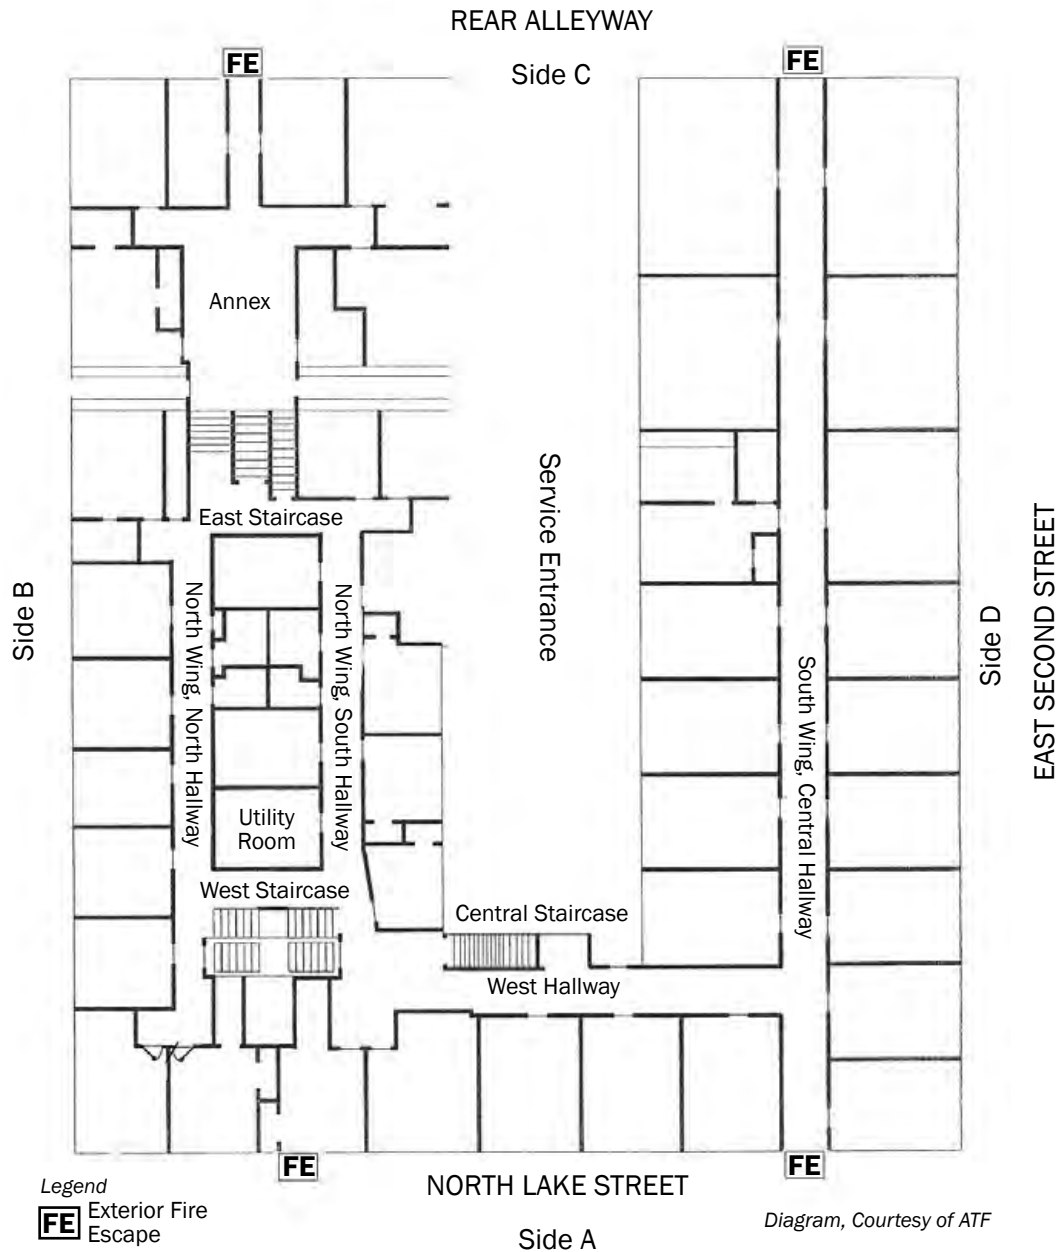
**Figure 4. Basic Floor Plan of Annex and Hotel.**

The second and third floors of the north wing were similar in layout, with two parallel hallways terminating at stairwells at either end. The western staircase was the only stairway in the hotel that led directly to the exterior of the building through the main entrance on Side A of the hotel. A third central staircase was located at midway of the west hallway between the north and south wings. This staircase accessed the residential rooms on the second and third floors of the south wing. A single central hallway provided access to all rooms in the south wing. Figure 4 shows the basic floor plan of the second through fourth floors of the Annex and north and south wings.

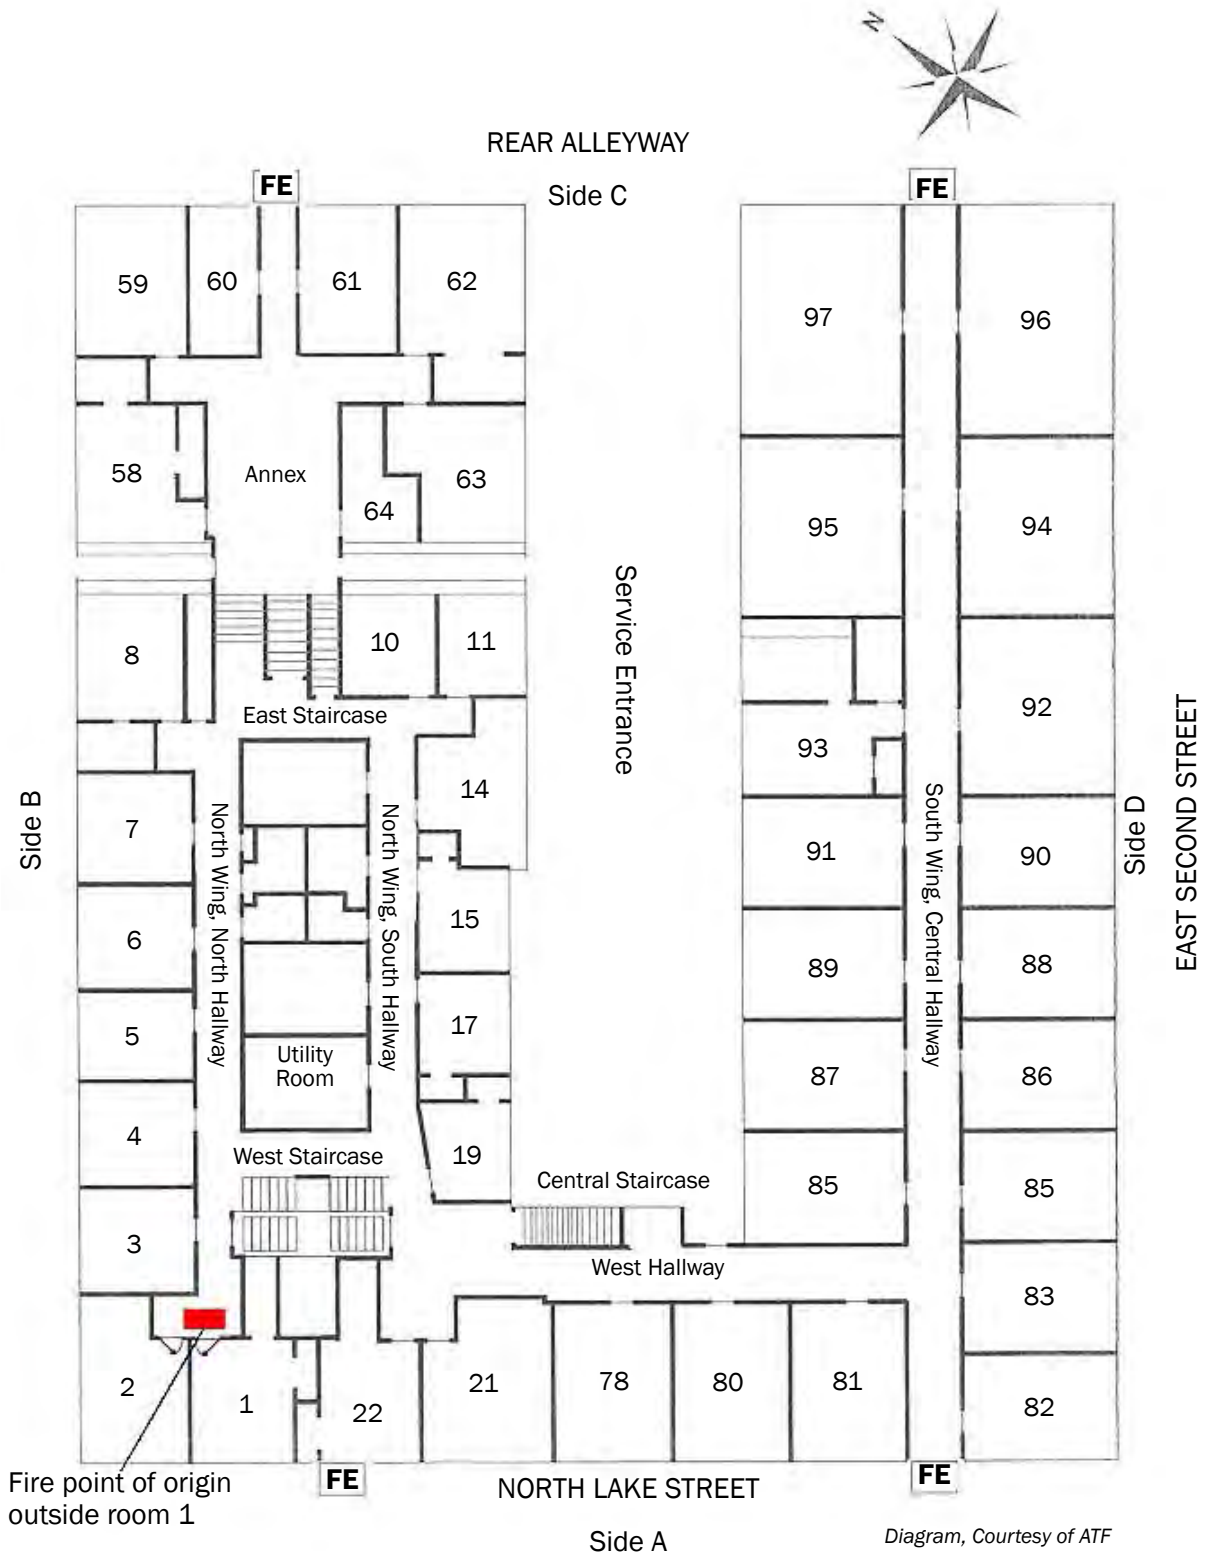
Figure 7. Fire Zone 8.

The system first alerted to the fire at 9:59 p.m. when a smoke detector in Zone 8 activated. This zone covered the entire second floor of both the north and south wings. Fire investigators determined the fire started on the second floor of the north wing. In less than 2 minutes detectors in Zones 3, 4, and 5 activated as well, which is a good indication of how fast the smoke and heat were spreading. Figure 7 shows the second floor area encompassing Zone 8 in which the first smoke detector alerted. Table 2, which follows, shows the time sequence of smoke detector and alarm activations the evening of the fire.

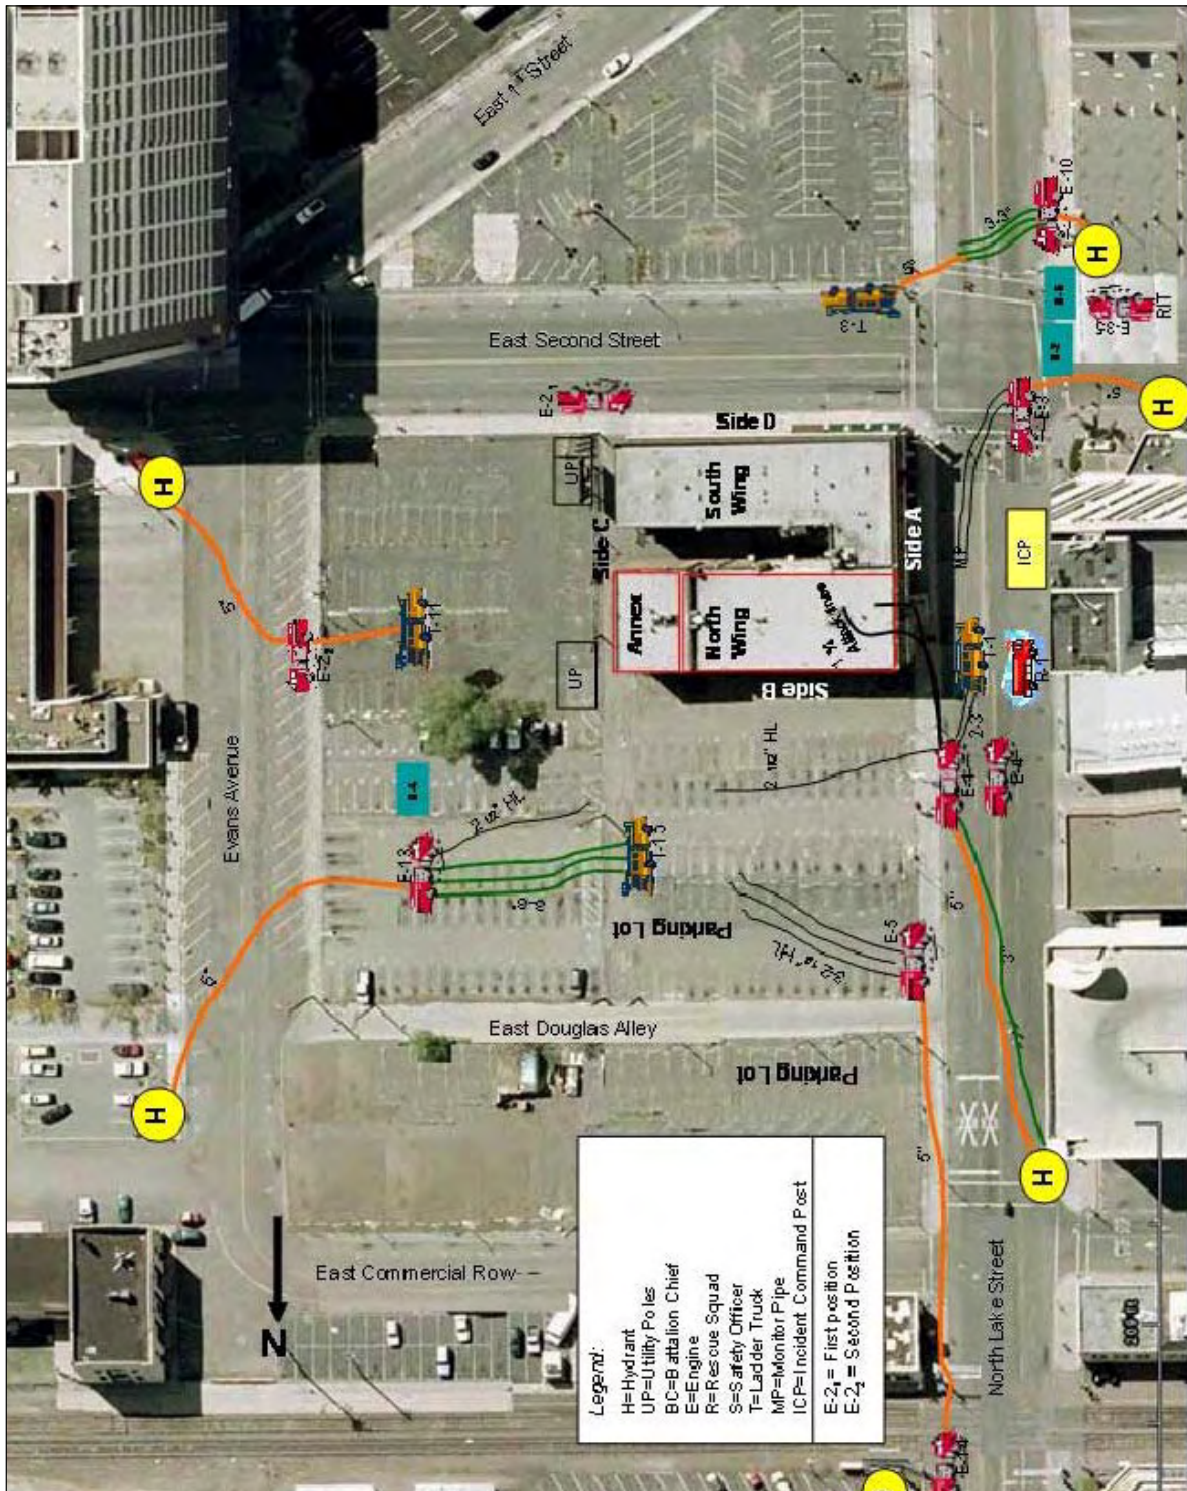
Figure 8. Positioning of Fire Apparatus.

During the incident, three Safety Officers were used to monitor fireground activities. Two were deployed on Side A and one on Side C of the building. The Safety Officers had the authority to stop and report all unsafe fireground practices and activities to the IC. Despite the intense heat and smoke conditions inside the building and the partial collapse of the building, there were no firefighter injuries reported. Figure 8 shows the positioning of fire apparatus at the fire scene during the fire.
